# **Brockman River Catchment**

## ***Water Quality Monitoring Snapshot***

### ***August and October 2011***

**Prepared by the Ellen Brockman Integrated Catchment Group: June 2012**

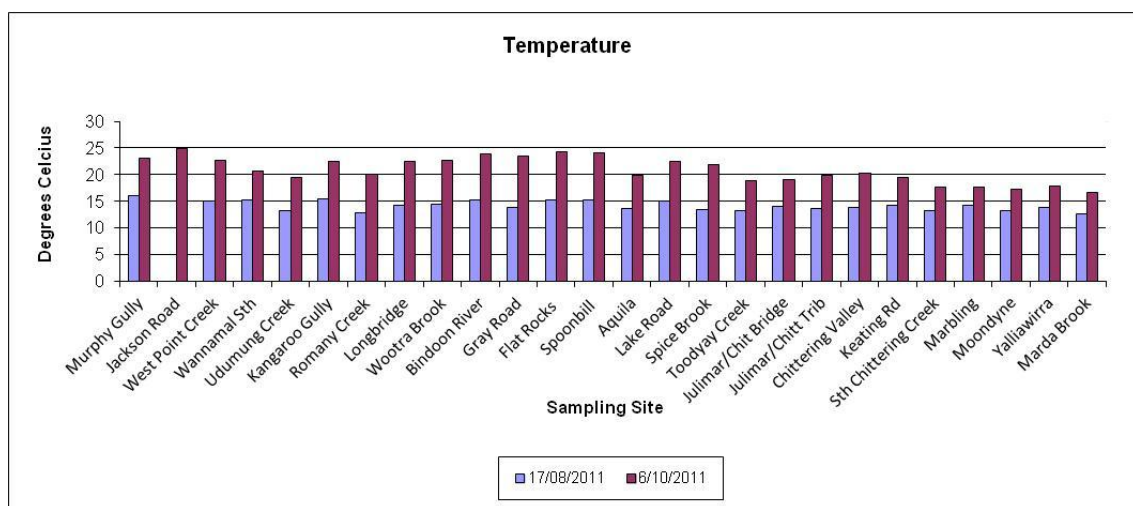
**Figure 6:** Water temperature of surface water within the Brockman River Catchment on the 17<sup>th</sup> August and 6<sup>th</sup> October 2011.

Samples taken were from sites with flowing water at a depth ranging from 10-20cm below the surface and not in contact with the sediment at any time. August temperatures ranged between 5.2°C at Marda Brook (BRN26) and 25°C at Wootra Brook (BRN9). Water temperatures were generally warmer during the October sampling run, and ranged between 13.6°C at South Chittering Creek (BRN22) and 22.4°C at Longbridge (BRN8), (Figure 6).

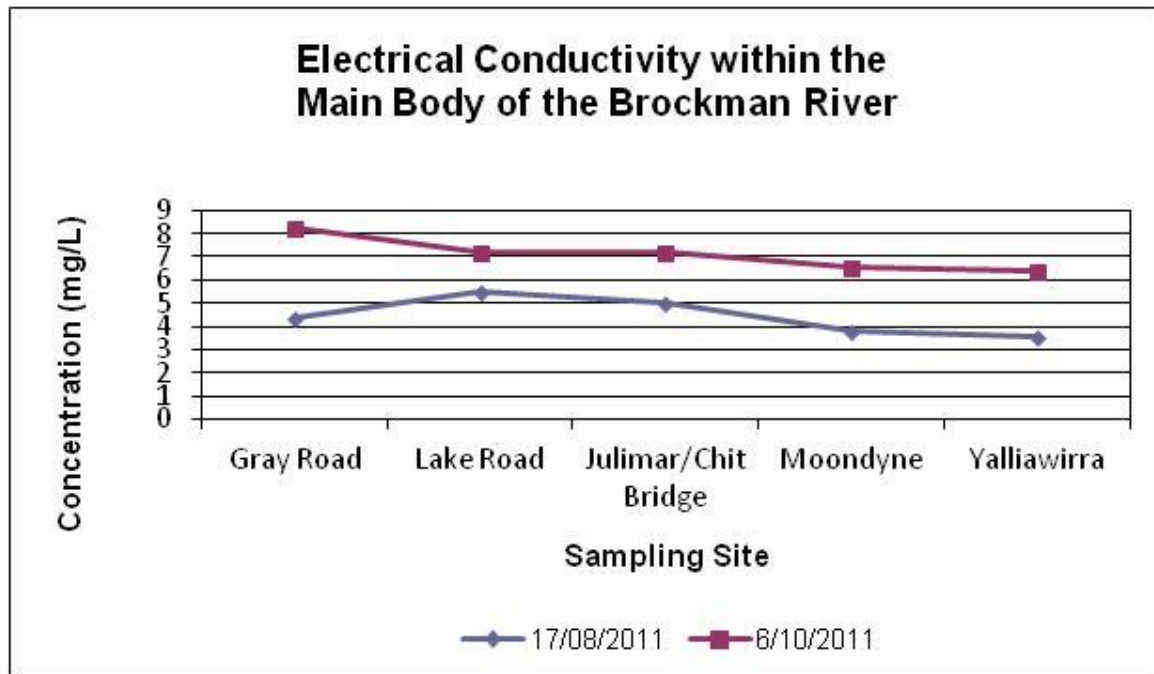
**Figure 8:** Electrical conductivity within the main body of the Brockman River, recorded at sampling sites Grey Road (BRN27), Lake Road (BRN15), Julimar/Chittering Bridge (BRN18), Moondyne (BRN24) and Yalliwirra (BRN25) in 2011.

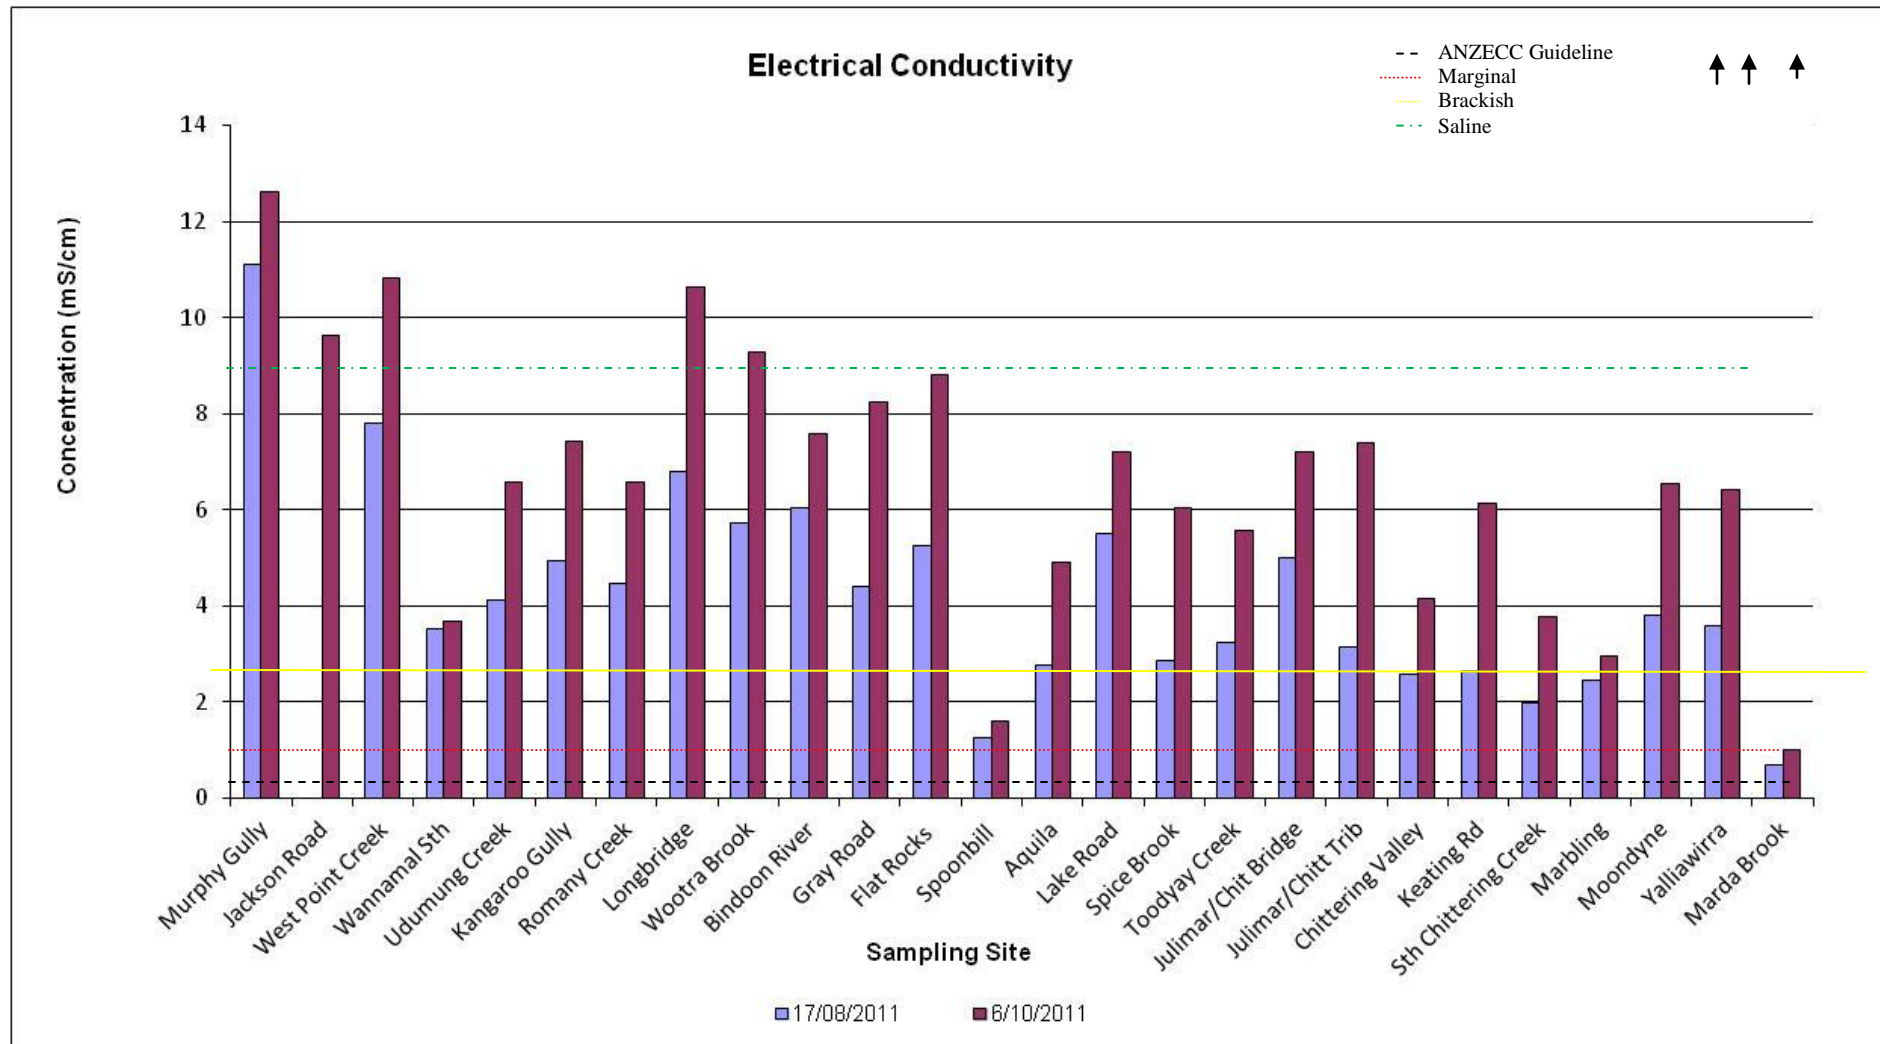
**Figure 9:** Conductivity in surface water within the Brockman River catchment on 17<sup>th</sup> August and 6<sup>th</sup> October 2011.

Electrical conductivity ranged from 0.707mS/cm at Marda Brook (BRN26) to 12.63mS/cm at Murphy Gully (BRN2). All sites consistently exceeded the ANZECC guidelines for freshwater lowland rivers of 0.12mS/cm to 0.3mS/cm (Figure 9). It should be noted that of the sites that exceeded the guidelines for ecosystem value, the majority of them were also within the brackish levels, with 4 sites within saline levels on at least one sampling occasion. Brackish water is between 3mS/cm and 9.1mS/cm, saline water is between 9.5mS/cm and 23mS/cm), anything above 2.7 is becoming brackish and would be detrimental for irrigation of stone fruit and citrus orchards (Figure 9).

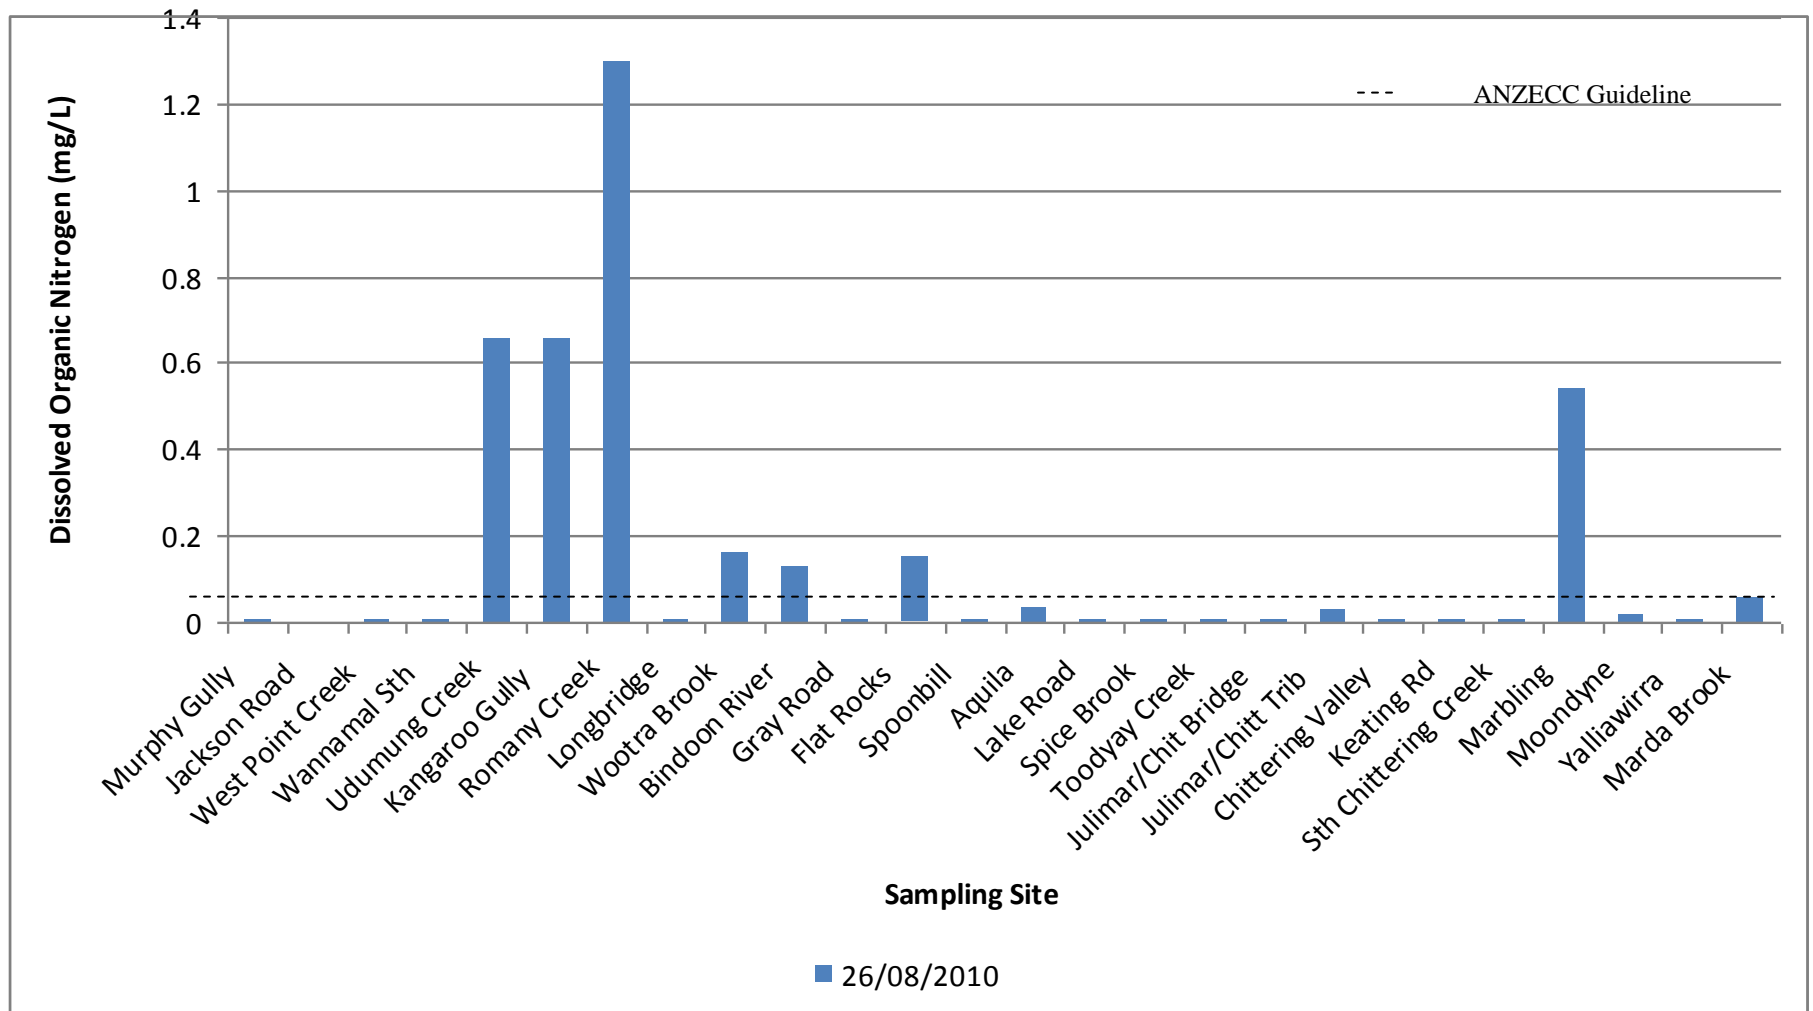
**Figure 13:** Filterable Organic Nitrogen concentrations in surface water within the Brockman River catchment on 26<sup>th</sup> August 2010 \*blanks represent no sample taken.

It is important to mention that DON concentrations compared with total nitrogen, ammonia and total oxidised nitrogen concentrations showed that nitrogen exists primarily in its soluble form in the Brockman River catchment.

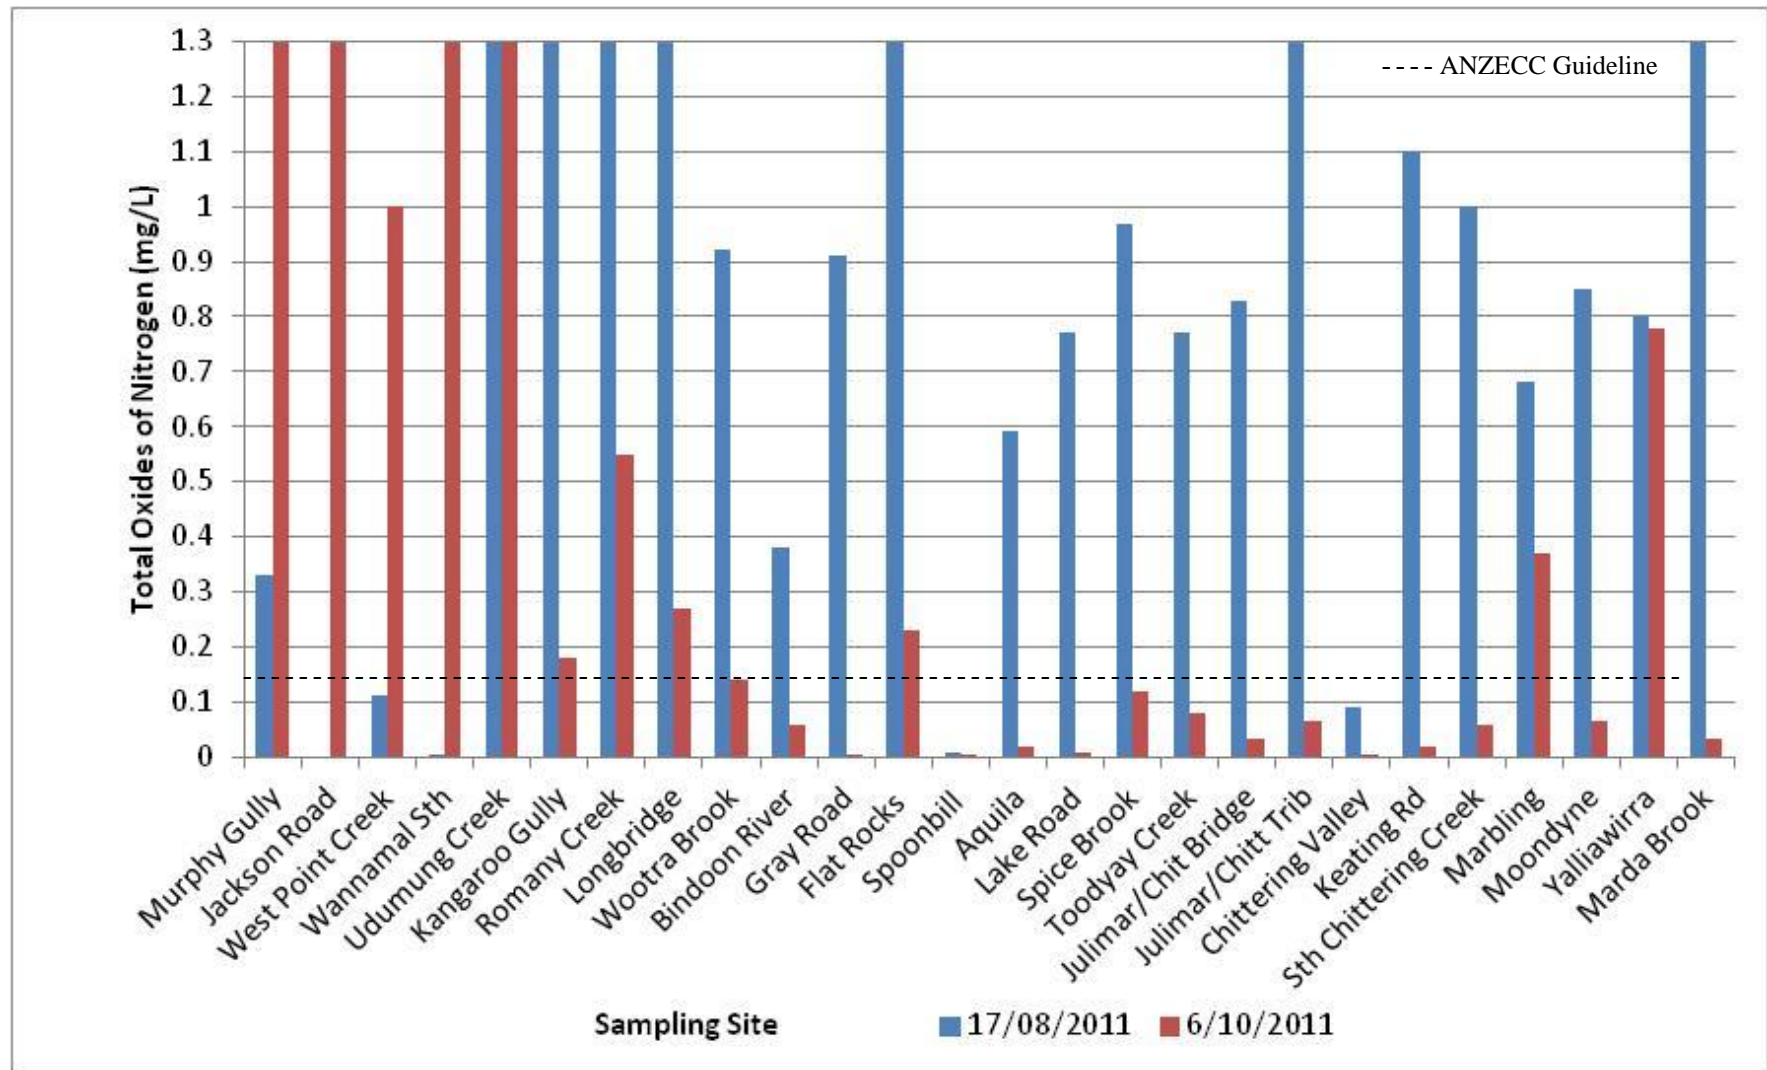
**Figure 14:** NOX\_N (TON) concentrations in surface water within the Brockman River catchment in 17<sup>th</sup> August and 6<sup>th</sup> October 2011. \*note blanks represent no sample taken

sampling occasions where as only 21 sites exceeded the ANZECC guideline on one or more sampling occasion in 2010. This difference can most likely be accounted for by the significantly reduced rainfall season in 2010. Cereal production, beef, pigs, and sheep may contribute to the higher concentrations of TON in the northern half of the catchment. In comparison, the primary production of the southern half of the catchment in the Chittering valley is vineyards and orchards. As a result the TON entering the river upstream from runoff carrying manure and organic matter is diluted as it flows through the catchment.

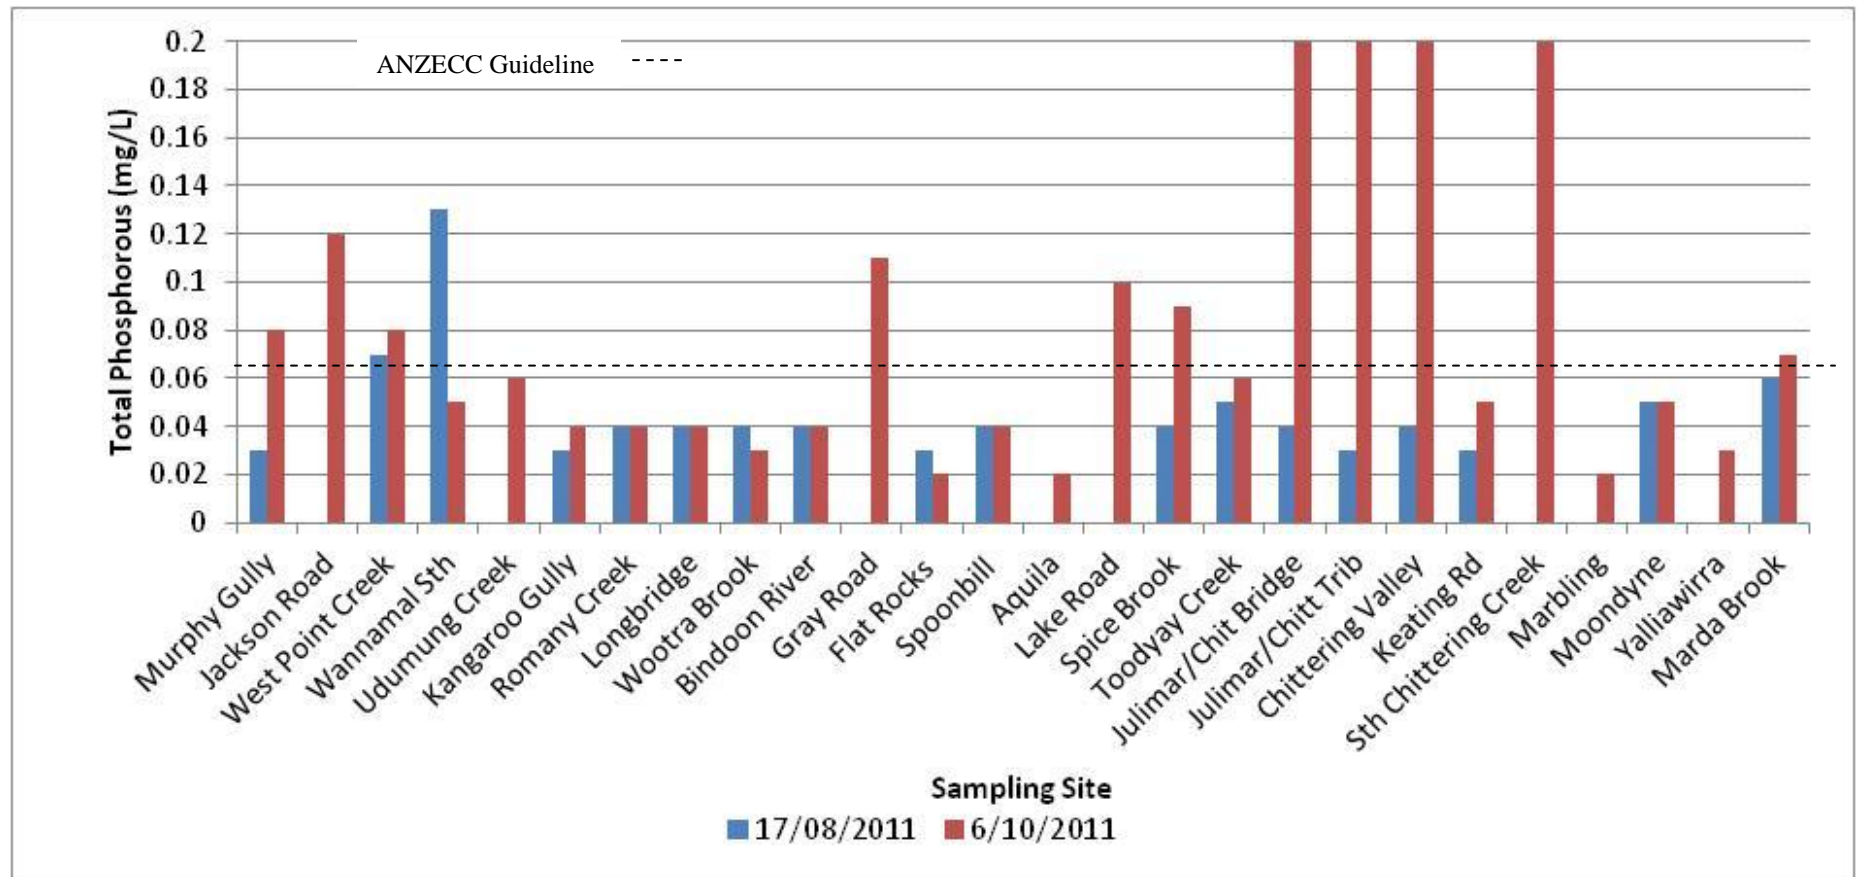
**Figure 15:** Total Phosphorous concentrations in surface water within the Brockman River catchment sampled on 17<sup>th</sup> August and 6<sup>th</sup> October 2011. \*note blanks represent no sample taken

comparison to the October sampling occasion. Continued long term monitoring is recommended to gain an understanding of phosphorous export from this catchment.

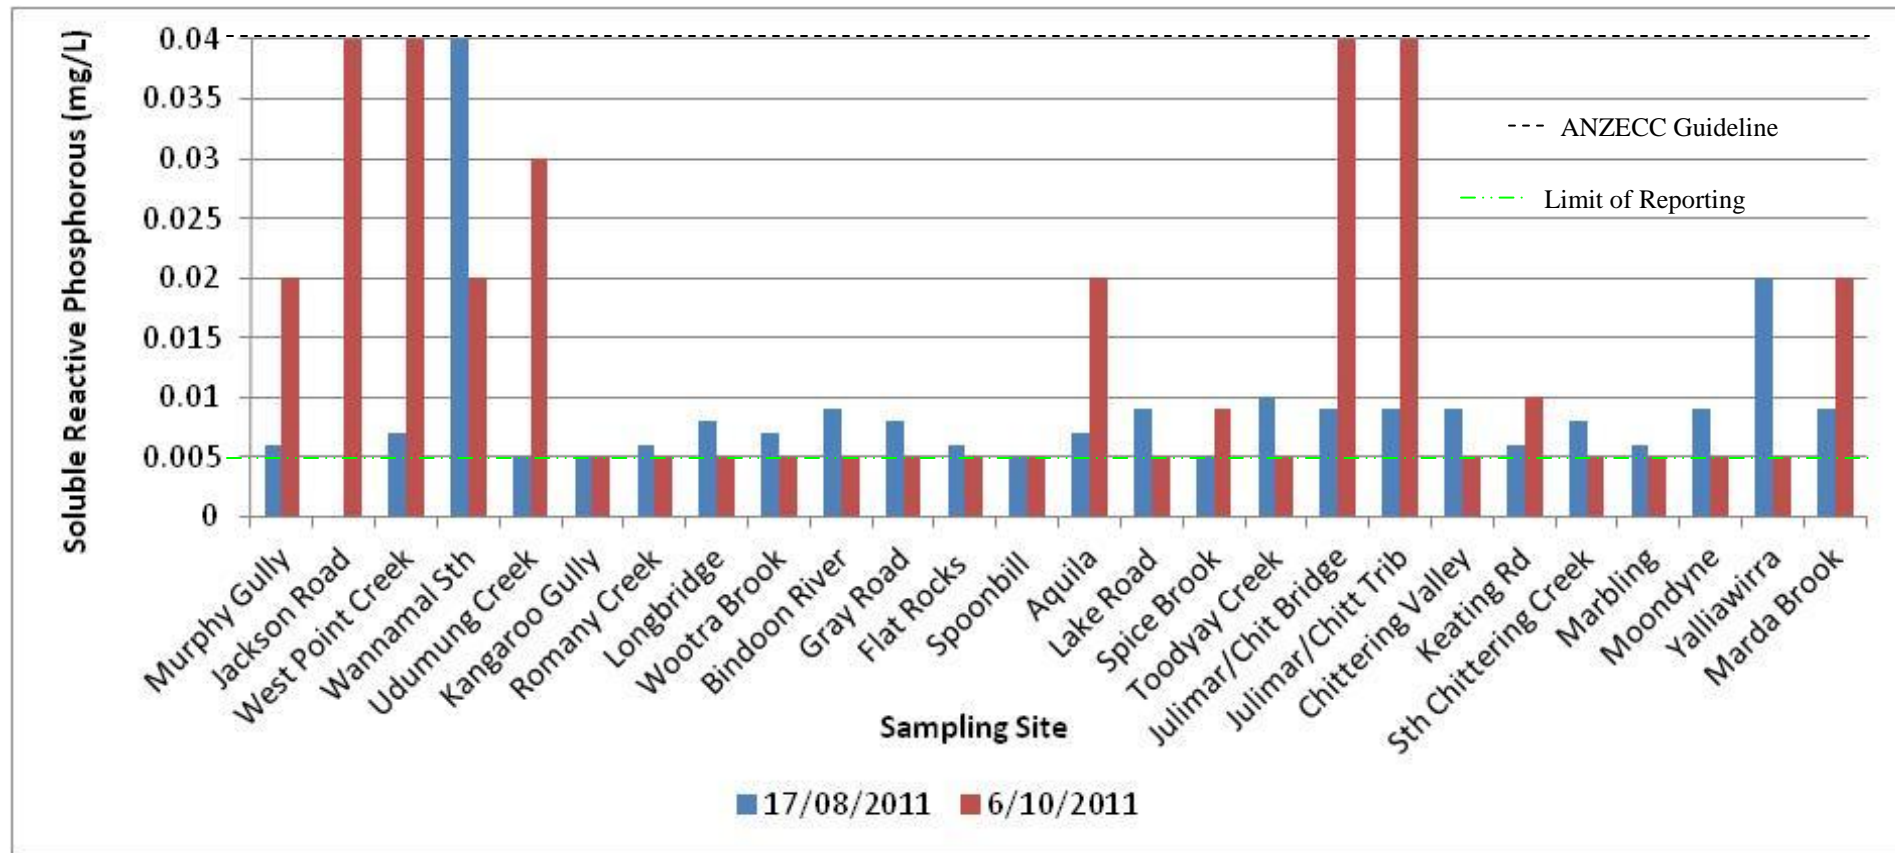
**Figure 16:** Filterable Reactive Phosphorous concentrations in surface water within the Brockman River catchment sampled on 17<sup>th</sup> August and 6<sup>th</sup> October 2011. \*blanks represent no sample taken

FRP concentrations in surface water within the Brockman catchment were at or below the ANZECC water quality guideline for lowland river systems value of 0.04mg/L at all sites and below the Limit of Reporting (LOR) at most sampling sites on both sampling occasions. Jackson Rd (BRN2), West Point Creek (BRN3), Wannamal South (BRN4), Julimar Bridge (BRN18) and Julimar Tributary (BRN19) were the only sites to be at the guideline on one sampling occasion (Figure 16).

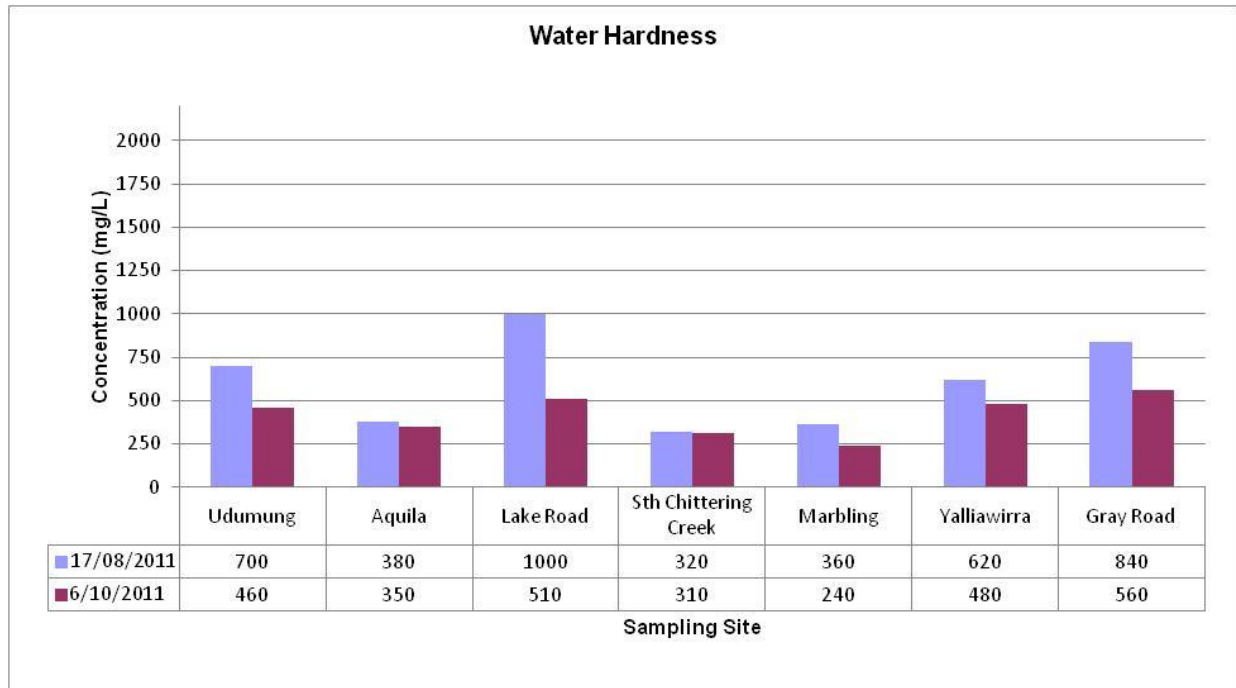
**Figure 17:** Water Hardness sampled from surface waters within the Brockman River catchment on 17<sup>th</sup> August and 6<sup>th</sup> October 2011.

240mg/L at Marbling (BRN23) – very hard, and 1000mg/L at Lake Road (BRN15) – extremely hard (Figure 17). This was significantly lower than the previous year's results.

**Table 5:** Hardness-Modified Trigger Values (HMTV) for Cadmium, Copper, Chromium, Lead, Nickel and Zinc based on Figure 17 and Appendix D calculations.

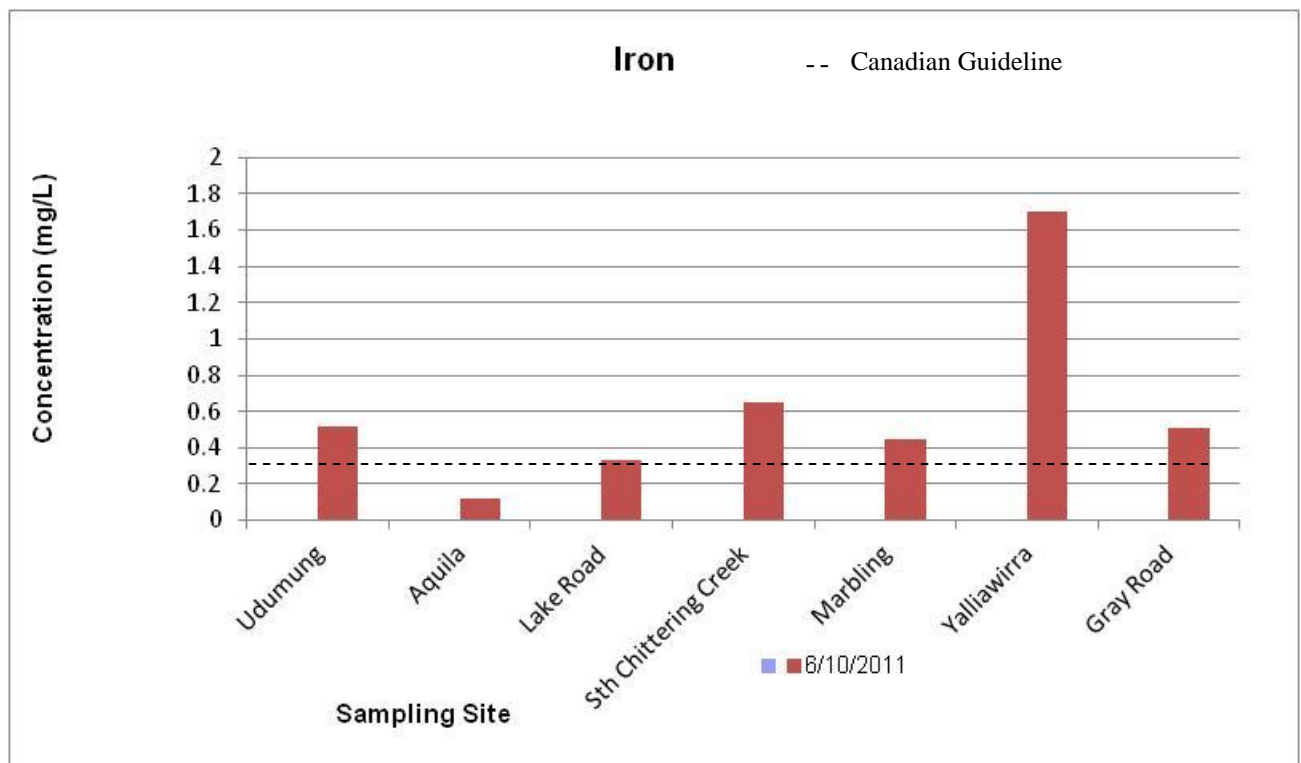
**Figure 19:** Iron concentrations in surface water within the Brockman River catchment on the 6<sup>th</sup> October 2011.

There is no ANZECC guideline trigger value or environmental concern level (ECLs) available for iron in fresh water as a result of insufficient data (ANZECC and ARMCANZ, 2000). All sites recorded iron concentrations above the current Canadian guideline of 0.3mg/L during the October sampling occasion, (Figure 19). This guideline is advised by the ANZECC water quality guidelines to be used as an interim indicative working level for aquatic ecosystems and requires further monitoring. During the August sampling occasion the samples were not analysed for iron due to a miscommunication with the laboratory.

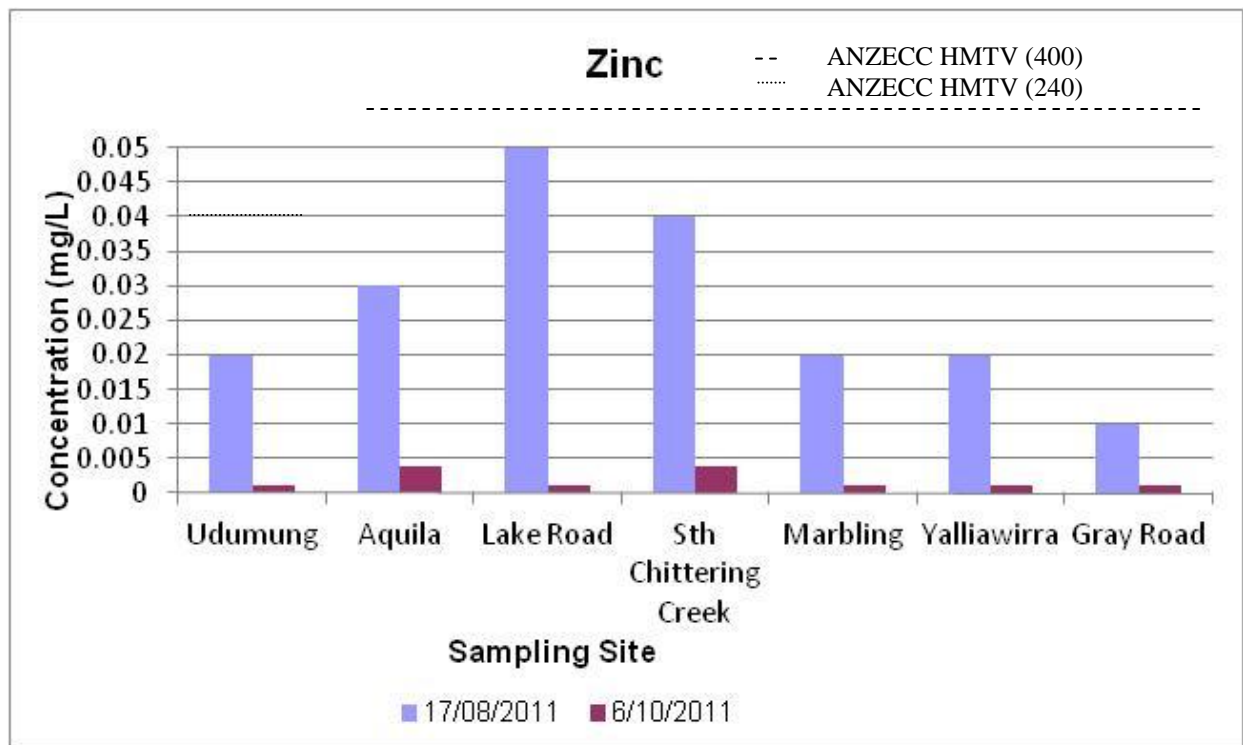
**Figure 20:** Zinc concentrations in surface water within the Brockman River catchment on the 17<sup>th</sup> August and 6<sup>th</sup> October 2011.

All sites were below the Hardness Modified Trigger Values (HMTV) of 0.07mg/L for sites with extreme water hardness: Aquila Reserve (BRN14); Lake Road (BRN15), South Chittering Creek (BRN22), Marbling Brook (BRN23), Yalliwirra (BRN25) and Grey Road Bridge (BRN27), and 0.04mg/L for Udamung (BRN5) with very hard water, during both sampling occasion, (Figure 20). Concentrations were generally higher on the August sampling occasion.

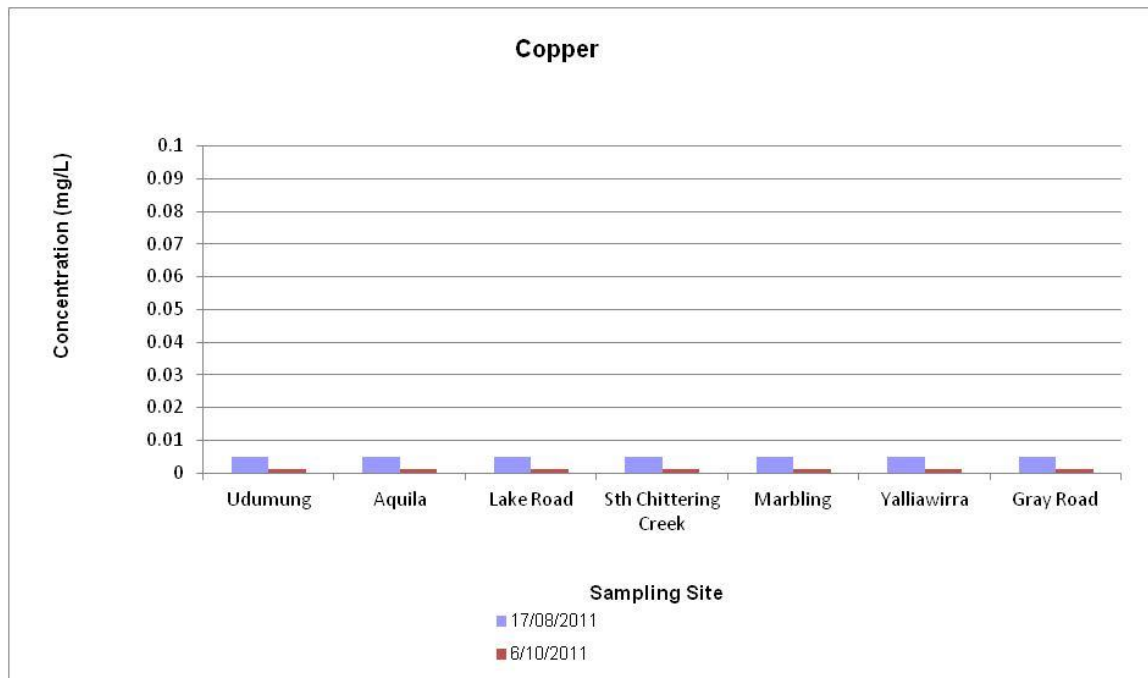
**Figure 21:** Copper concentrations in surface water within the Brockman River catchment on the 17<sup>th</sup> August 2011.

All sites are well below the recommended ANZECC trigger values for livestock, which are 0.5mg/L for sheep, 1mg/L for cattle, and 5mg/L for pigs and poultry (low risk) in livestock drinking water on all sampling occasions.

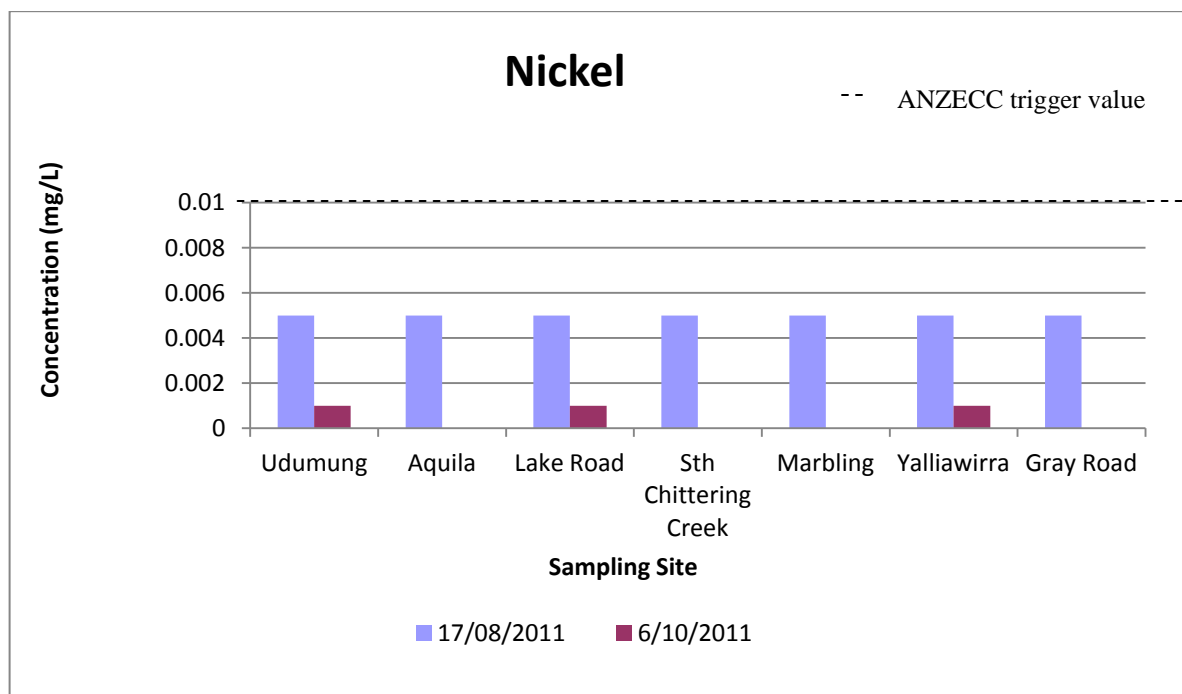
**Figure 22:** Nickel concentrations in surface water within the Brockman River catchment on the 17<sup>th</sup> August and 6<sup>th</sup> October 2011. \*blanks represent not measured

The concentration of nickel in natural waters is usually below 0.01 mg/L unless it has been contaminated by either corrosion of nickel plated plumbing, industrial waste or fallout from burning of fossil fuels.
