# **Brockman River Catchment**

## ***Water Quality Monitoring Snapshot***

### ***August and October 2012***

**Prepared by the Ellen Brockman Integrated Catchment Group: March 2013**

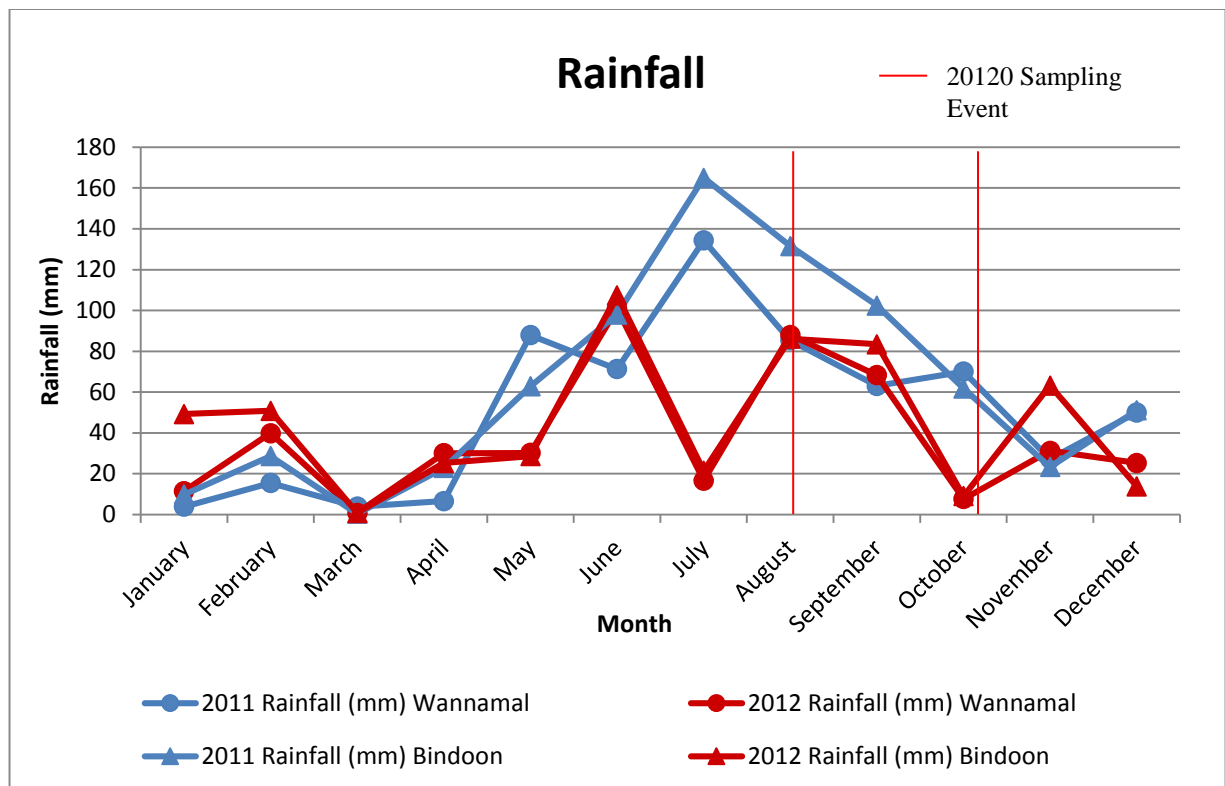
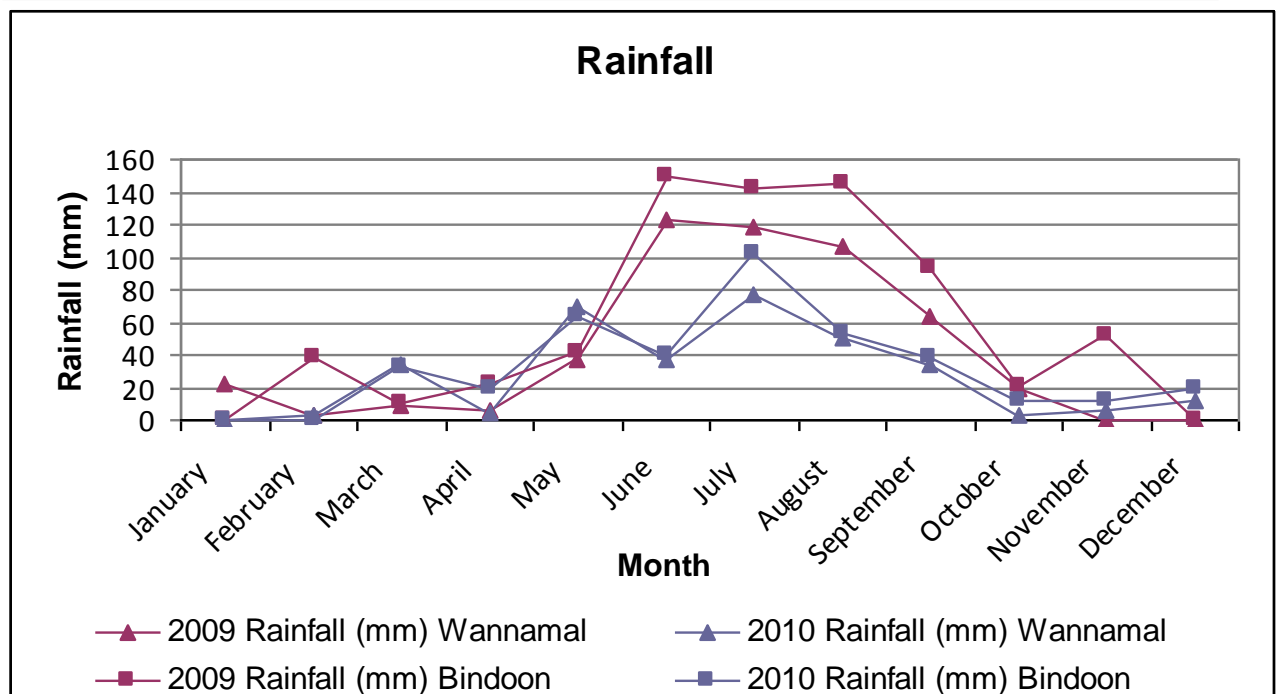
Figure 3: Total monthly rainfall within the Brockman River catchment recorded at Bindoon Station (009112), and Wannamal Station (009040) in 20109 and 20120 (Bureau of Meteorology, 20130).

The catchment experiences a typical Mediterranean climate of hot dry summers and cool wet winters. Average rainfall for the southern portion is 800mm/yr decreasing to less than 600mm/yr in the northern regions (Bureau of Meteorology, 1998). Rainfall in 2011 was significantly below the average annual rainfall for the region with a total of 450333.1mm received between January and December at Wannamal (Station 009040) and 394.2mm received at Bindoon (Station 009112) (Figure 3). This is significantly less than the rainfall received in 2011, which was slightly above the annual average. July and October were particularly dry months which have affected the water quality results, as they correspond with the sampling events. 'good' season due to the extended months of rainfall, the total annual rainfall was still below the average.

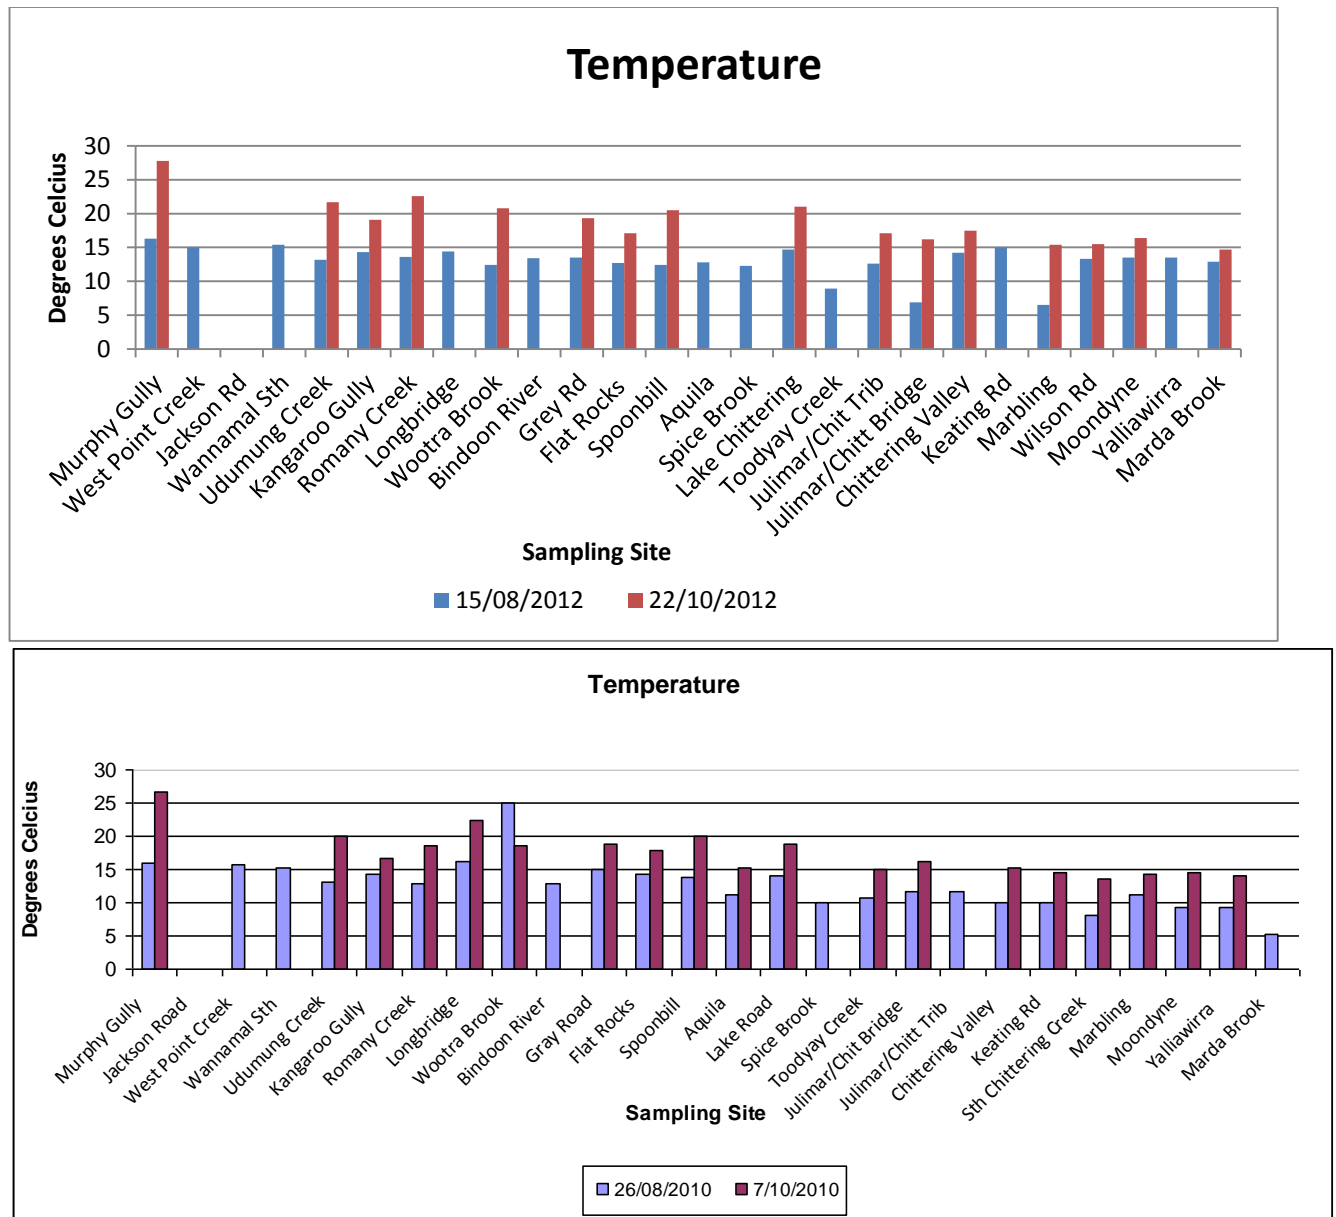
**Figure 6:** Water temperature of surface water within the Brockman River Catchment on the 526<sup>th</sup> August and 22<sup>nd</sup> October 20102.

Samples taken were from sites with flowing water at a depth ranging from 10-20cm below the surface and not in contact with the sediment at any time. August temperatures ranged between 6.5°C at Marbling (BRN23) and 16.3°C at Murphy Gully (BRN1). Water temperatures were generally warmer during the October sampling run, and ranged between 14.7°C at Marda Brook (BRN26) and 27.8°C at Murphy Gully (BRN1), (Figure 6).

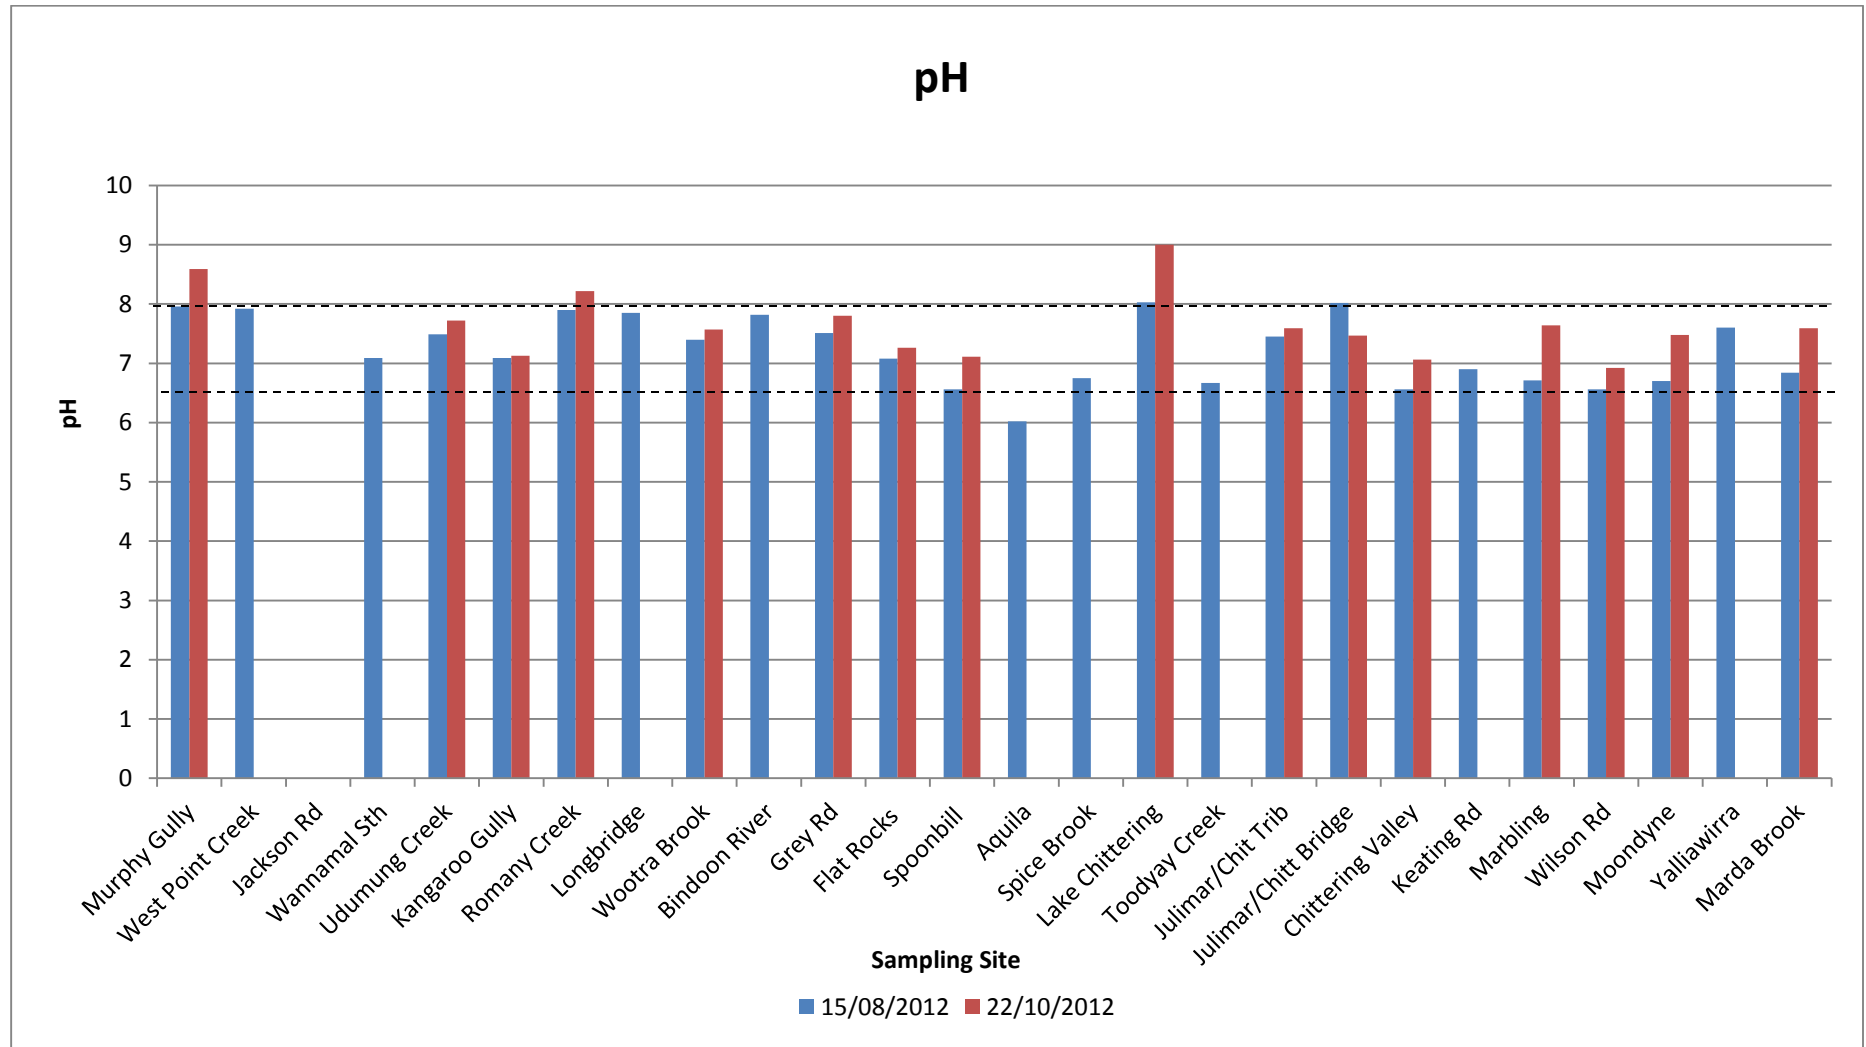
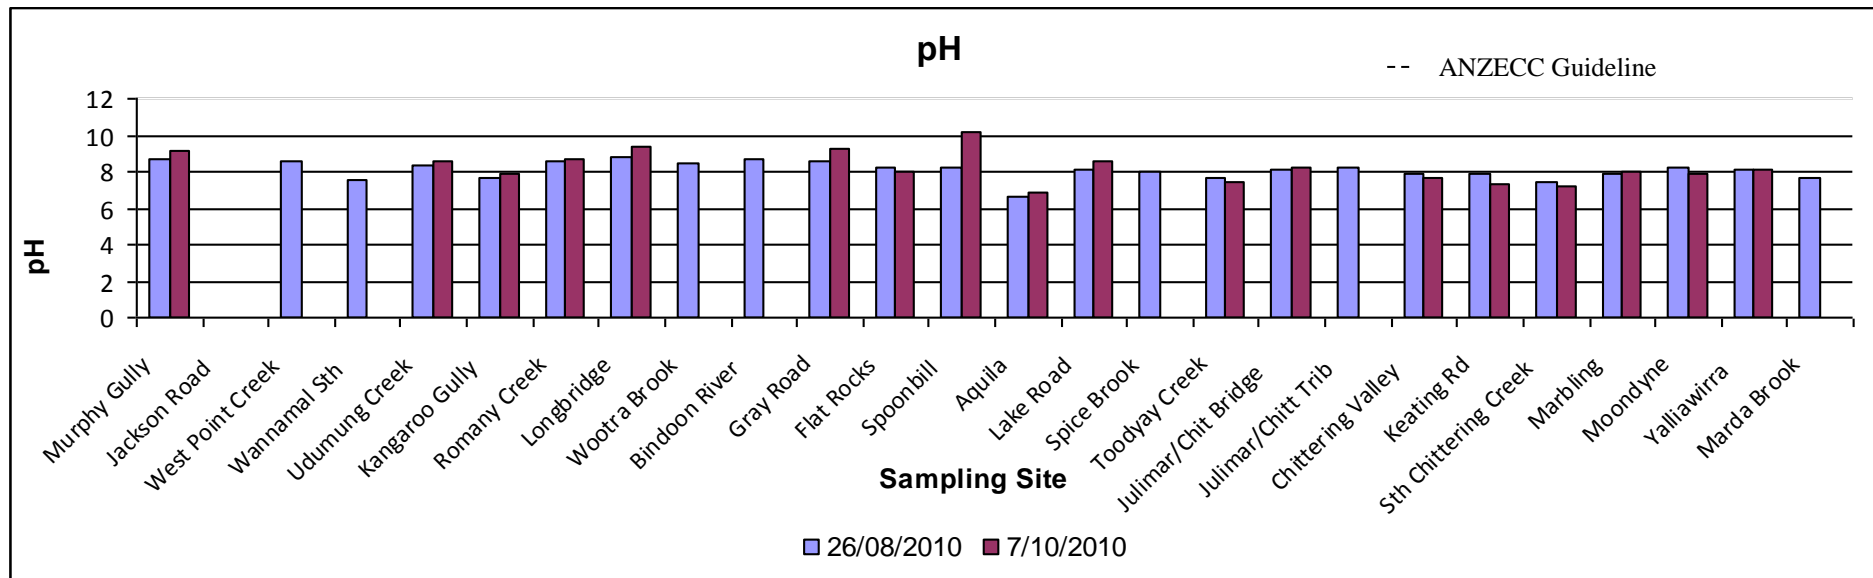
**Figure 7:** pH of surface water within the Brockman River catchment on 526<sup>th</sup> August and 22<sup>nd</sup> October 20102.

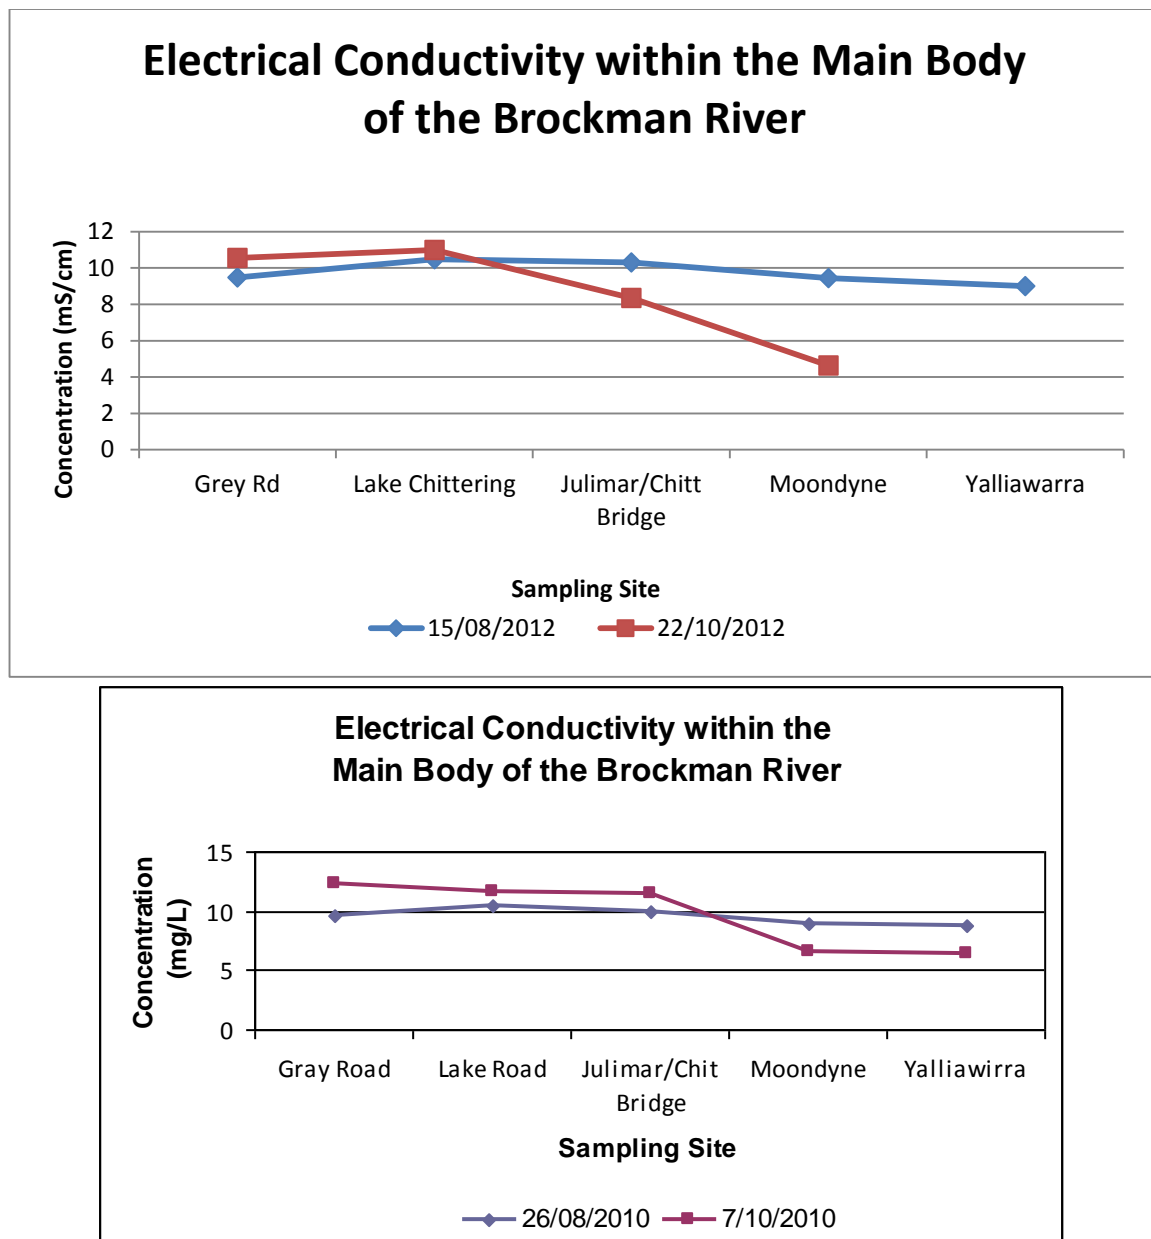
**Figure 8:** Electrical conductivity within the main body of the Brockman River, recorded at sampling sites Grey Road (BRN27), Lake Road (BRN15), Julimar/Chittering Bridge (BRN18), Moondyne (BRN24) and Yalliwarra (BRN25) in 20102.

The high level of vegetation clearing, primarily at the top of the catchment creates a weak correlation with increasing stream salinity, and a strong correlation with increasing groundwater salinity (Fulwood, 2001). This shows that the higher conductivity levels coming down the catchment and tributaries are diluted as they

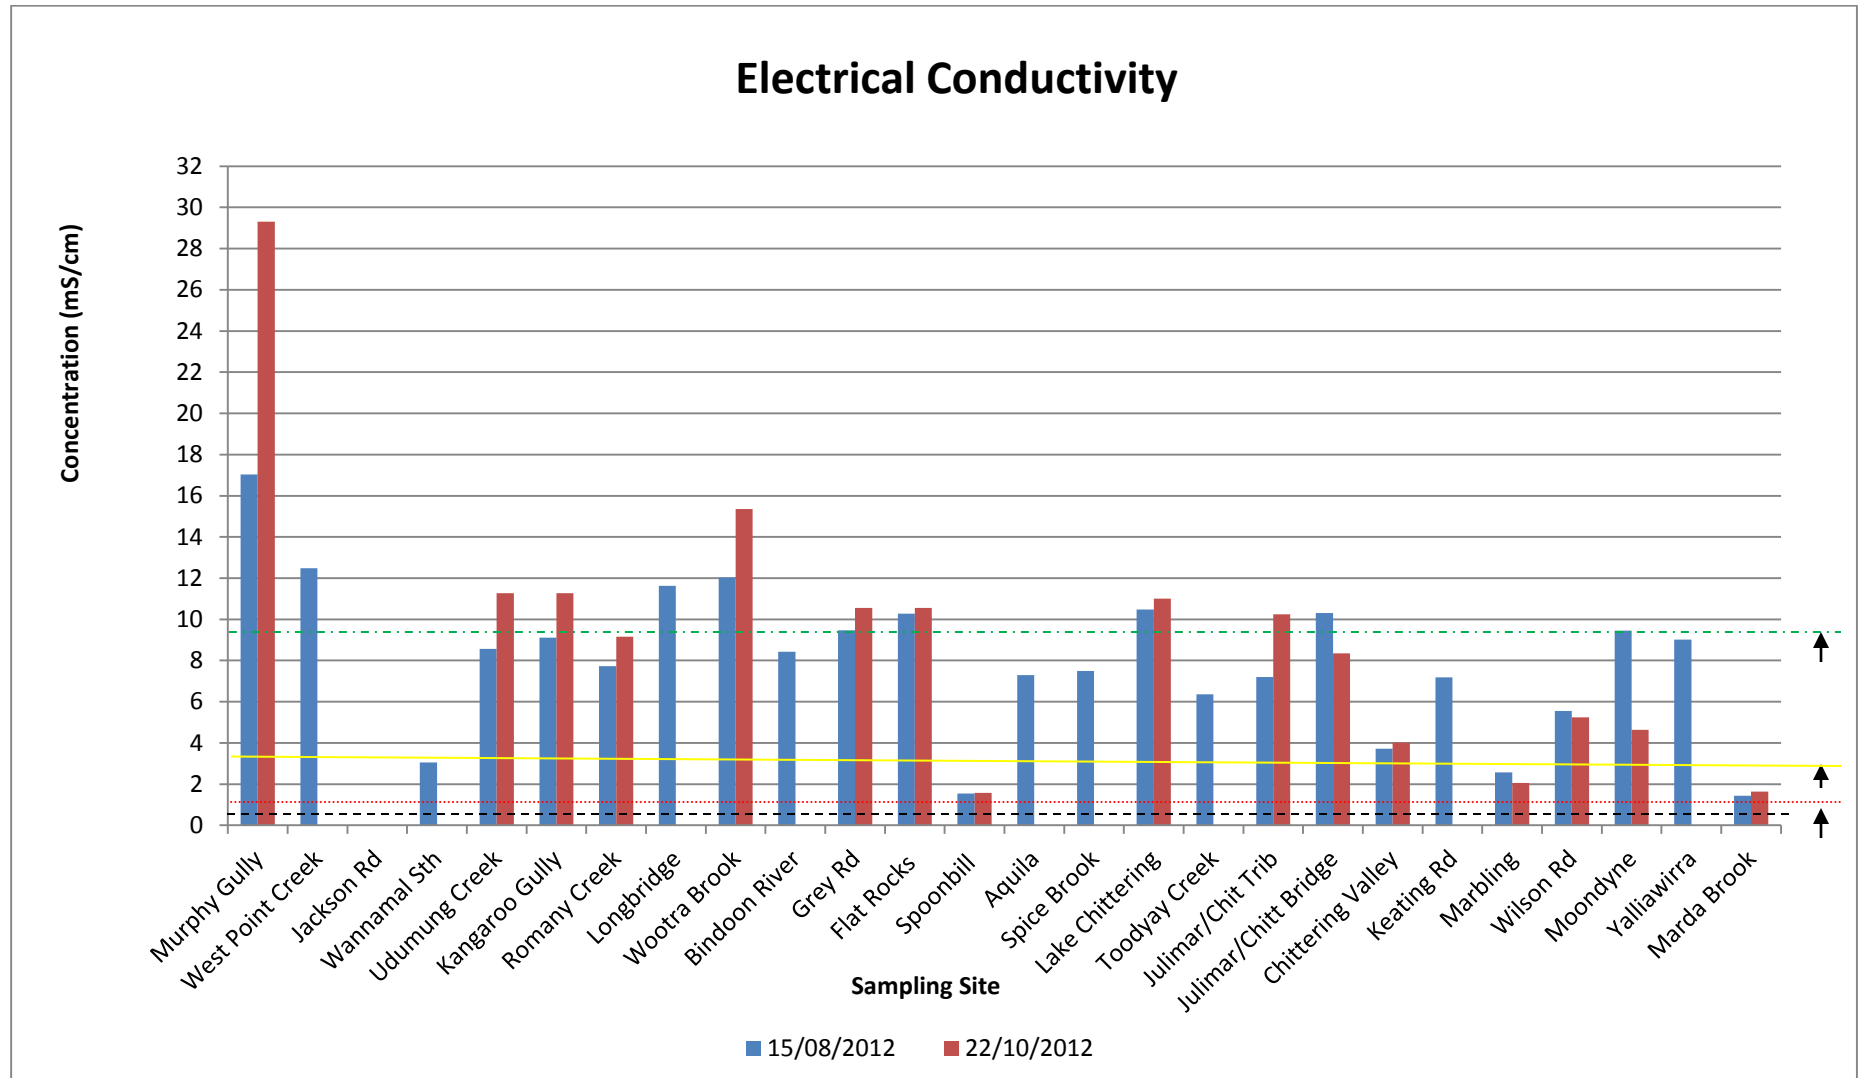
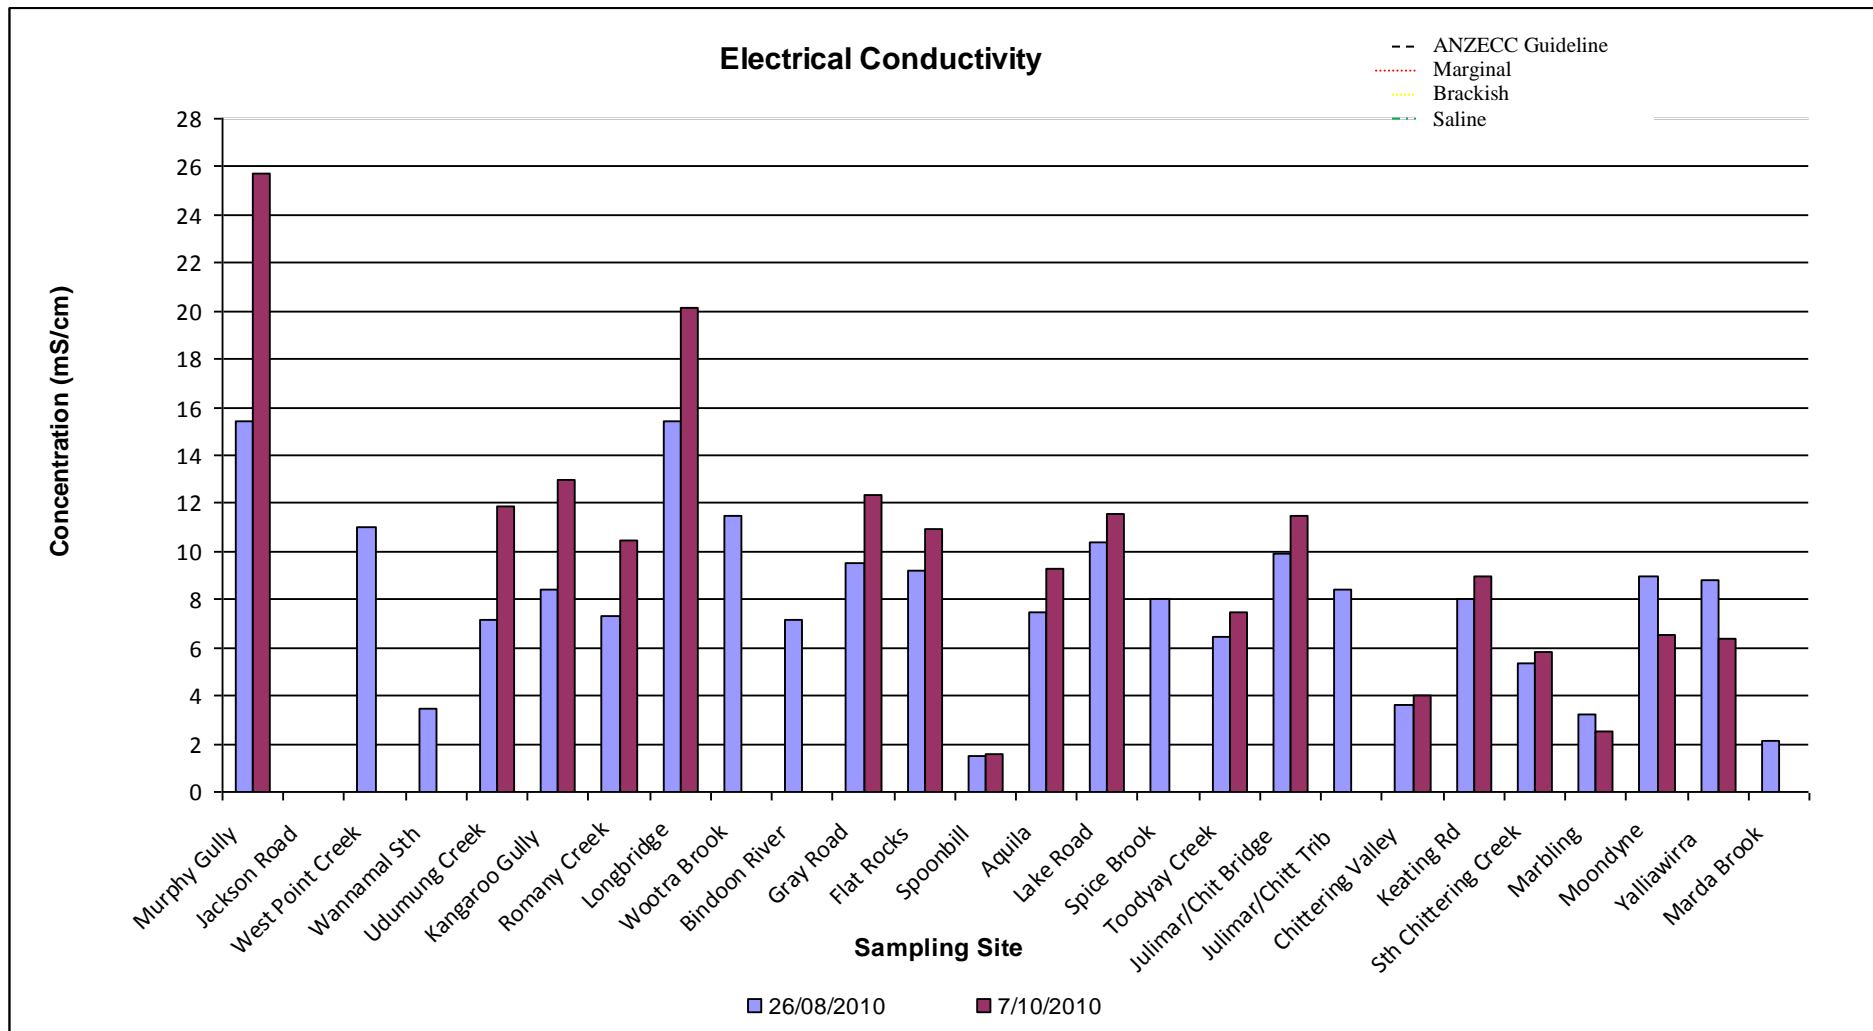
Figure 9: Conductivity in surface water within the Brockman River catchment on 526<sup>th</sup> August and 22<sup>nd</sup> October 20120.

Electrical conductivity ranged from 4.441.517mS/cm at Spoonbill (BRN13) to 29.325.7mS/cm at Murphy Gully (BRN2). All sites except Spoonbill (BRN13) and Marda Brook (BRN26) during the August sampling occasion consistently exceeded the ANZECC guidelines for freshwater lowland rivers of 0.12mS/cm to 0.3mS/cm (Figure 9). It should be noted that of the sites that exceeded the guidelines for ecosystem value, the majority of them were also within the brackish to saline levels<sup>11</sup> (occasionally Brackish water is between 3mS/cm and 9.1mS/cm, saline water is between 9.5mS/cm and 23mS/cm), anything above 1.6 is becoming brackish and would be detrimental for irrigation of stone fruit and citrus orchards. All sites sampled in October except Spoonbill (BRN13) and Marbling Brook (BRN23) also exceeded the ANZECC guidelines for freshwater lowland rivers (Figure 9).

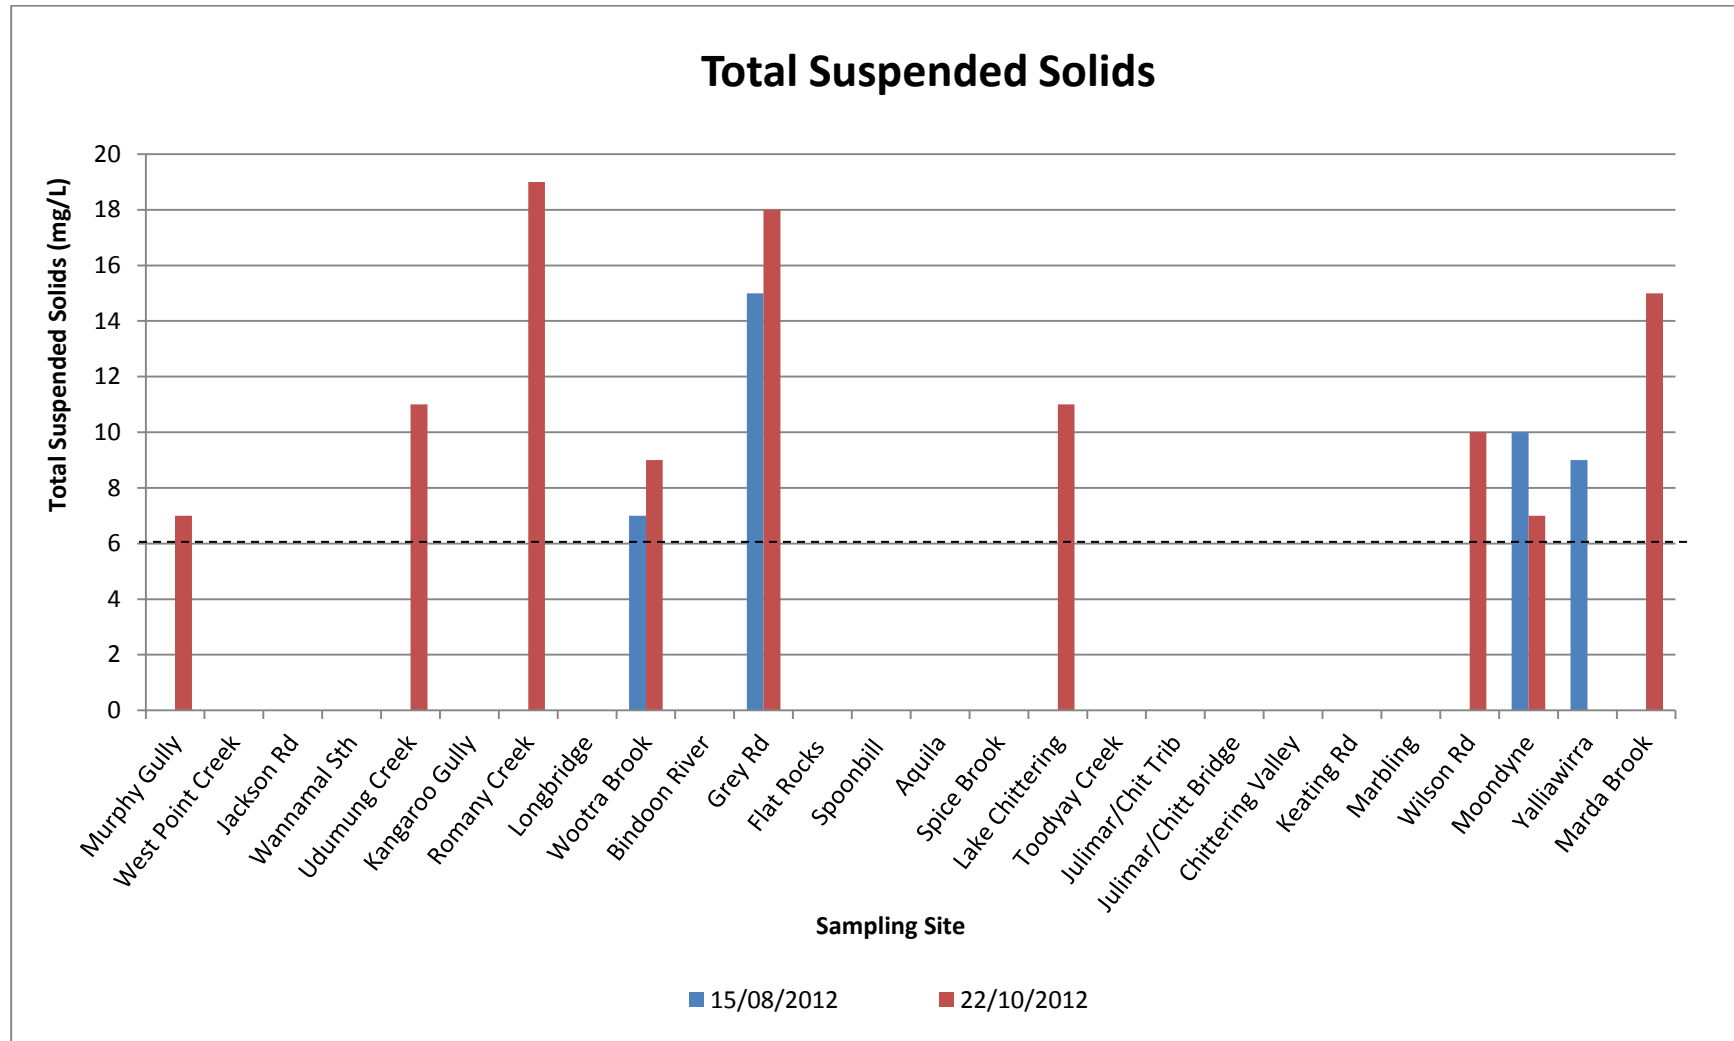
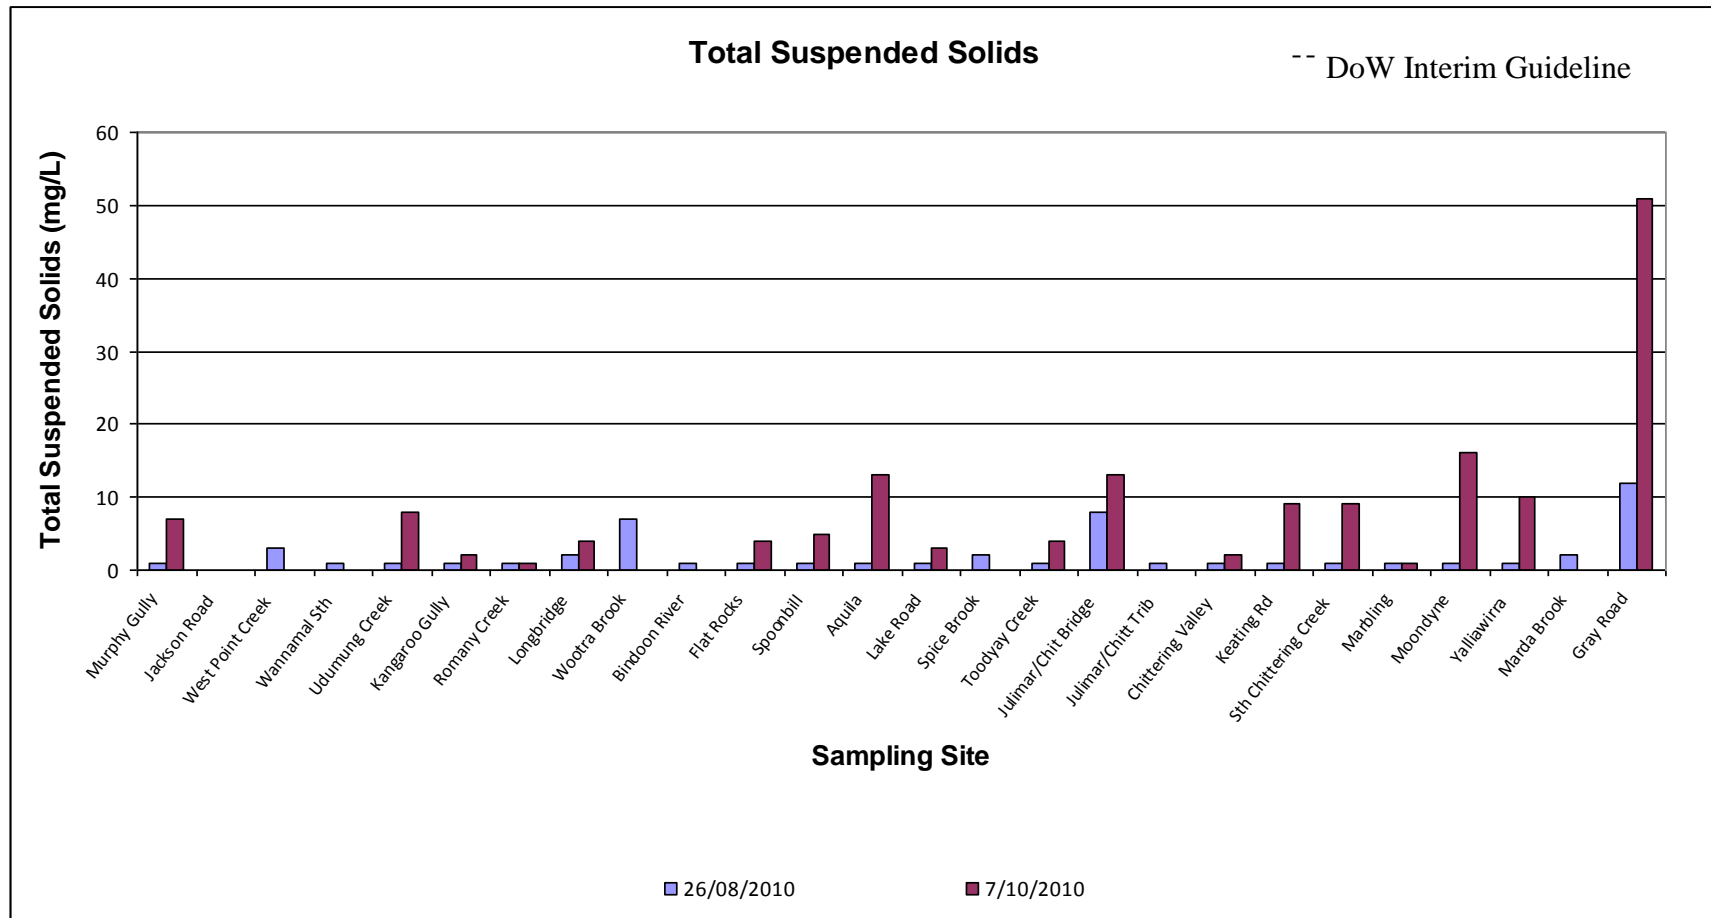
**Figure 10:** Total Suspended Solids in surface water within the Brockman River catchment sampled 526<sup>th</sup> August and 722<sup>nd</sup> October 20120. \*blanks represent no sample take

and a lack of riparian vegetation. Stock have access to waterways in most of these areas causing increased erosion rates and sedimentation.

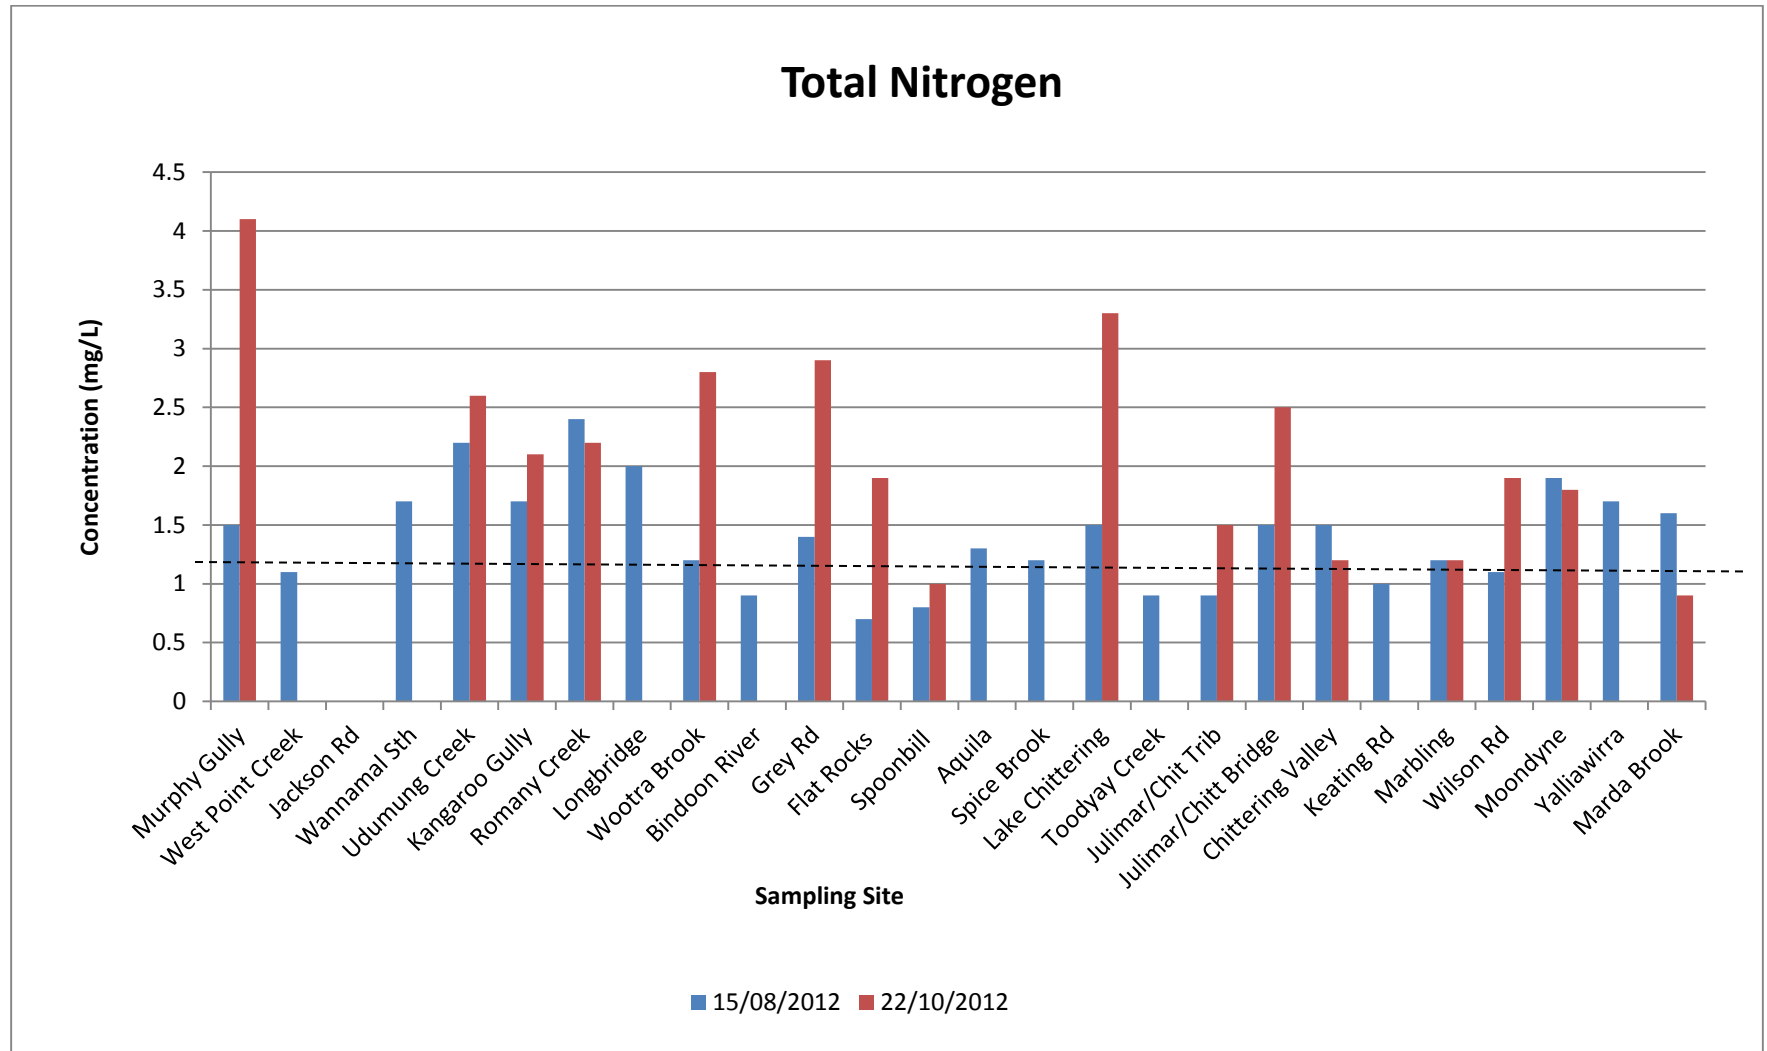
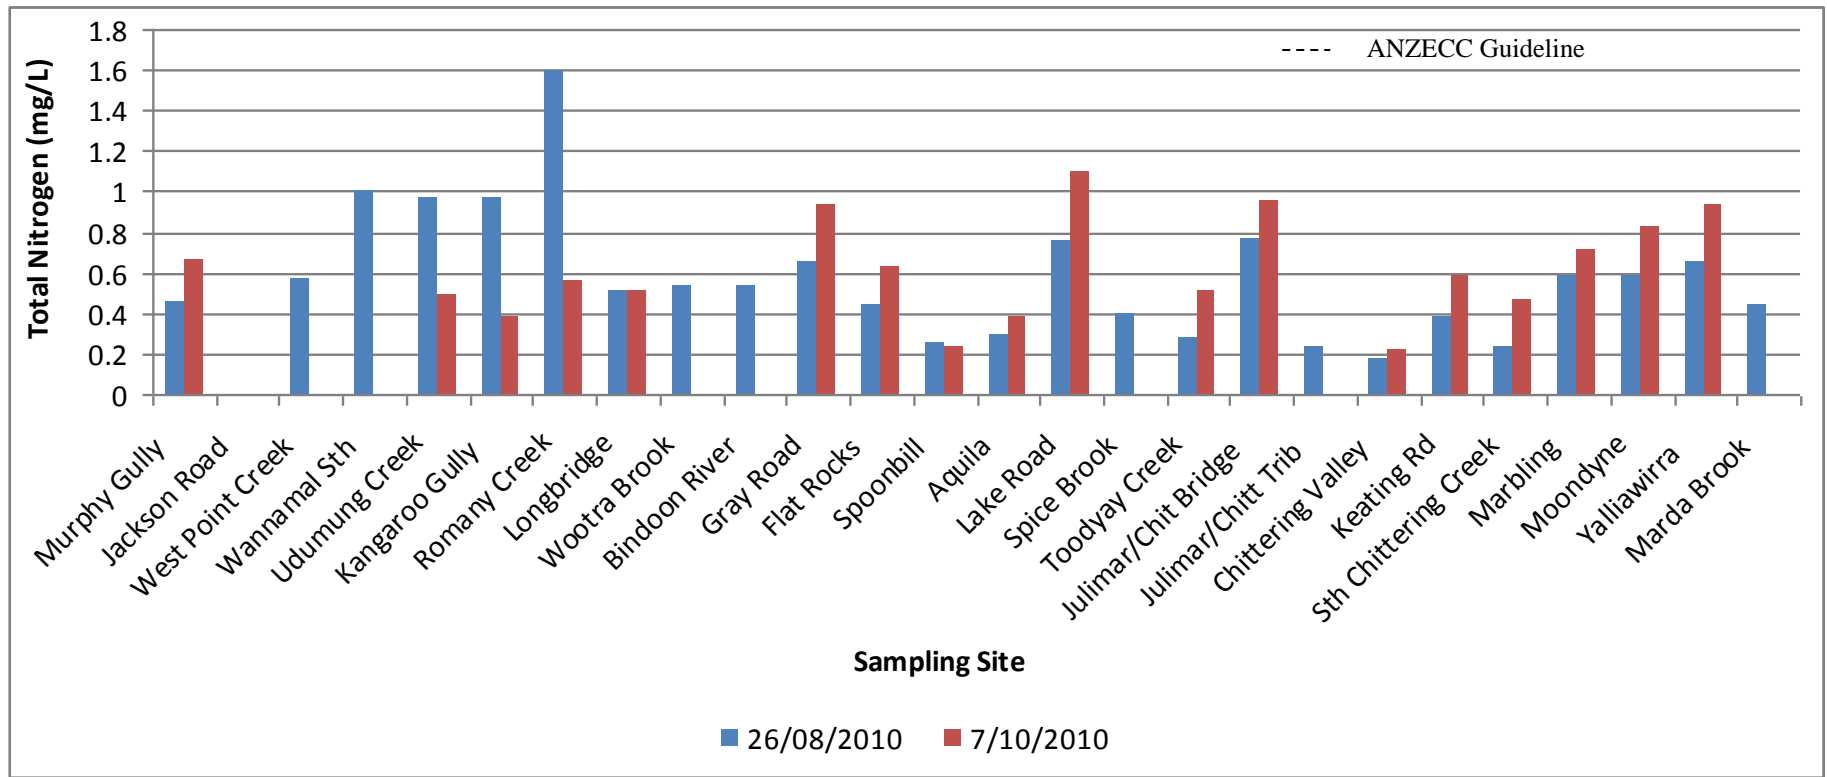
**Figure 11:** Total Nitrogen in surface water within the Brockman River catchment sampled 526<sup>th</sup> August and 22<sup>nd</sup> October 20102. \*blanks represent no sample taken

These results are higher than in previous years, but do not have a high rainfall event associated with the sampling occasions as could be expected. The fractions of Nitrogen analysed in this report (Total Oxidised Nitrogen, Dissolved Organic Nitrogen and Nitrogen as Ammonia) do not show a similar increased trend. Therefore it may be the undissolved organic fraction of the Nitrogen contributing to the increase. This could be due to the low flow at the time of sampling especially during the October sampling occasion. The erratic, atypical rainfall that was experienced during the 2012 season could have played a factor in the increase in TN concentrations as well. Continued monitoring is important to understand these processes.

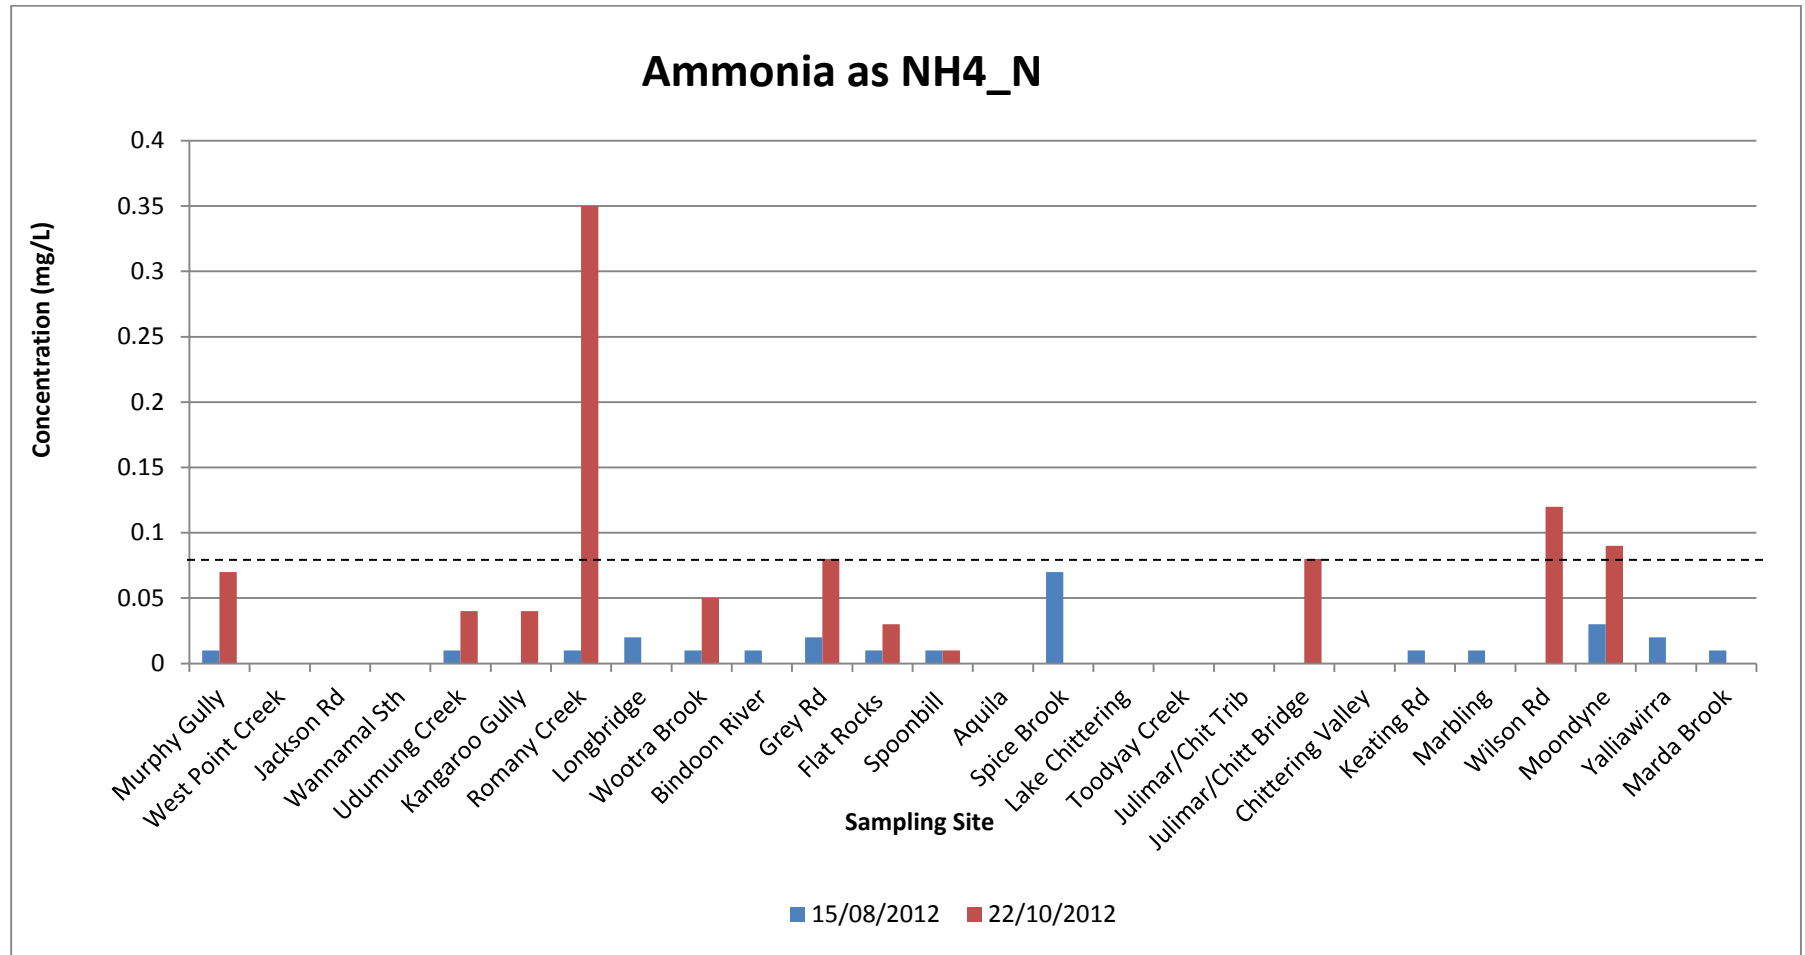
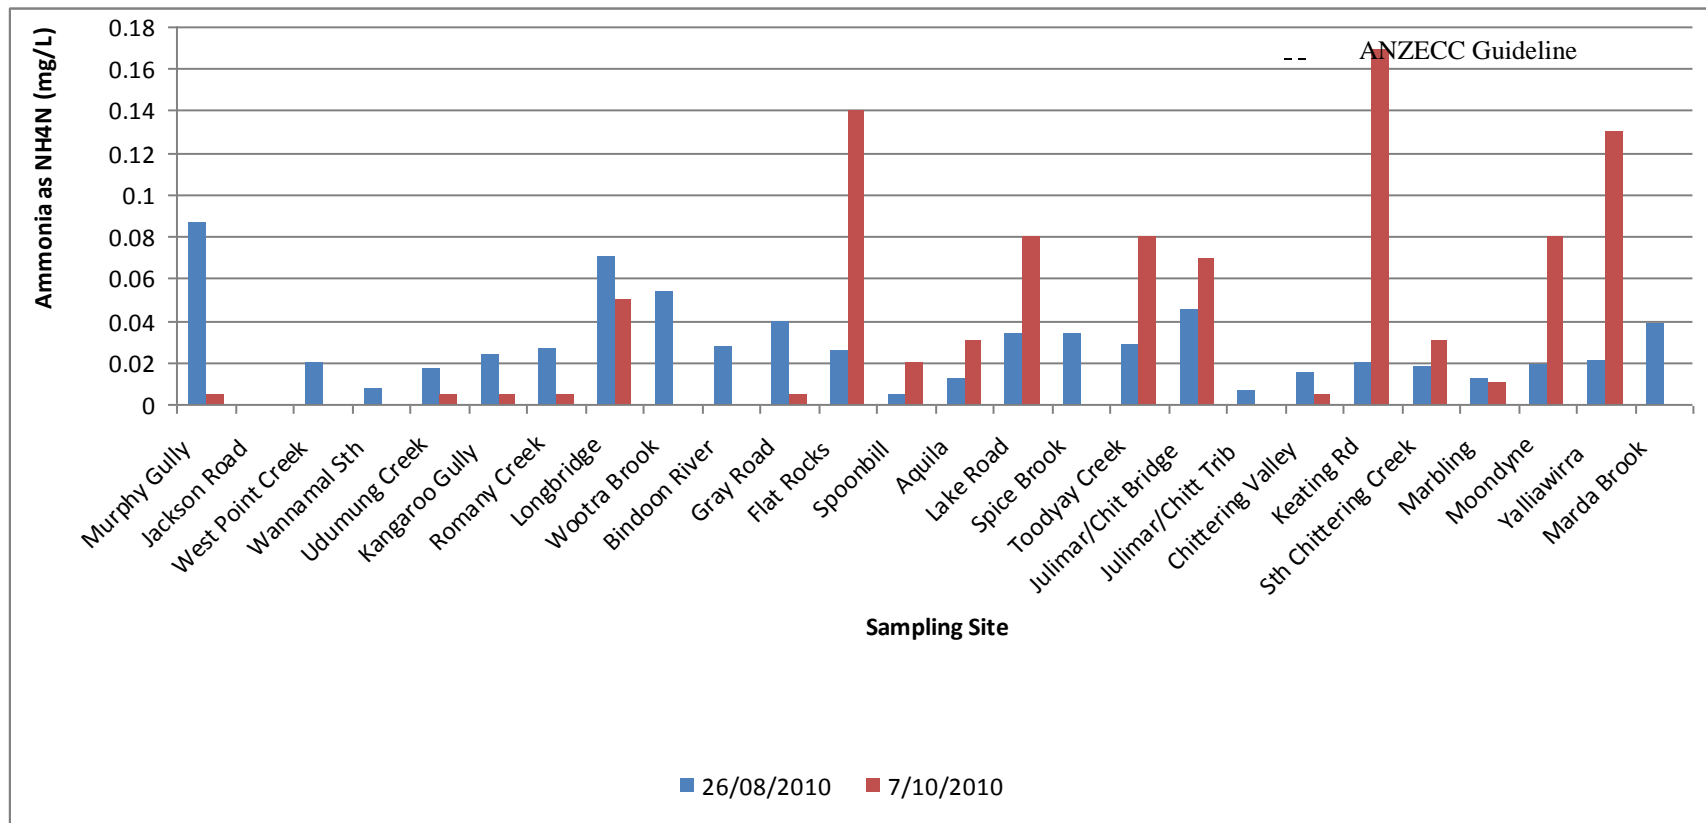
**Figure 12:** Ammonia as NH<sub>4</sub>N concentrations in surface water within the Brockman River catchment on 526<sup>th</sup> August and 722<sup>nd</sup> October 20102. \*blanks represent no sample taken
