# **Brockman River Catchment**

## ***Water Quality Monitoring Snapshot***

### ***August and October 2012***

**Prepared by the Ellen Brockman Integrated Catchment Group: March 2013**

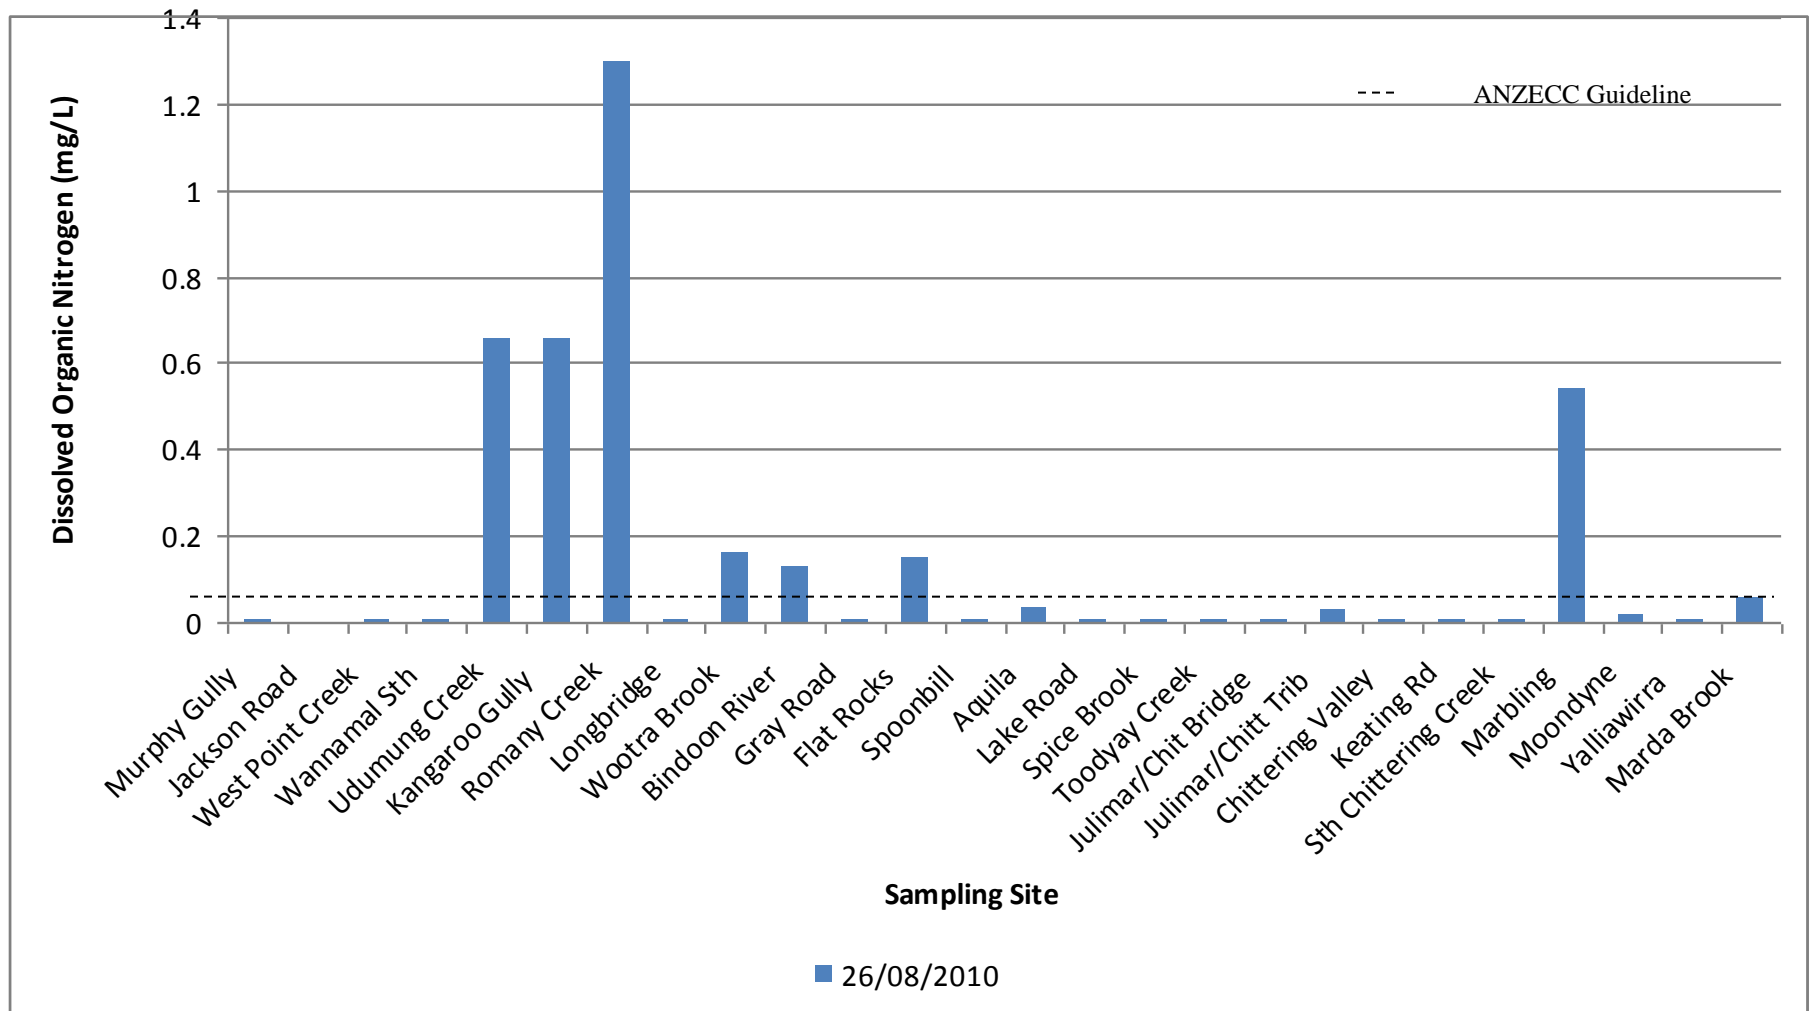
**Figure 13:** Dissolved Organic Nitrogen concentrations in surface water within the Brockman River catchment on 26<sup>th</sup> August 2010 \*blanks represent no sample taken.

It is important to mention that DON concentrations compared with total nitrogen, ammonia and total oxidised nitrogen concentrations showed that nitrogen exists primarily in its soluble form in the Brockman River catchment.

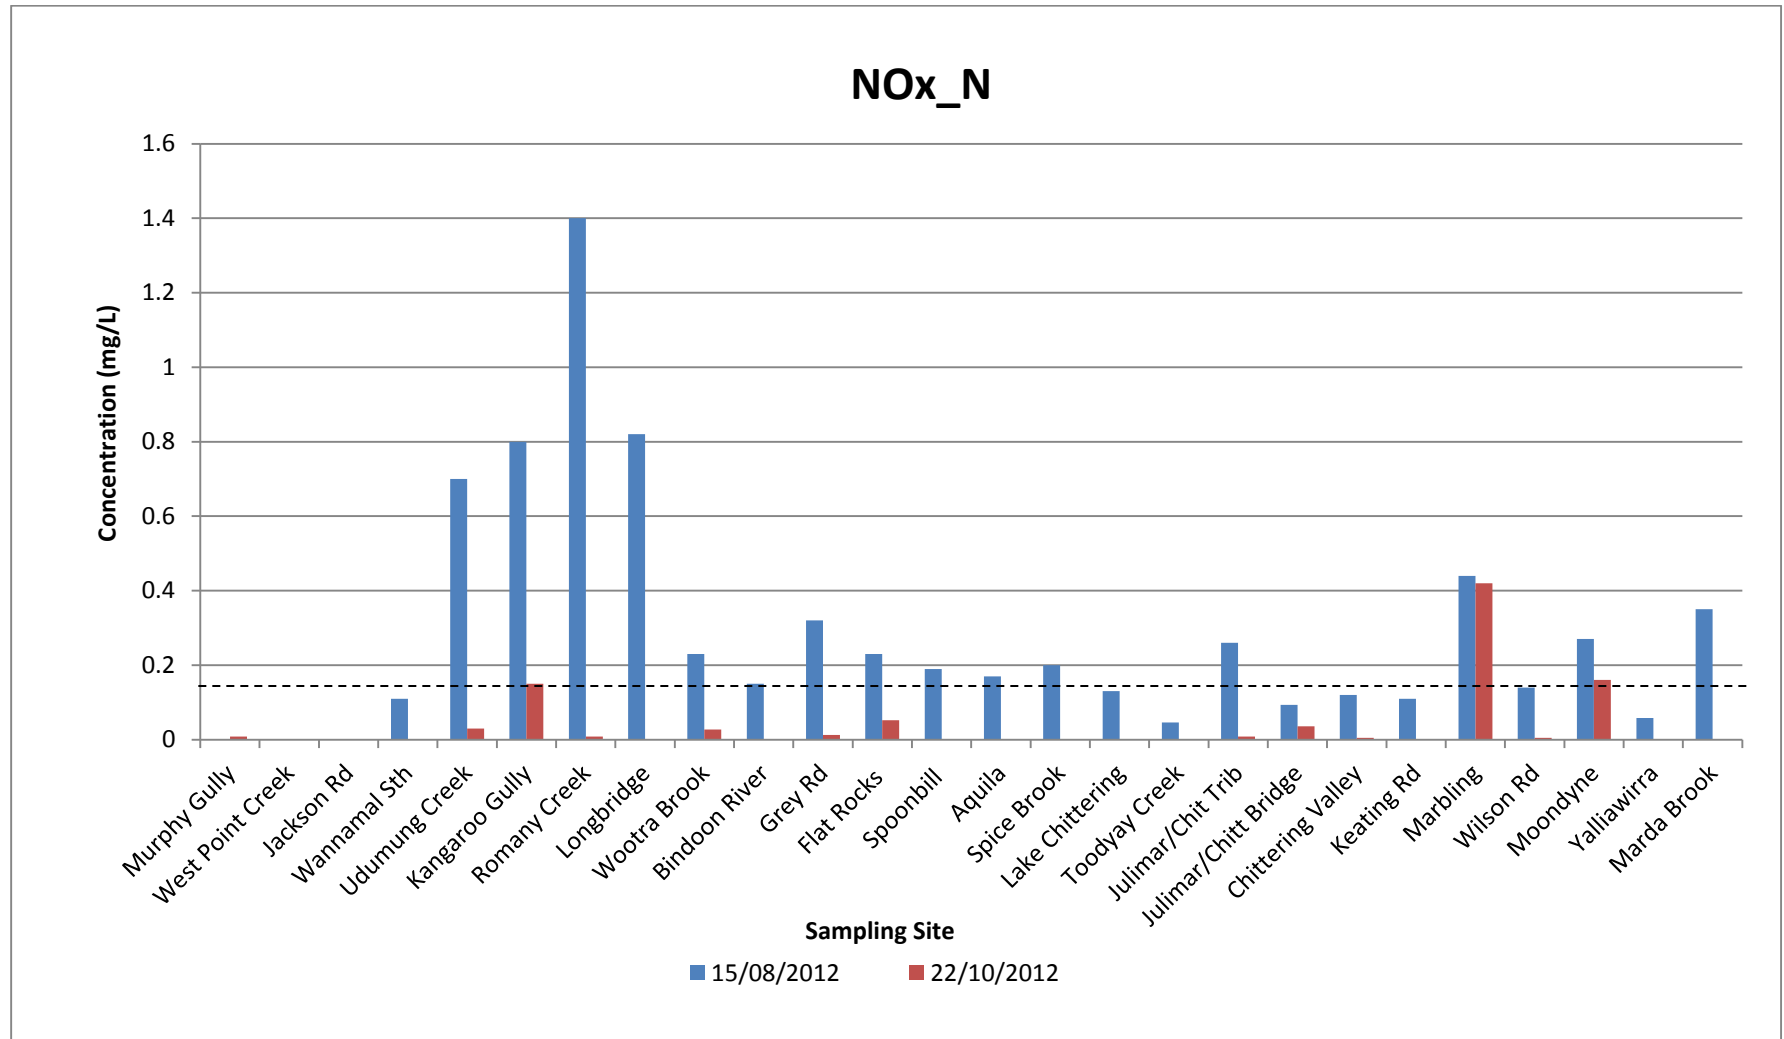
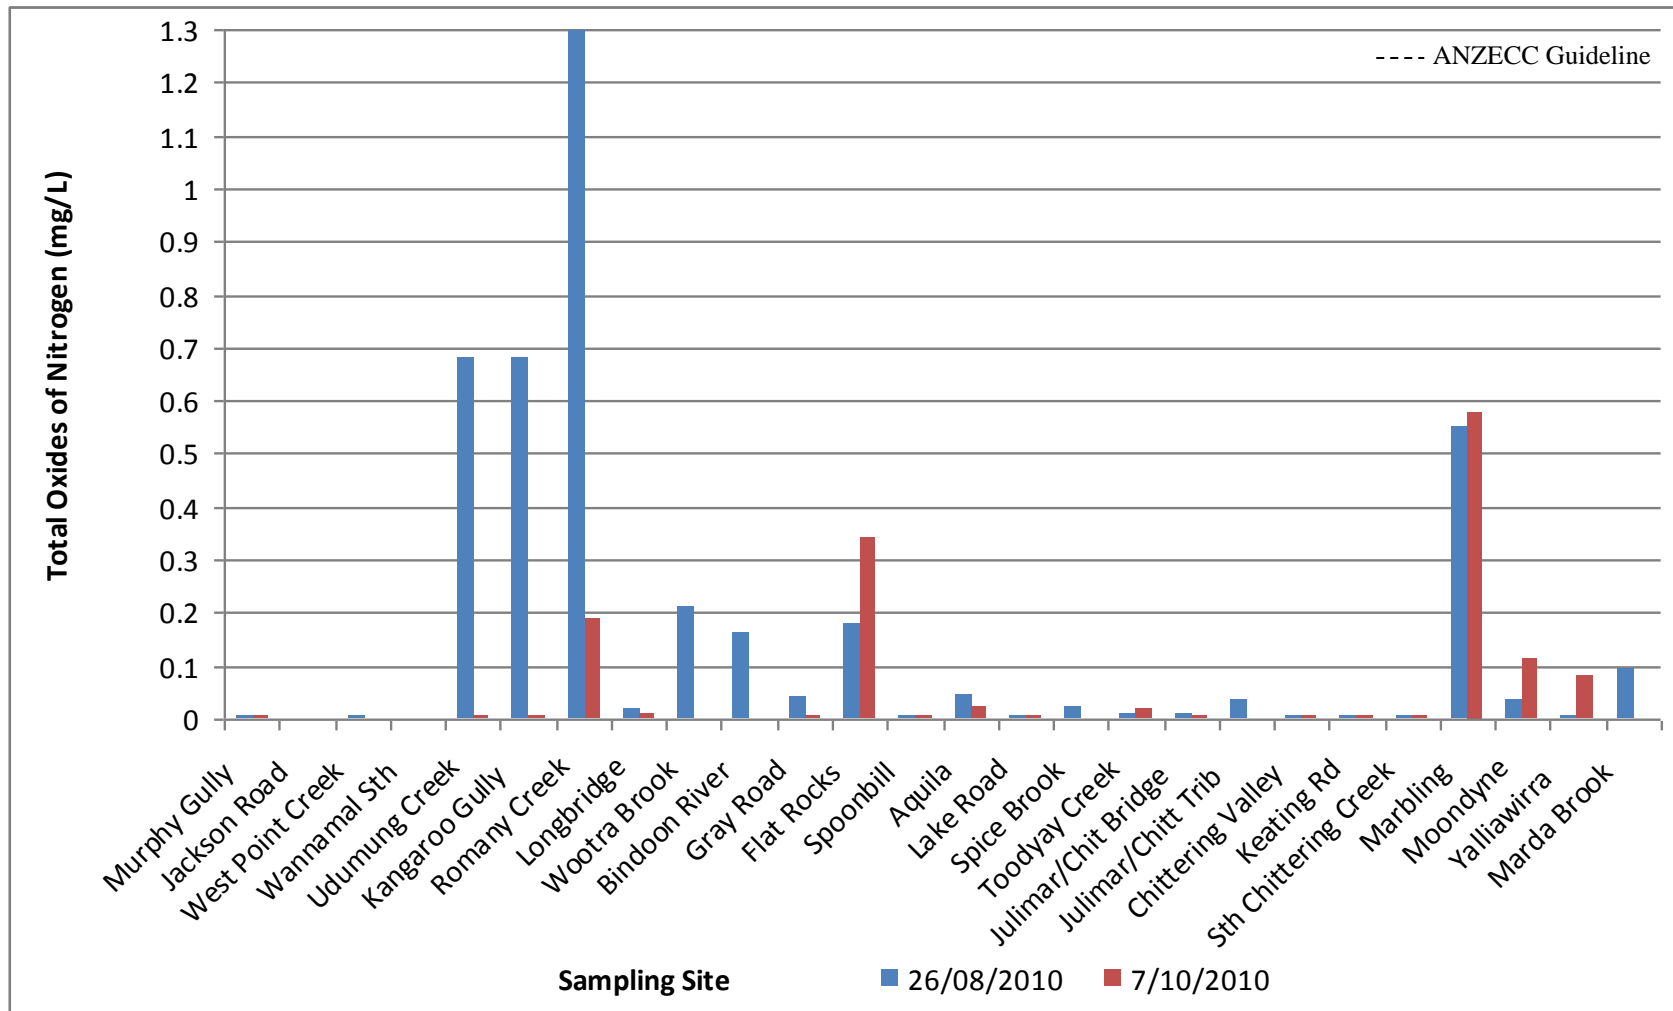
**Figure 14:** NOX\_N (TON) concentrations in surface water within the Brockman River catchment in 526<sup>th</sup> August and 722<sup>nd</sup> October 20102. \*note blanks represent no sample taken

21 sites exceeded the ANZECC Guideline on one or more sampling occasions where as only 157 sites exceeded the ANZECC guideline on one or more sampling occasion<sup>2</sup>. This can most likely be accounted for the reduced rainfall received in 2012, where 2011 had a more average rainfall season. Cereal production, beef, pigs, and sheep may contribute to the higher concentrations of TON in the northern half of the catchment. In comparison, the primary production of the southern half of the catchment in the Chittering valley is vineyards and orchards. As a result the TON entering the river upstream from runoff carrying manure and organic matter is diluted as it flows through the catchment.

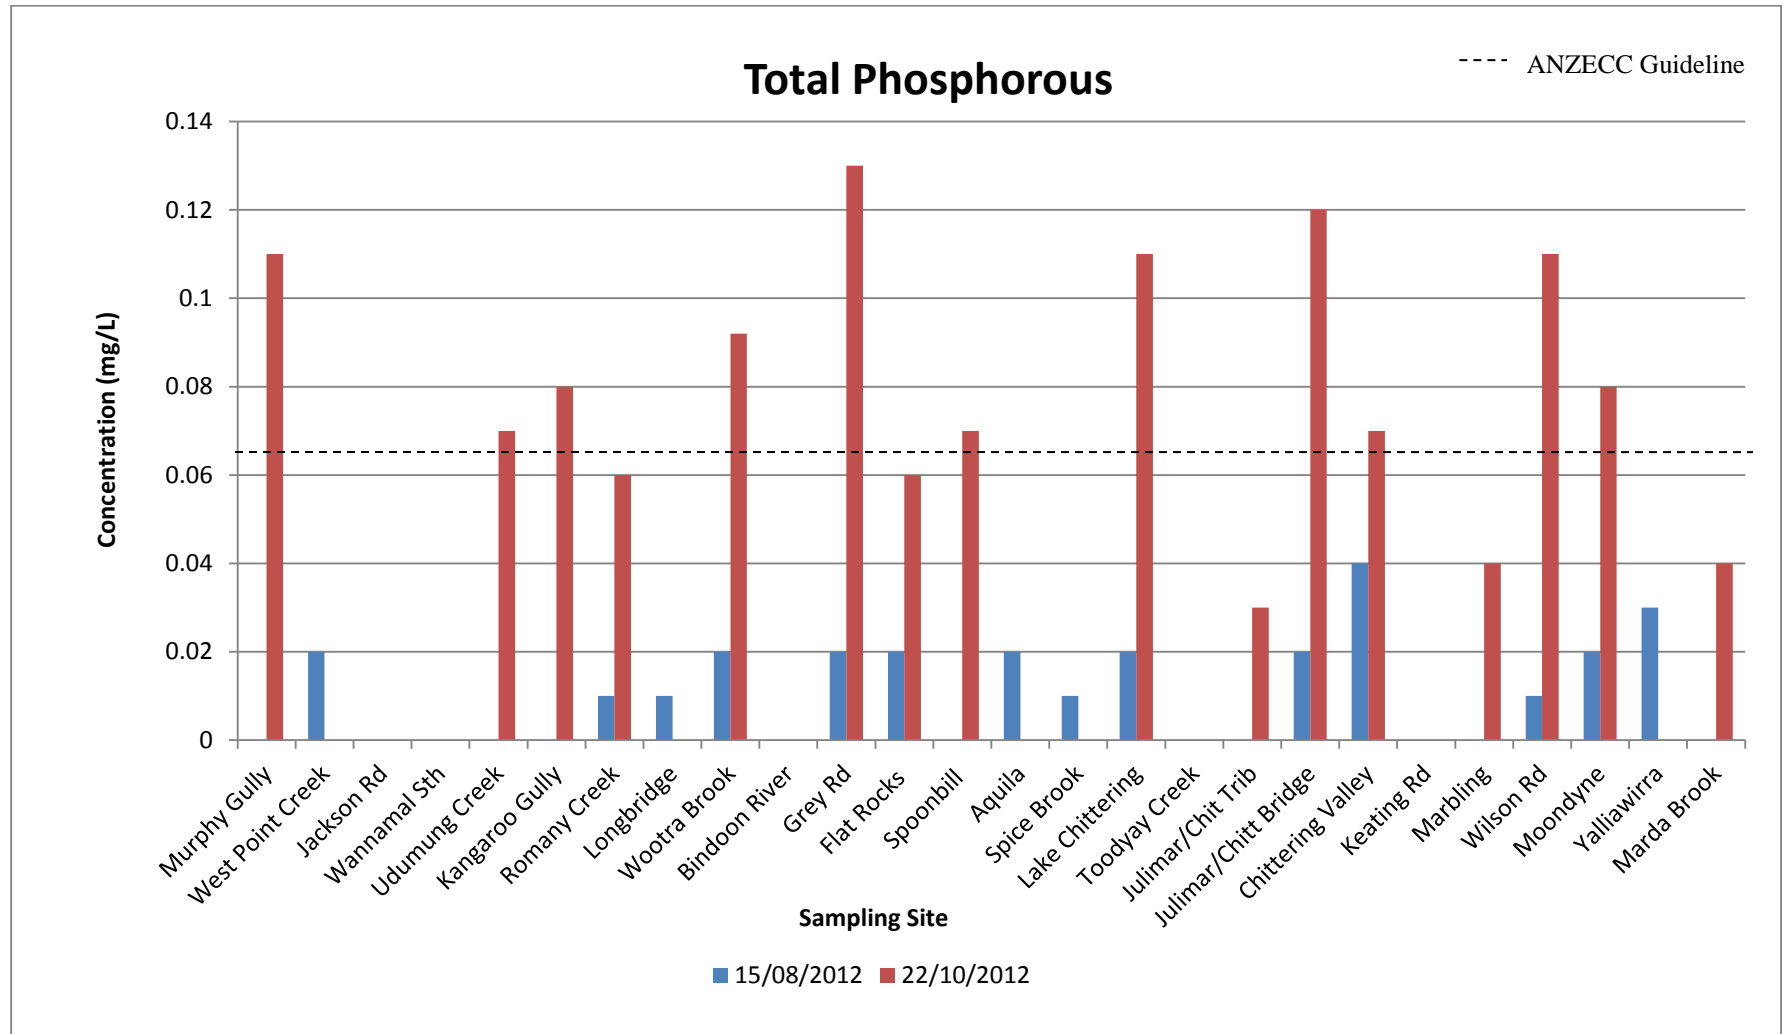
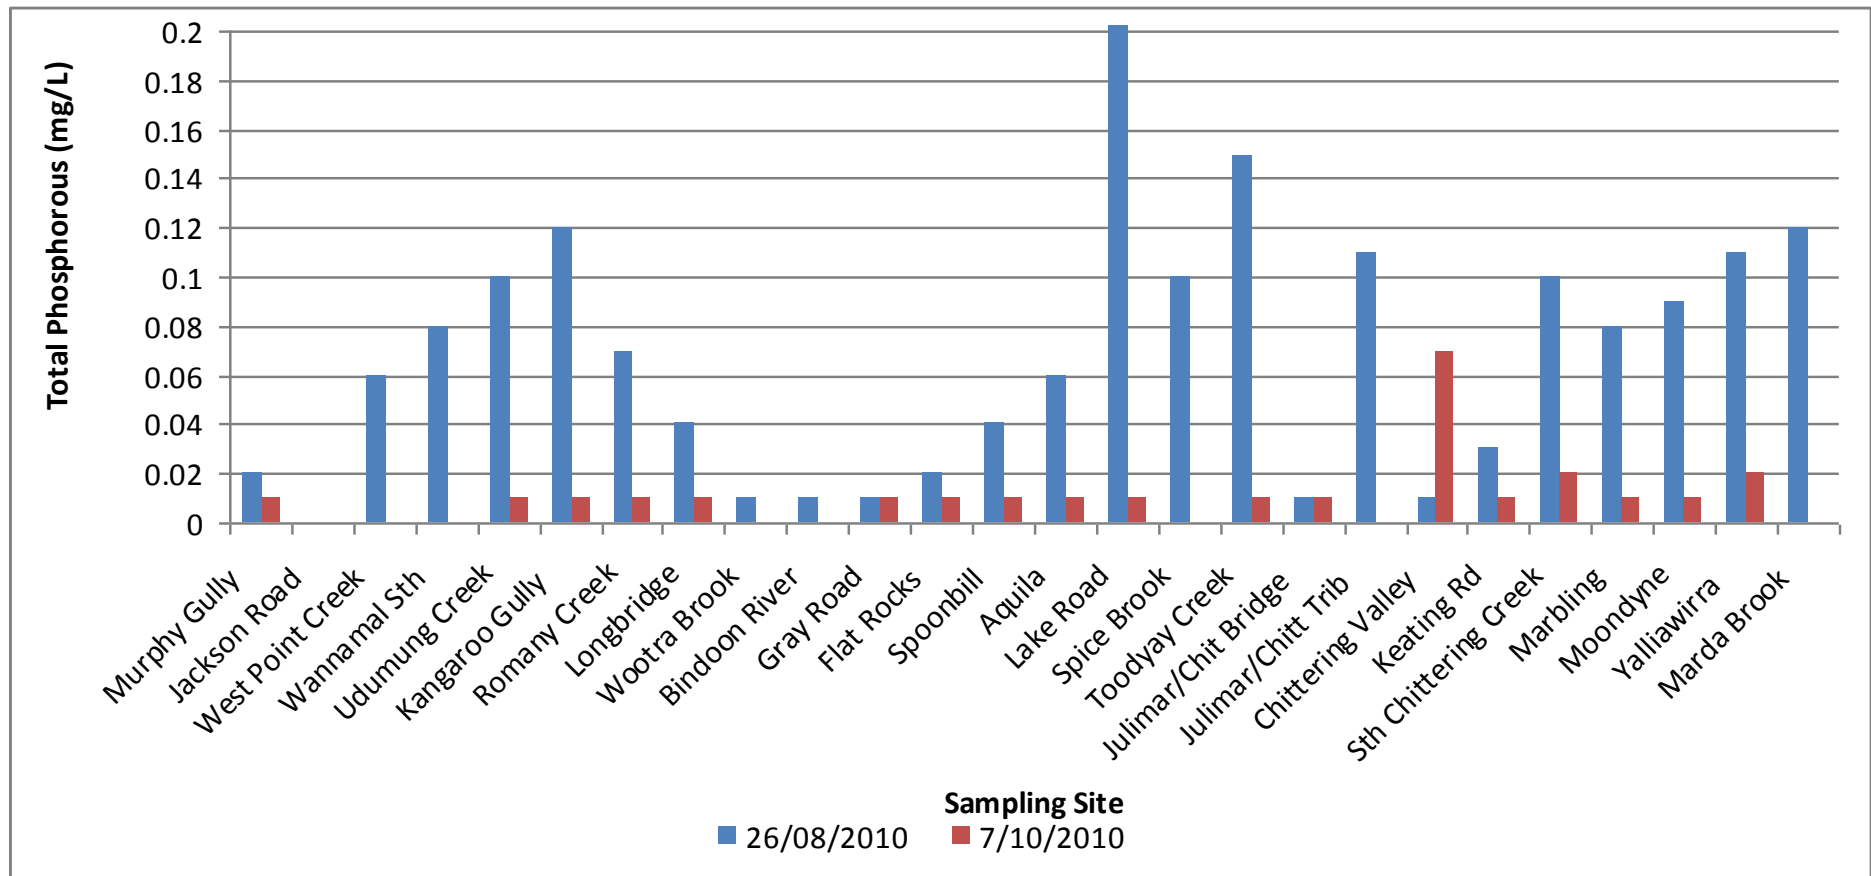
**Figure 15:** Total Phosphorous concentrations in surface water within the Brockman River catchment sampled on 5<sup>th</sup> August and 7<sup>th</sup> October 2012. \*note blanks represent no sample taken

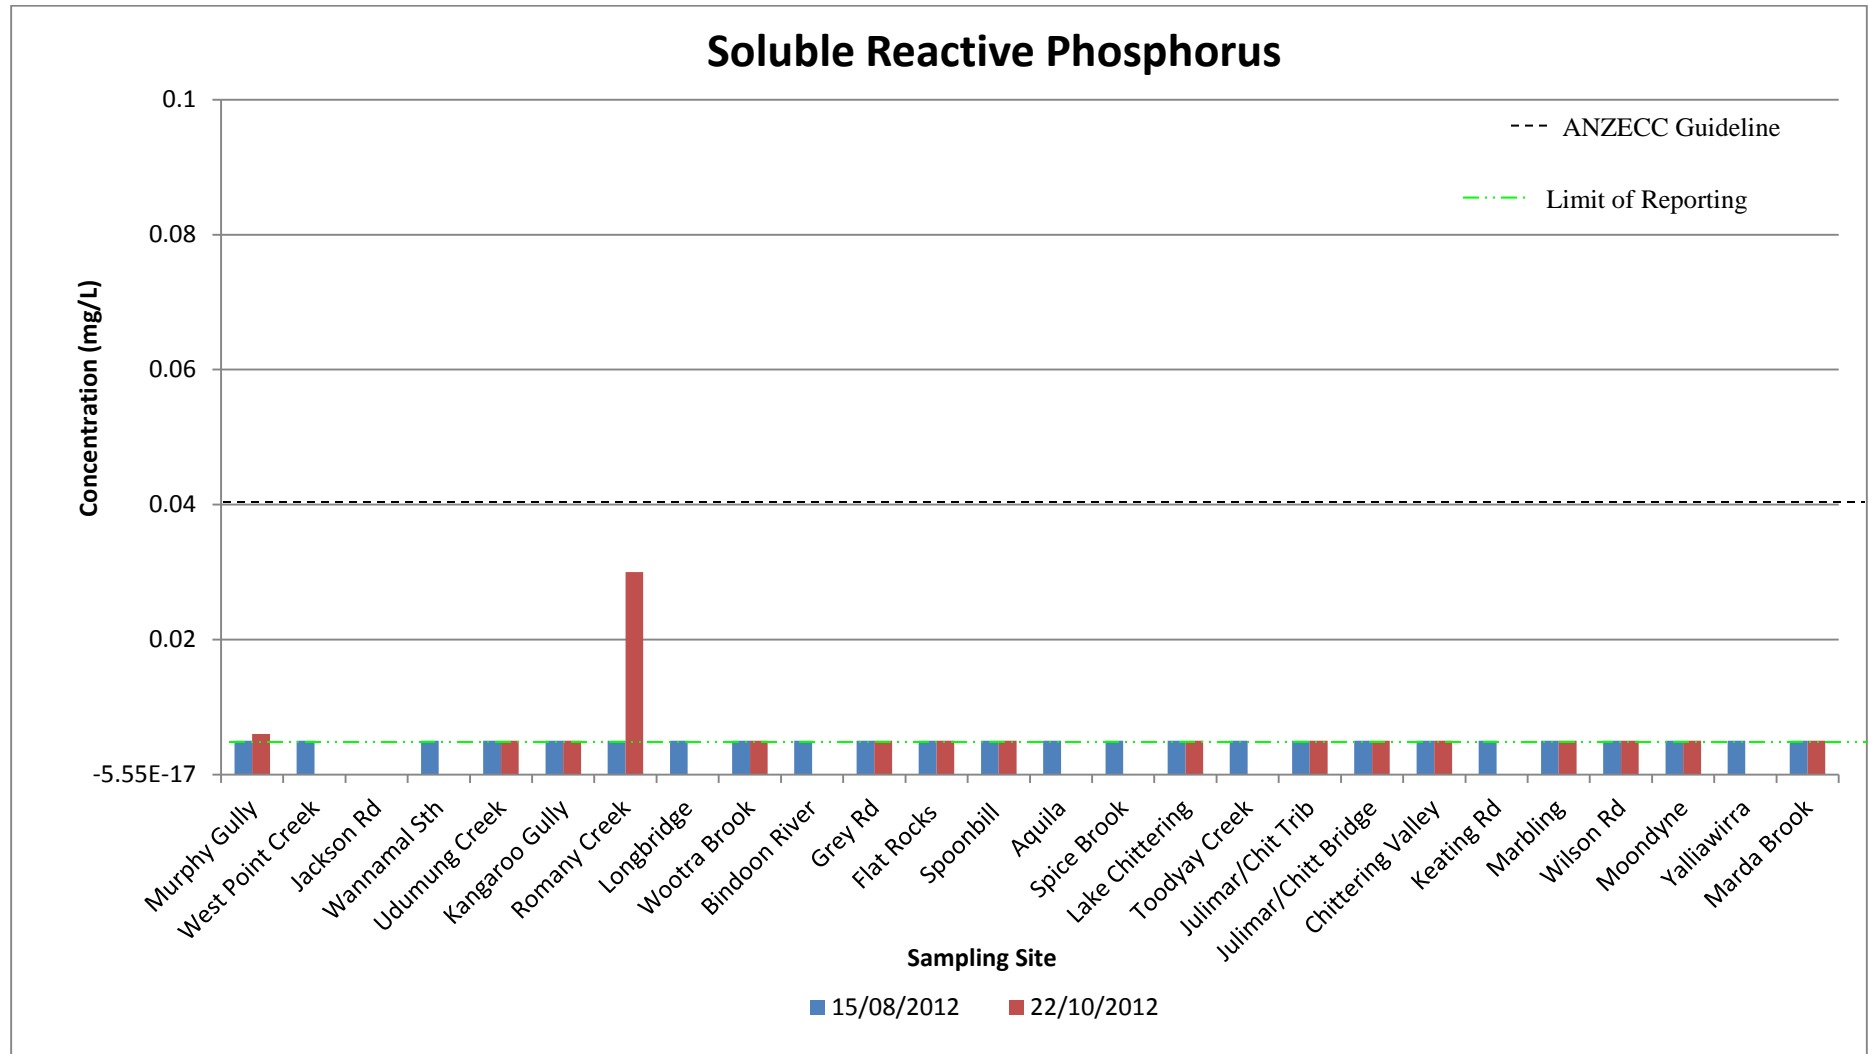
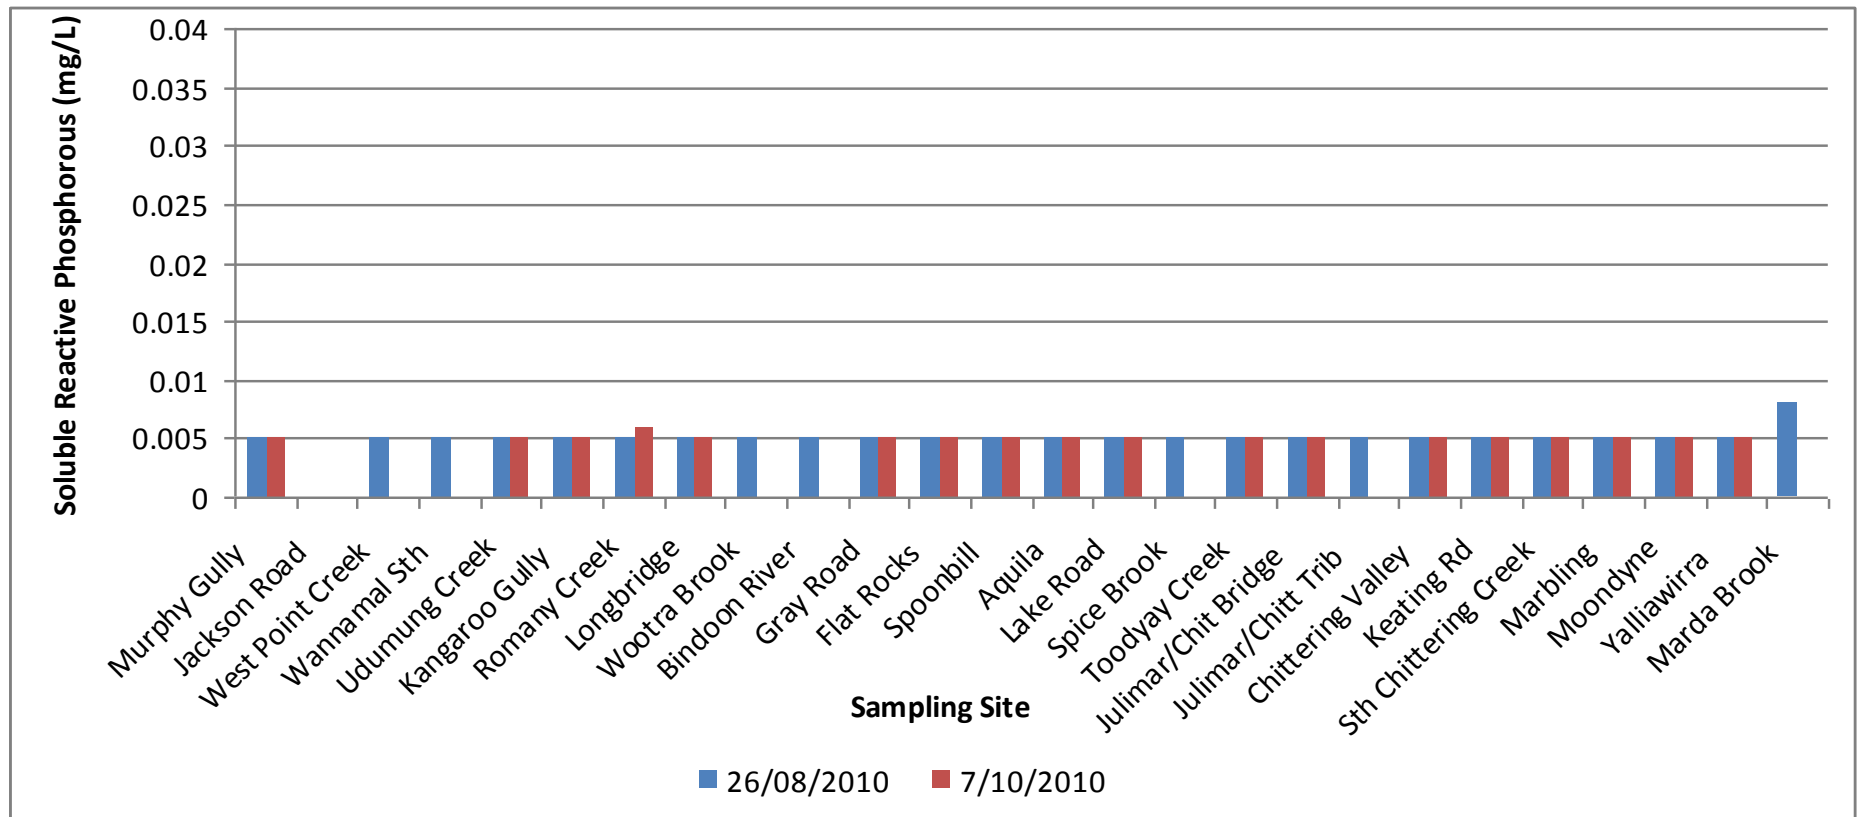
**Figure 16:** Filterable Reactive Phosphorous concentrations in surface water within the Brockman River catchment sampled on 526<sup>th</sup> August and 722<sup>nd</sup> October 2012. \*blanks represent no sample taken

SRP concentrations in surface water within the Brockman catchment were well below the ANZECC water quality guideline for lowland river systems value of 0.04mg/L and below the Limit of Reporting (LOR) at all sampling sites on both sampling occasions. Romany Creek (BRN7) was the only site to approach occasion, the rest were near or under the limit of reporting value except for Marda Brook (BRN26) with a value of 0.008 mg/L and Romany creek with a value of 0.006mg/L (LOR is 0.005mg/l) (Figure 16).

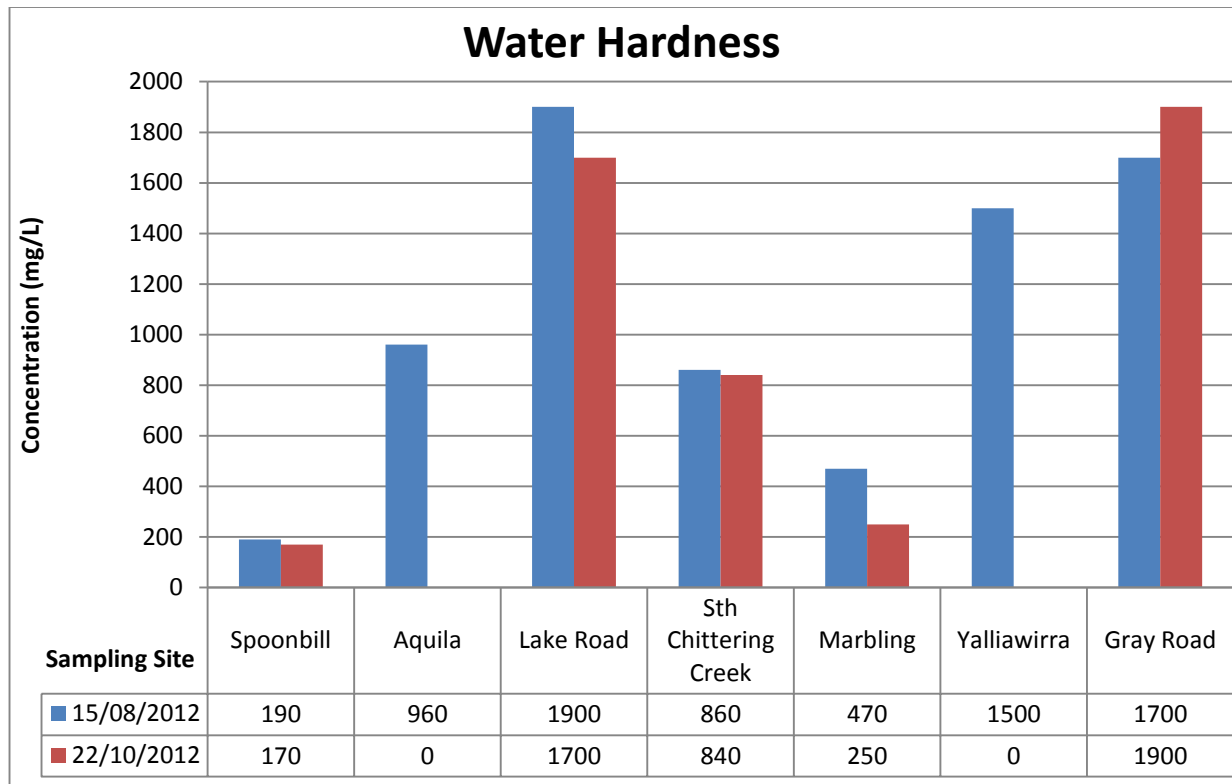
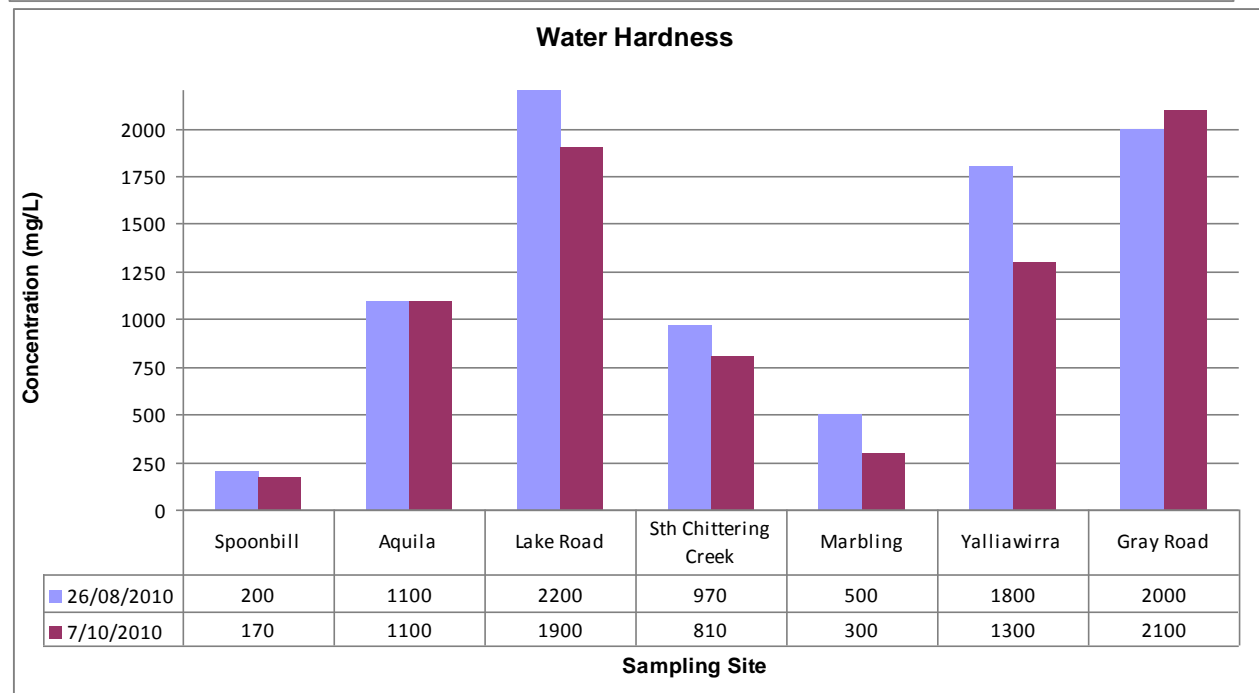
**Figure 17:** Water Hardness sampled from surface waters within the Brockman River catchment on 5<sup>th</sup> August and 722<sup>nd</sup> October 20102.

Water hardness can have an ameliorating effect on the toxicity of some heavy metals including cadmium, copper, zinc, lead, nickel and chromium, as the calcium and carbonate ions compete directly for the same uptake pathways as these metals. Water samples with higher concentrations of water hardness need to have the trigger values for these metals adjusted by a hardness-dependent algorithm or the approximate factors applied to soft water trigger values of varying water hardness provided in ANZECC and ARMCANZ (2000), (Appendix D). Refer to Table 5 for the calculated Hardness-Modified Trigger Values (HMTV) for cadmium, copper, chromium, lead, nickel and zinc. Hardness ranged between 170170mg/L at Spoonbill LakeSpoonbill (BRN113) – very hard, and 92200mg/L at Lake Road (BRN15) and Gray Rd (BRN27) – extremely hard (Figure 17).

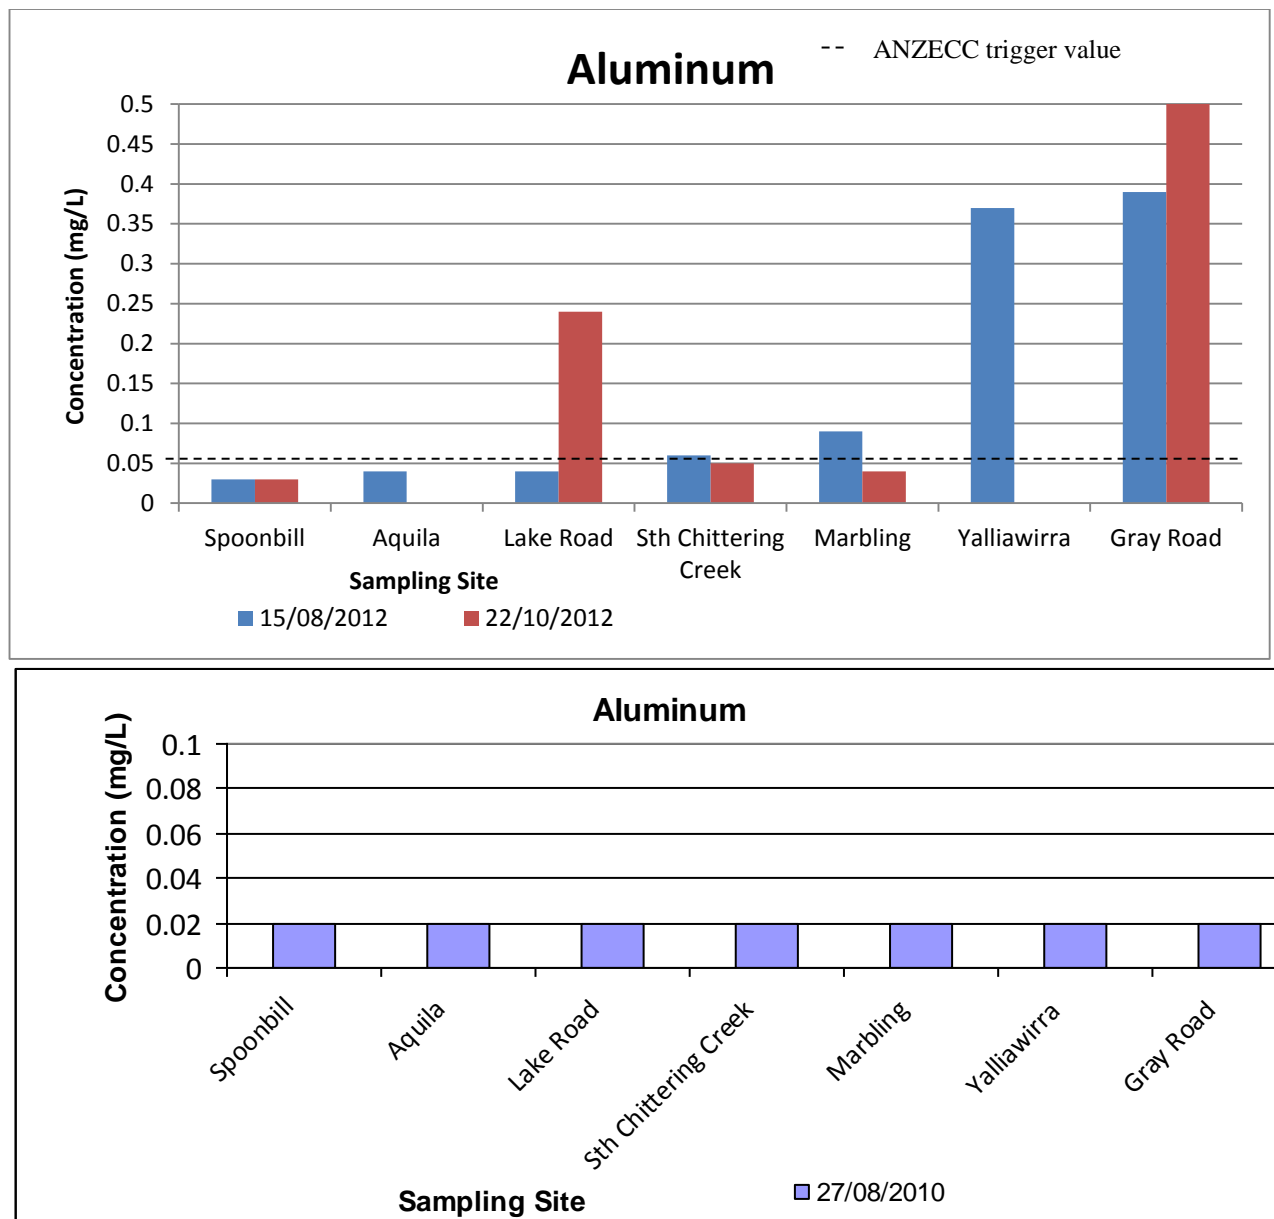
**Figure 18:** Aluminium concentrations in surface water within the Brockman River catchment on the 526<sup>th</sup> August 22<sup>nd</sup> 22010.

South Chittering Creek (BRN22), Marbling (BRN23), Yalliwarra (BRN25) and Gray Rd (BRN27) were above the ANZECC guideline of 0.055mg/L on the August sampling occasion (Figure 18). Lake Rd (BRN15) and Gray Rd (BRN27) exceeded the guideline on the October sampling occasion. In fact no site even reached the limit of reporting for Aluminium which is 0.02mg/L. occasion the samples were not analysed for aluminium due to a miscommunication with the laboratory.

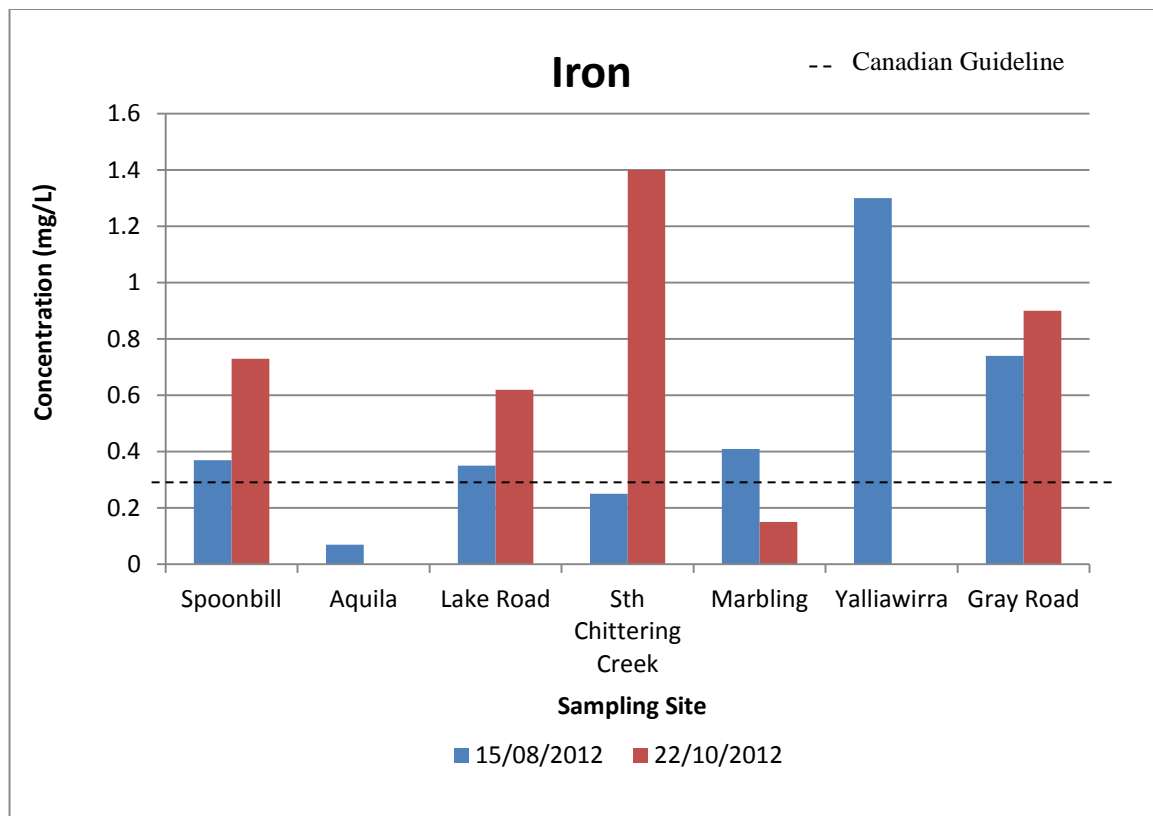
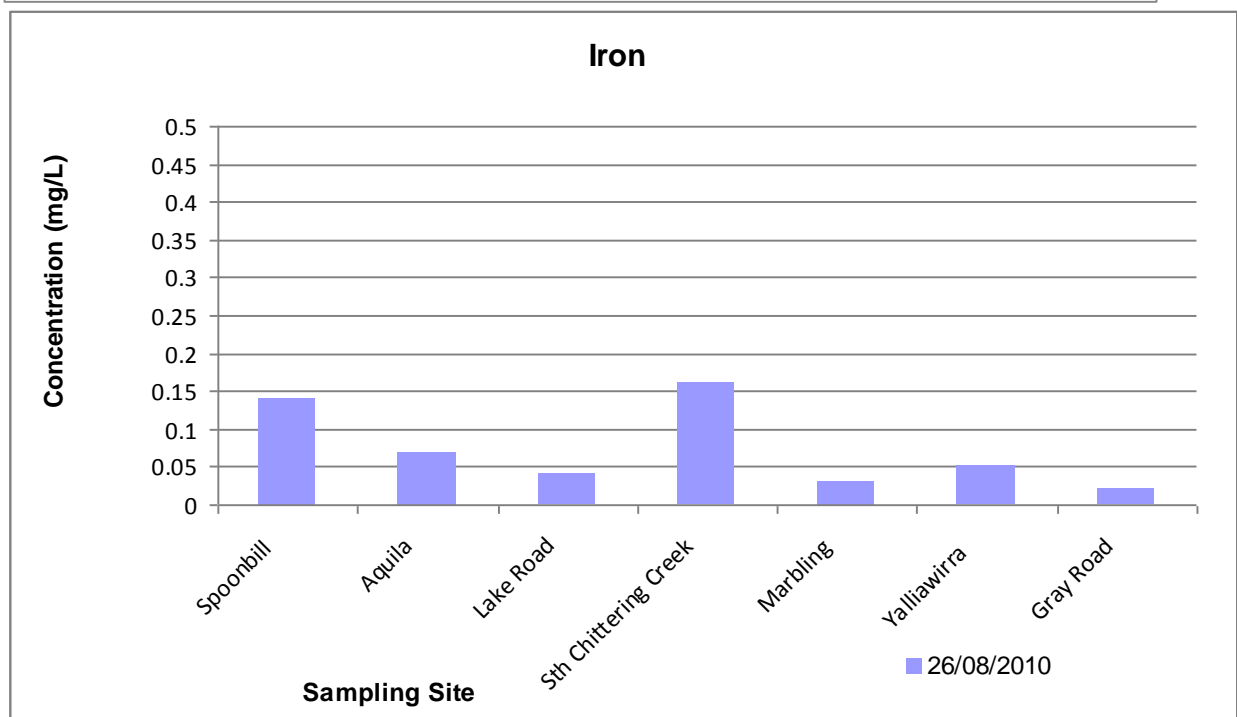
**Figure 19:** Iron concentrations in surface water within the Brockman River catchment on the 15<sup>th</sup> of August and the 22<sup>nd</sup> August 2012.

There is no ANZECC guideline trigger value or environmental concern level (ECLs) available for iron in fresh water as a result of insufficient data (ANZECC and ARMCANZ, 2000). Only Aquila (BRN14) and South Chittering Creek (BRN22) recorded iron concentrations below the current Canadian guideline of 0.3mg/L on the August sampling occasion (Figure 19). This guideline is advised by the ANZECC water quality guidelines to be used as an interim indicative working level for aquatic ecosystems and requires further monitoring. Marbling (BRN23) was the only site to record a Iron concentration below the guideline on the October occasion.

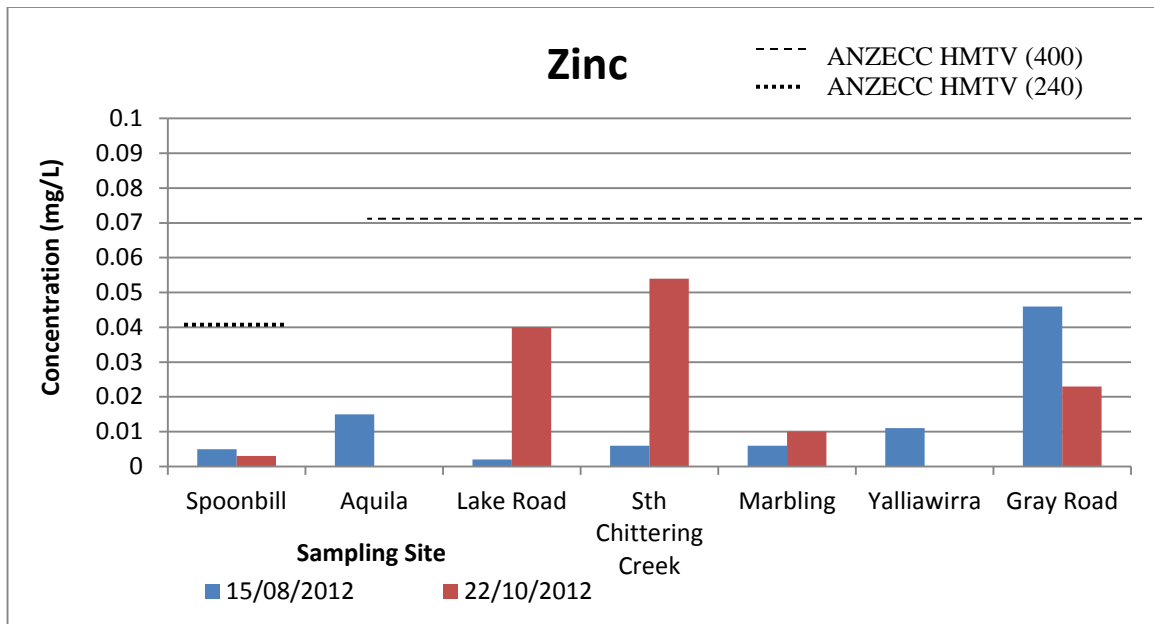
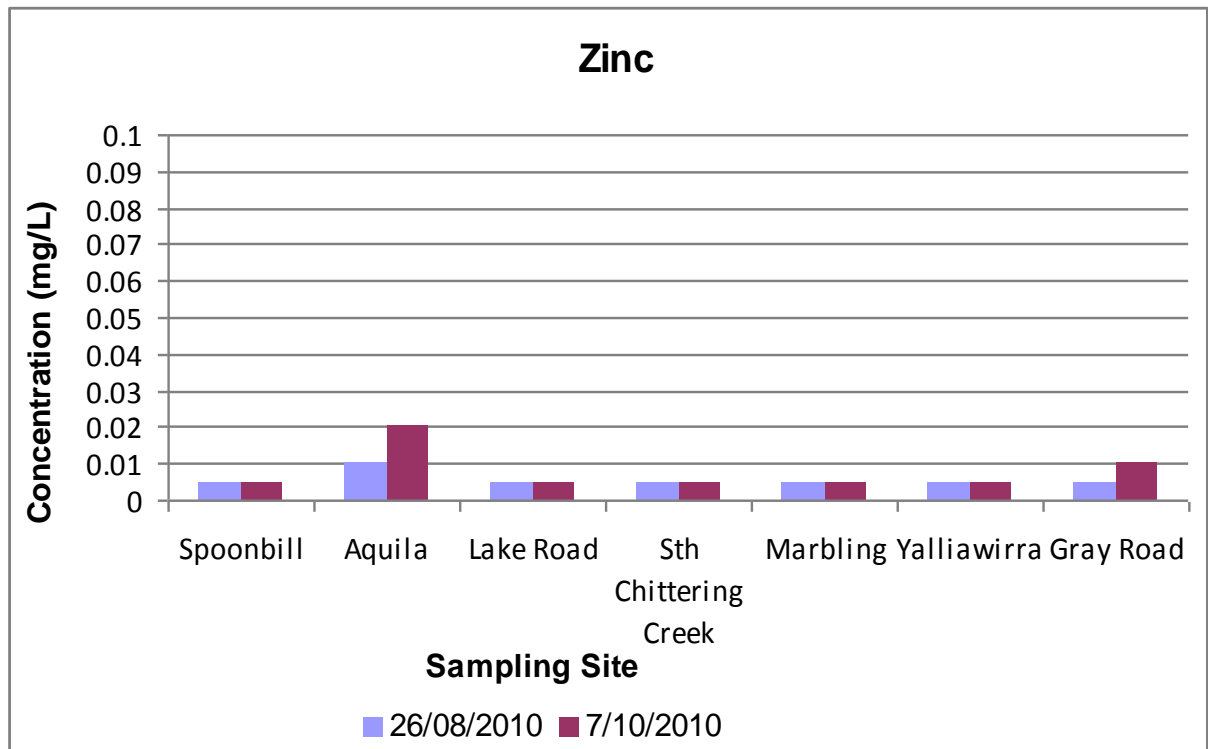
**Figure 20:** Zinc concentrations in surface water within the Brockman River catchment on the 526<sup>th</sup> August and 22<sup>nd</sup> October 20102.

All sites were below the Hardness Modified Trigger Values (HMTV) of 0.07mg/L for sites with extreme water hardness: Aquila Reserve (BRN14); Lake Road (BRN15), South Chittering Creek (BRN22), Marbling Brook (BRN23), Yalliwirra (BRN25) and Grey Road Bridge (BRN27), and 0.04mg/L for Spoonbill (BRN1313) with very hard water, during both sampling occasion, (Figure 20).

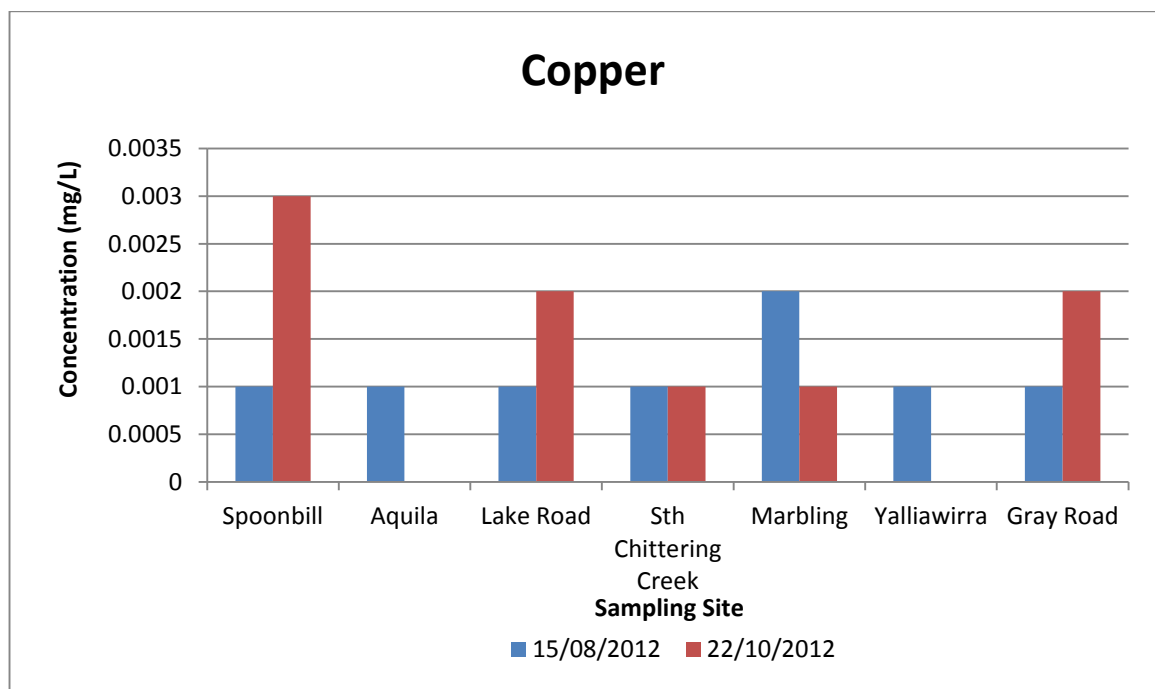
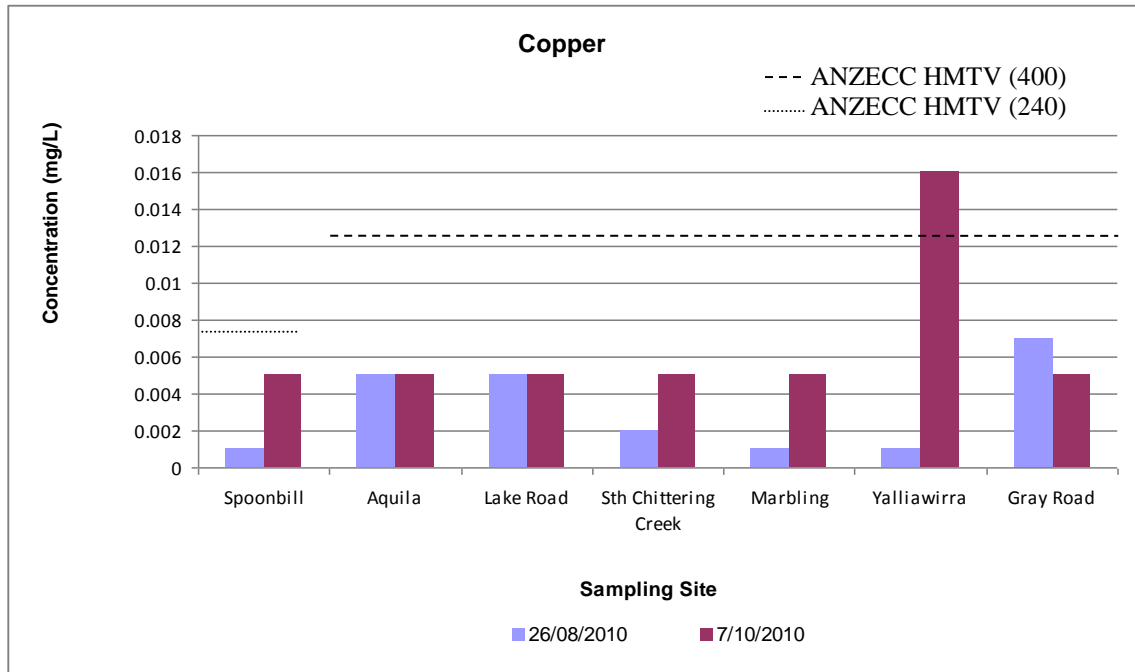
**Figure 21:** Copper concentrations in surface water within the Brockman River catchment on the 5<sup>th</sup> August and the 22<sup>nd</sup> October and 7<sup>th</sup> October 20102.
