# **Brockman River Catchment**

## ***Water Quality Monitoring Snapshot***

### ***August and October 2012***

**Prepared by the Ellen Brockman Integrated Catchment Group: March 2013**

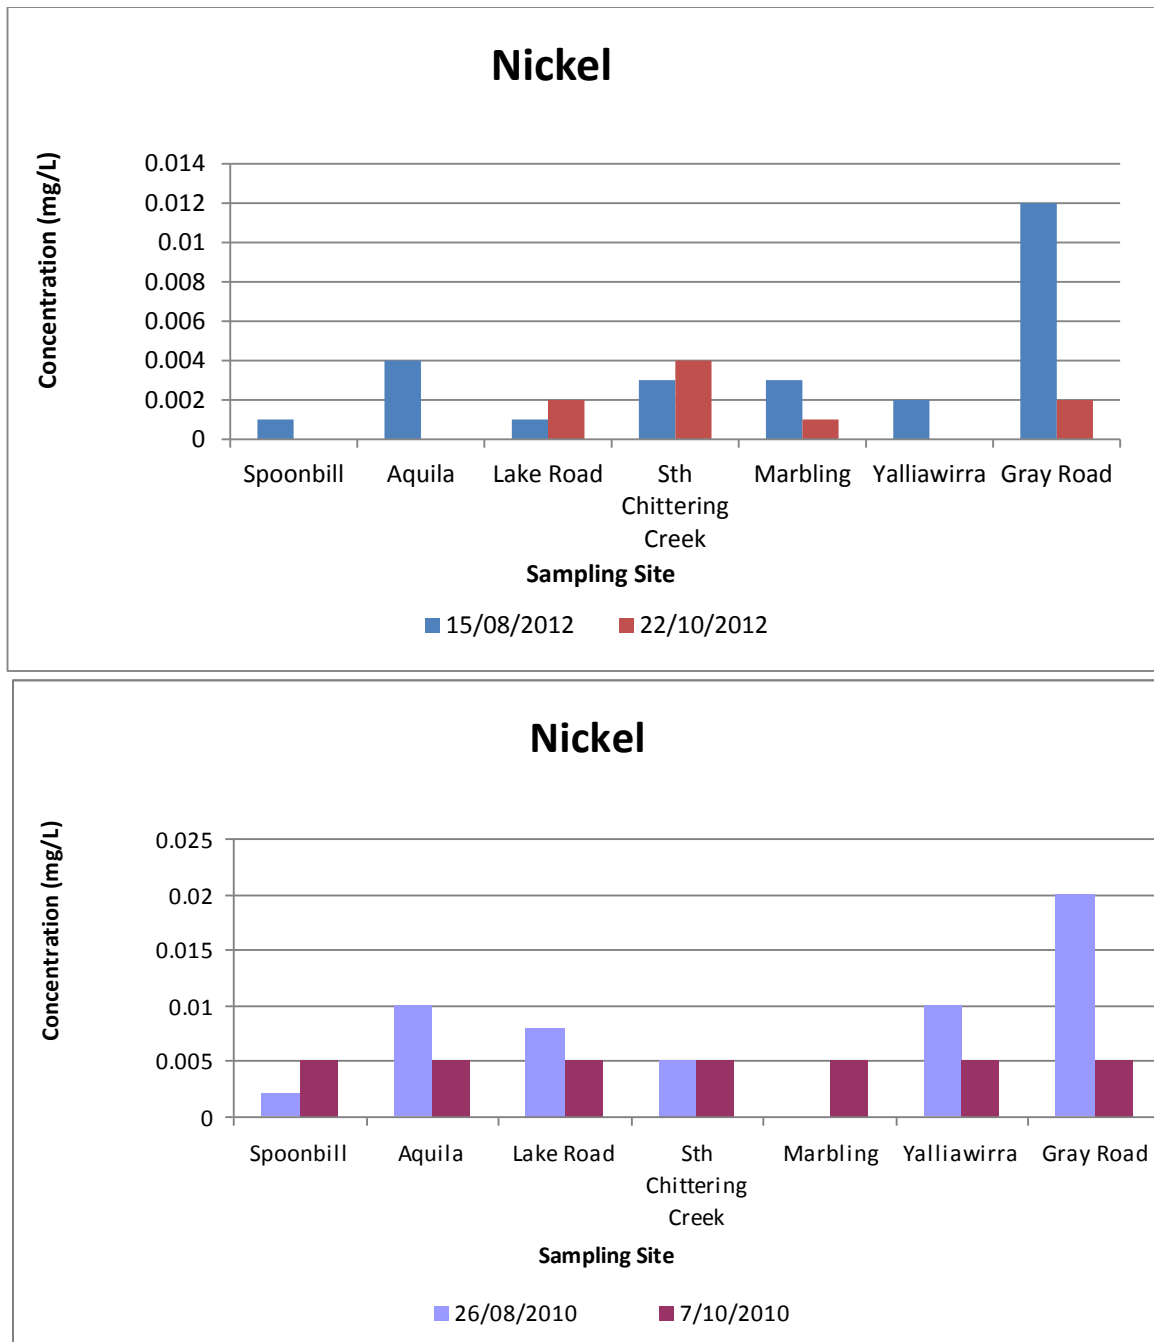
**Figure 22:** Nickel concentrations in surface water within the Brockman River catchment on the 526<sup>th</sup> August and 22<sup>nd</sup> October 2012.
