Prepared by the Ellen Brockman Integrated Catchment Group: December 2016

#### 2. Executive Summary

Brockman River Catchment Water Quality Monitoring Snapshot August & September 2015

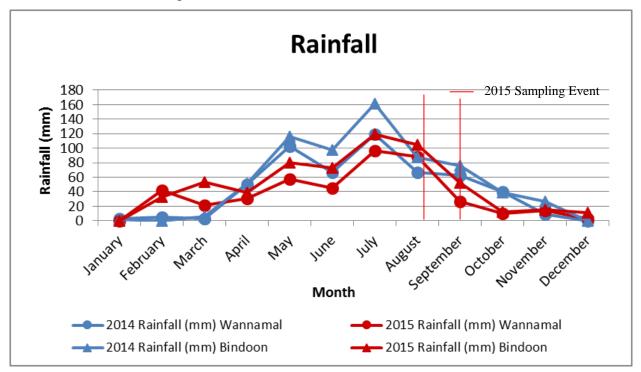
The catchment experiences a typical Mediterranean climate of hot dry summers and cool wet winters. Average rainfall for the southern portion is 800mm/yr decreasing to less than 600mm/yr in the northern regions (Bureau of Meteorology, 1998). The annual rainfall that was received in Wannamal (Station 009040) was a total of 436.7mm and Bindoon (Station 009112) with a total of 594mm (Figure 3). This is less than the rainfall received in 2014, which was still below the annual average.

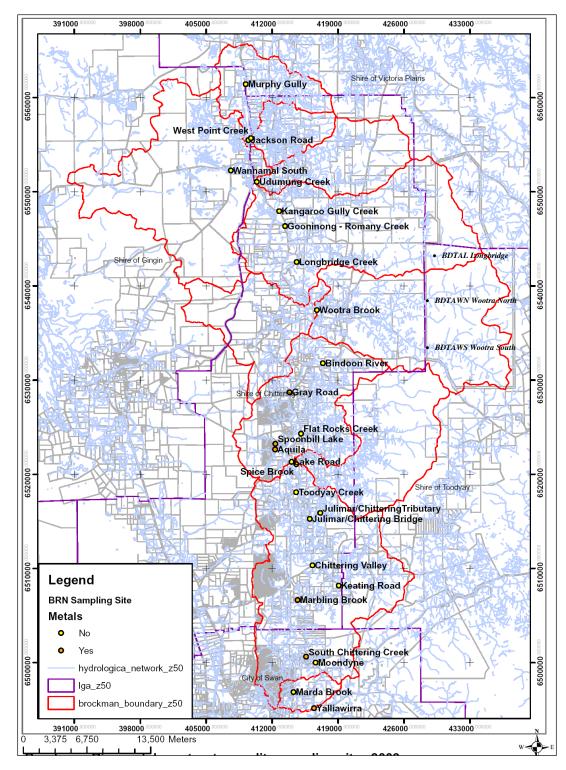
**Figure 5:** Sampling site locations within the Brockman River Catchment. NB: Sampling Sites in *'italic'* are not part of the BROCKMANWQ program. These sites were part of the BDTA water quality monitoring program (CLG, 2010).

Water samples were taken from twenty-six sites within the Brockman River catchment (Figure 5). Crest Hill Road (BRN11) was removed from the sampling program in 2008 and replaced with Grey Road Bridge (BRN27). These sites were selected to be representative of sub-catchments carrying large volumes of water to the Brockman River, to determine their salinity, relative nutrient and metal contribution, and whether they were situated upstream or downstream of potentially high impact land uses or of likely contaminant sources. Table 3 lists the twenty-six sample sites by site number, site name and relative waterway component. Site location is also provided using street names, northings and eastings.

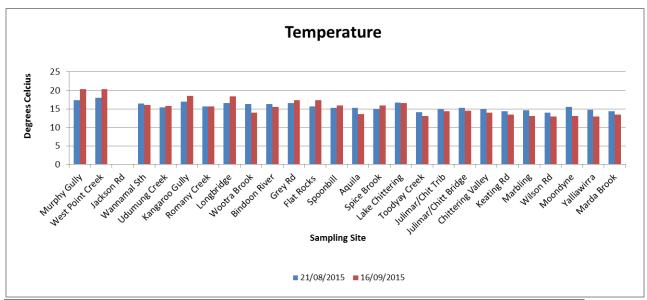
**Figure 6:** Water temperature of surface water within the Brockman River Catchment on the 21<sup>st</sup> August and 16<sup>th</sup> September 2015. \*blanks represent no sample taken\*

Samples taken were from sites with flowing water at a depth ranging from 10-20cm below the surface and not in contact with the sediment at any time. August temperatures ranged between 13 °C at Wilson Road (BRN22) and 17°C at Murphy Gully (BRN1). Water temperatures were generally warmer during the September sampling run, and ranged between 15.5°C at Wilson Road (BRN22) and 23.7°C at Jackson Road (BRN2), (Figure 6).

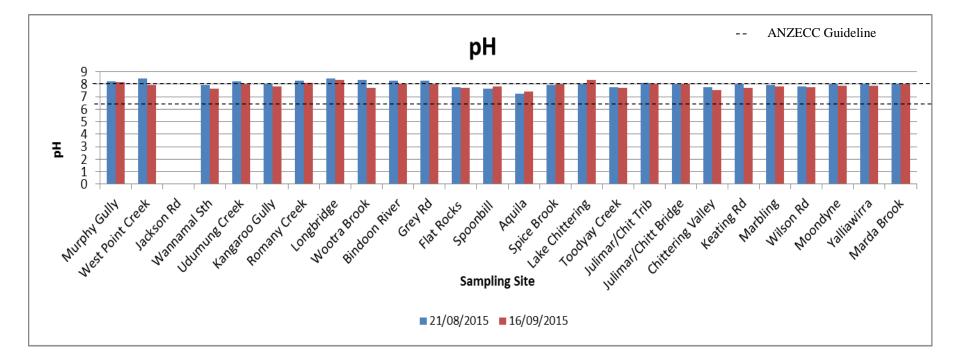
Figure 7: pH of surface water within the Brockman River catchment on 21<sup>st</sup> August and 16<sup>th</sup> September 2015.

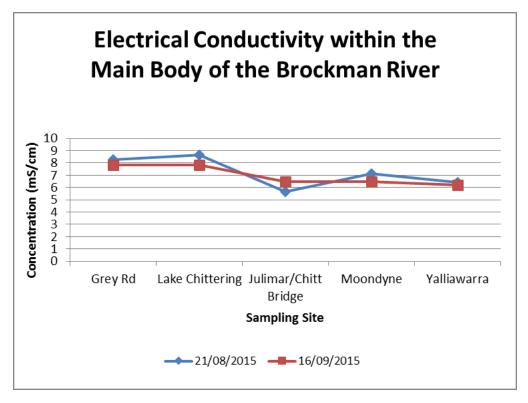
**Figure 8:** Electrical conductivity within the main body of the Brockman River, recorded at sampling sites Grey Road (BRN27), Lake Road (BRN15), Julimar/Chittering Bridge (BRN18), Moondyne (BRN24) and Yalliawirra (BRN25) in 2015.

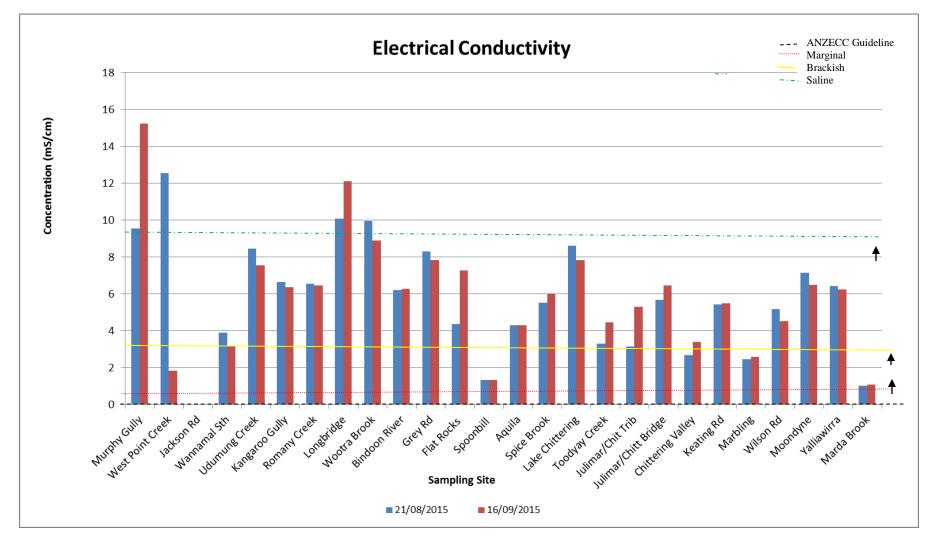
Figure 9: Conductivity in surface water within the Brockman River catchment on 21<sup>st</sup> August and 16<sup>th</sup> September 2015.

Electrical conductivity ranged from 1.008mS/cm at Marda Brook (BRN26) to 15.253mS/cm at Murphy Gully (BRN1). All sites consistently exceeded the ANZECC guidelines for freshwater lowland rivers of 0.12mS/cm to 0.3mS/cm (Figure 9). It should be noted that of the sites that exceeded the guidelines for ecosystem value, the majority of them were also within the brackish levels, with 22 sites within brackish levels on at least one sampling occasion. Brackish water is between 3mS/cm and 9.1mS/cm, saline water is between 9.5mS/cm and 23mS/cm), anything above 2.7 is becoming brackish and would be detrimental for irrigation of stone fruit and citrus orchards (Figure 9).

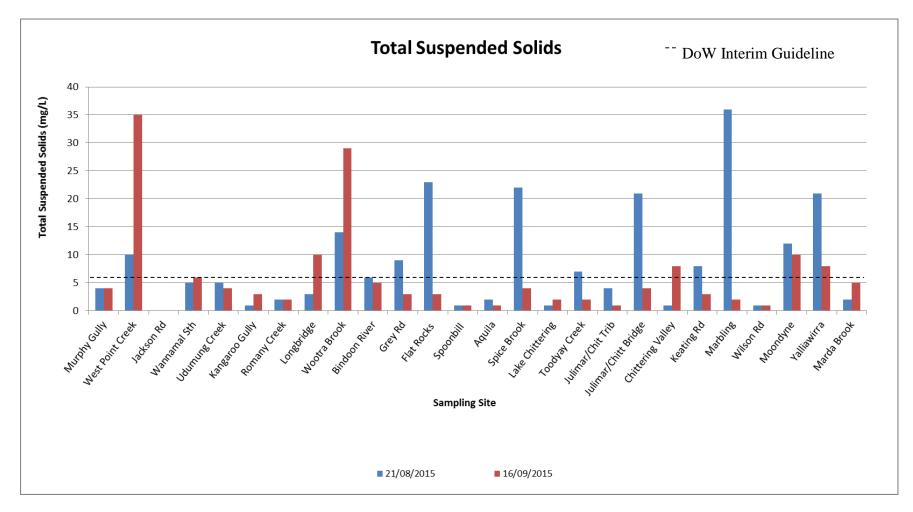
**Figure 10:** Total Suspended Solids in surface water within the Brockman River catchment sampled 21<sup>st</sup> August and 16<sup>th</sup> September 2015. \*blanks represent no sample taken or below limit of reporting

Eleven of the sites recorded a result over the guideline of 6mg/L for TSS in the August sampling run, there were six sites with a reading over the guideline on the September sampling occasion.

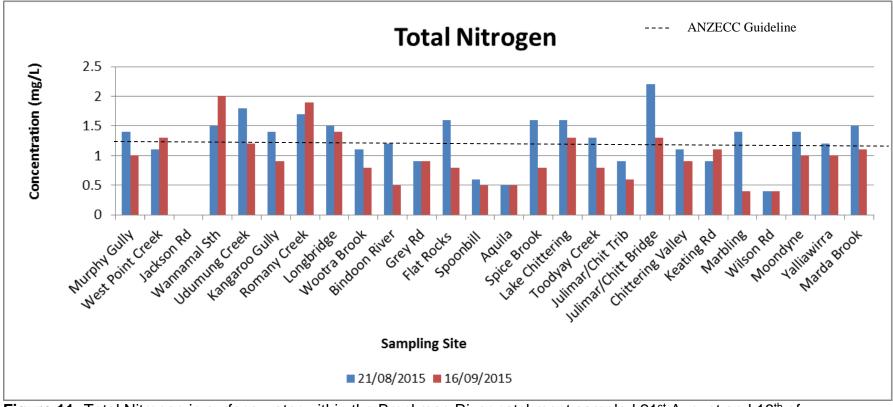
**Figure 11:** Total Nitrogen in surface water within the Brockman River catchment sampled 21<sup>st</sup> August and 16<sup>th</sup> of September 2015. \*blanks represent no sample taken or below limit of reporting

The majority of the readings that were above the ANZECC guideline of 1.2mg/L were on the August sampling occasion. Fourteen of the twenty-six sites had a result over the guideline on the August sampling occasion, and of these the majority were in the northern end of the catchment. Only six sites recorded Total Nitrogen readings above the guideline on the September occasion. Julimar Bridge(BRN18) recorded the highest concentration of 2.2mg/L on the August sampling occasion and Udamung creek (BRN 5) recorded the highest concentration for the September sampling run, with 1.8mg/L. Further monitoring is recommended.

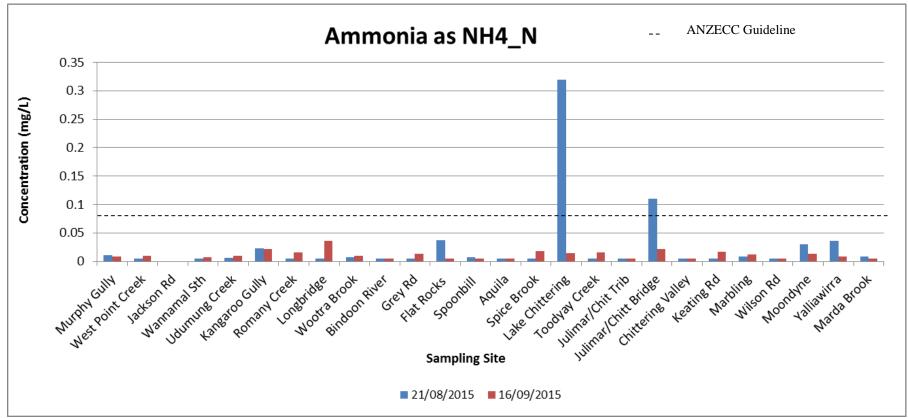
**Figure 12:** Ammonia as NH4N concentrations in surface water within the Brockman River catchment on 21<sup>st</sup> August and 16<sup>th</sup> September 2015. \*blanks represent no sample taken

Most sites were within the ANZECC guideline of 0.08mg/L on both sampling occasions (Figure 12). Concentrations were higher on the August sampling occasion. This could be due to a rainfall event with increased runoff transporting nutrients directly into waterways, timing of fertiliser application and stock access to waterways. Lake Chittering (BRN15) and Julimar Bridge (BRN18) did record levels above the guideline which is highly unusual. These two sites are also consecutive in terms of the main channel of the Brockman River. The likely cause is related to the chittering lake system discharging runoff however more investigations need to be made.

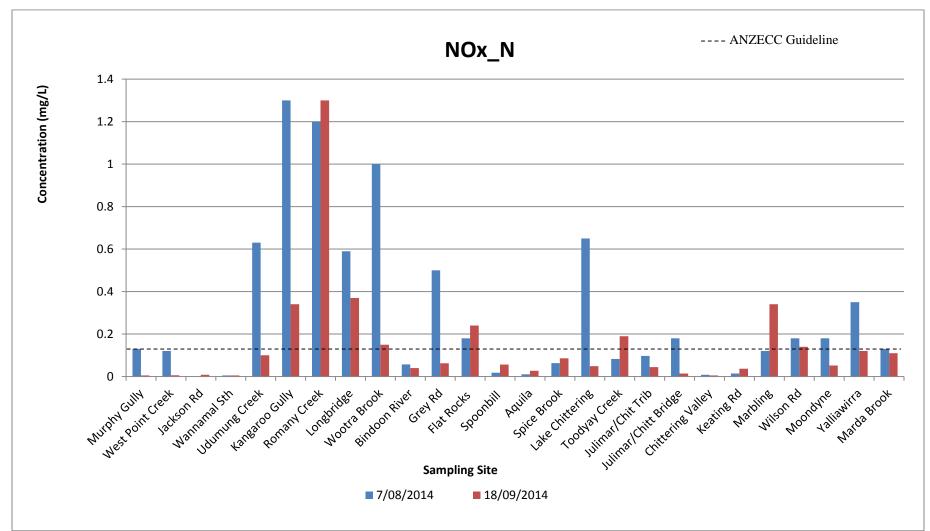
**Figure 13:** NOX\_N (TON) concentrations in surface water within the Brockman River catchment in 7<sup>th</sup> August and 18<sup>th</sup> September 2014. \*note blanks represent no sample taken

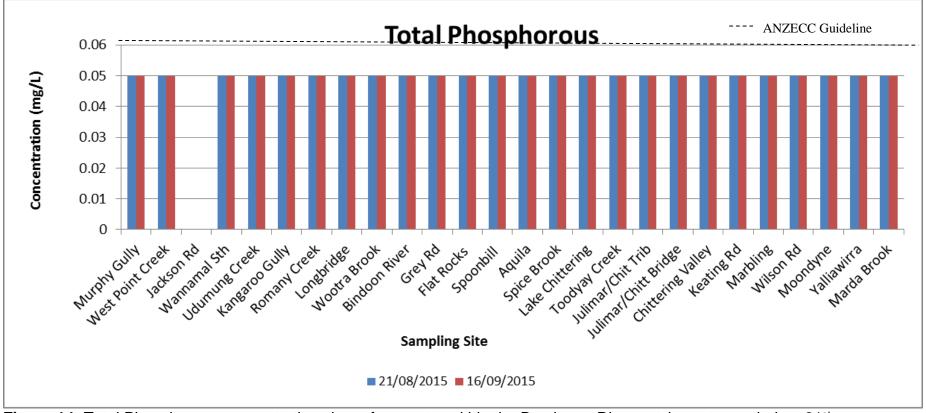
**Figure 14:** Total Phosphorous concentrations in surface water within the Brockman River catchment sampled on 21<sup>st</sup> August and 16<sup>th</sup> September 2015. \*note blanks represent no sample taken

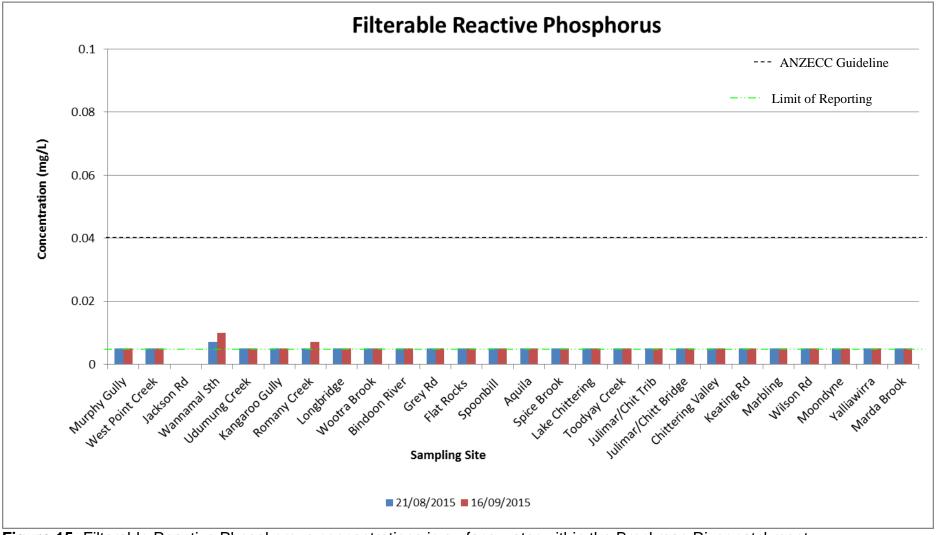
**Figure 15:** Filterable Reactive Phosphorous concentrations in surface water within the Brockman River catchment sampled on 21<sup>th</sup> August and 16<sup>th</sup> September 2015. \*blanks represent no sample taken

SRP concentrations in surface water within the Brockman catchment were below the ANZECC water quality guideline for lowland river systems value of 0.04mg/L at all sites and below the Limit of Reporting (LOR) at most sampling sites on both sampling occasions (Figure 15).

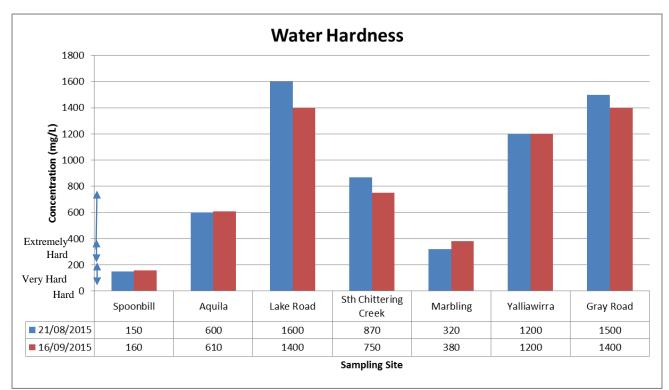
**Figure 16:** Water Hardness sampled from surface waters within the Brockman River catchment on 21<sup>st</sup> August and 16<sup>th</sup> September 2015.

Water hardness can have an ameliorating effect on the toxicity of some heavy metals including cadmium, copper, zinc, lead, nickel and chromium, as the calcium and carbonate ions compete directly for the same uptake pathways as these metals. Water samples with higher concentrations of water hardness need to have the trigger values for these metals adjusted by a hardness-dependent algorithm or the approximate factors applied to soft water trigger values of varying water hardness provided in ANZECC and ARMCANZ (2000), (Appendix D). Refer to Table 5 for the calculated Hardness-Modified Trigger Values (HMTV) for cadmium, copper, chromium, lead, nickel and zinc. Hardness ranged between 1600mg/L at Lake Rd (BRN15) –hard, and 150mg/L at Gray Rd (BRN27) – extremely hard (Figure 16).

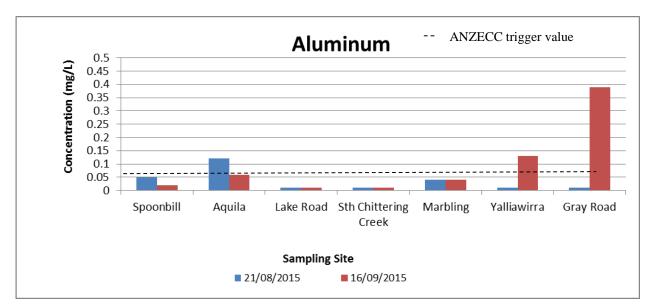
**Figure 17:** Aluminium concentrations in surface water within the Brockman River catchment on the 21<sup>st</sup> August and the 16<sup>th</sup> of September 2015.

Aquila (BRN 14), Yalliawarra (BRN 25) and Gray Rd (BRN 27) were over the ANZECC guideline of 0.055mg/L on both occasions. Values ranged from 0.12mg/L at Aquilla (BRN 14) to 0.39mg/L at Grey Rd (BRN 27). On this occasion the pH was within the guideline however alkalinity may have affected the result.

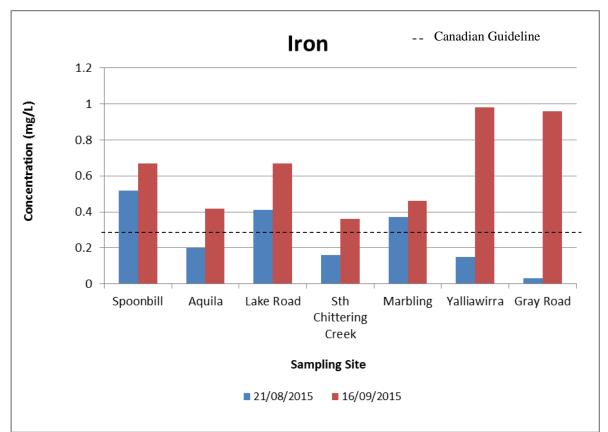
**Figure 18:** Iron concentrations in surface water within the Brockman River catchment on the 21<sup>st</sup> of August and the 16<sup>th</sup> September 2015.

There is no ANZECC guideline trigger value or environmental concern level (ECLs) available for iron in fresh water as a result of insufficient data (ANZECC and ARMCANZ, 2000). No sites were below the below the current Canadian guideline of 0.3mg/L on any sampling occaision (Figure 18). This guideline is advised by the ANZECC water quality guidelines to be used as an interim indicative working level for aquatic ecosystems and requires further monitoring.

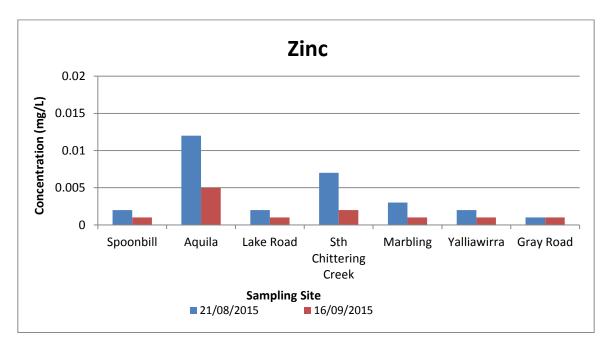
**Figure 19:** Zinc concentrations in surface water within the Brockman River catchment on the 7<sup>th</sup> August and 18<sup>th</sup> September 2015.

All sites were below the Hardness Modified Trigger Values (HMTV) of 0.07mg/L for sites with extremely hard water, 0.0312mg/L for sites with hard water.

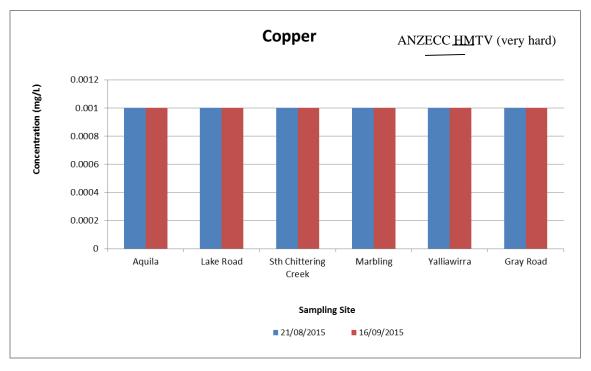
**Figure 20:** Copper concentrations in surface water within the Brockman River catchment on the 21<sup>st</sup> August and the 16<sup>th</sup> September 2015.

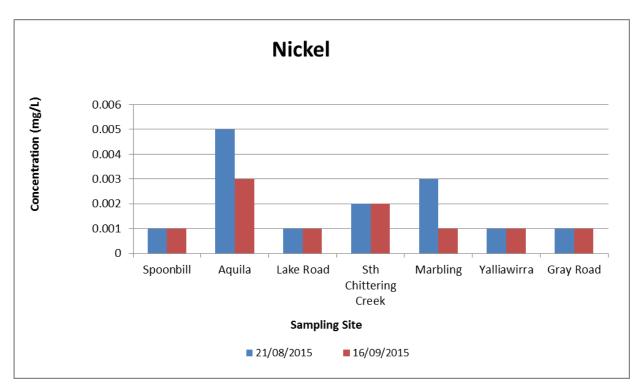
Figure 21: Nickel concentrations in surface water within the Brockman River catchment on the 21<sup>st</sup> August and 16<sup>th</sup> September 2015.\*blanks represent not measured

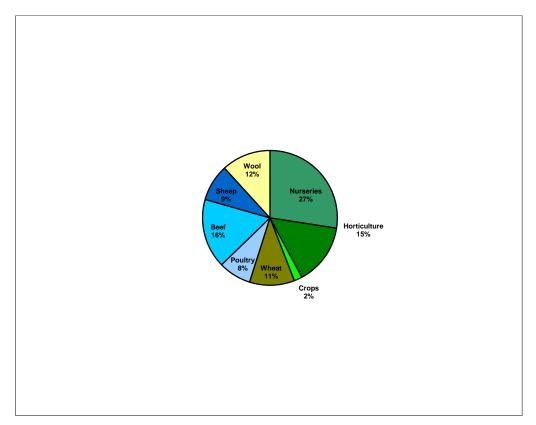
**Figure 24:** Proportion of Gross Value of Agricultural Production (GVAP) (Total \$23 million) by commodity: 1996/97. (Cook and Hatherly, 1997).
