# **Brockman River Catchment**

## ***Water Quality Monitoring Snapshot***

### ***August and September 2017***

**Prepared by the Ellen Brockman Integrated Catchment Group: March 2018**

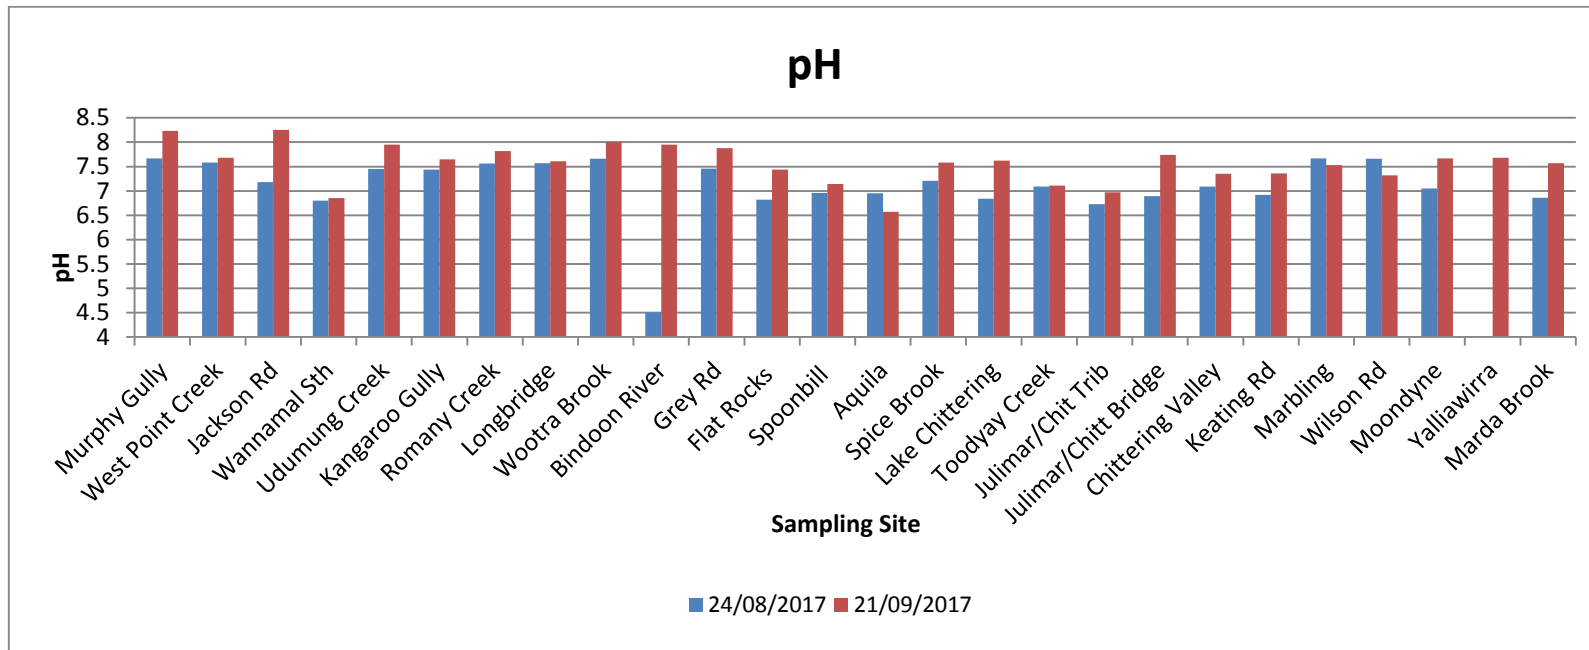
**Figure 7:** pH of surface water within the Brockman River catchment 2017.

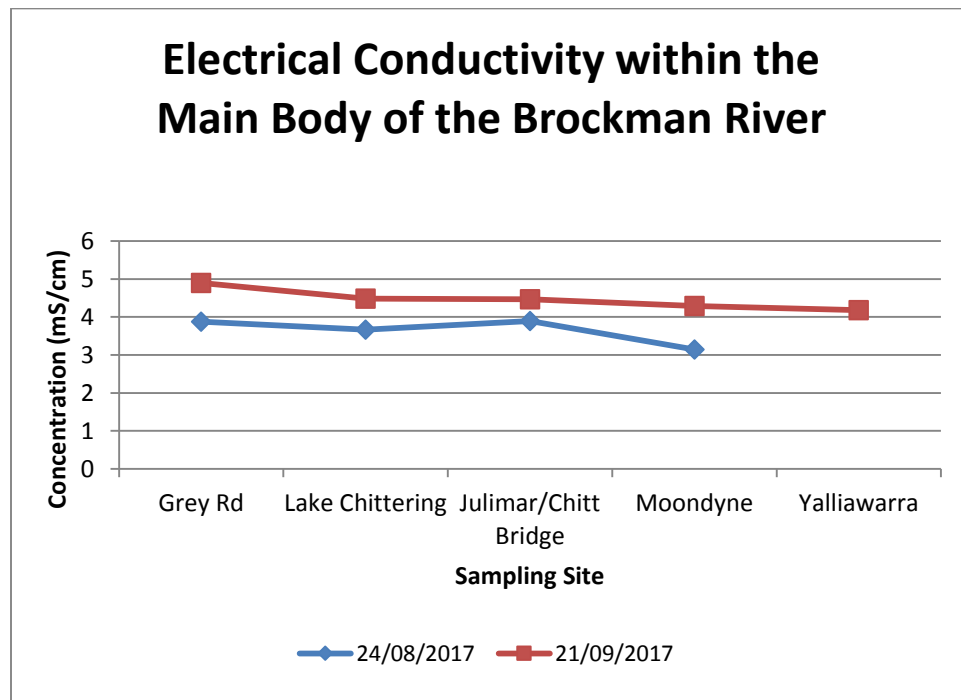
**Figure 8:** Electrical conductivity within the main body of the Brockman River, recorded at sampling sites Grey Road (BRN27), Lake Chittering (BRN15) Julimar/Chittering Bridge (BRN18), Moondyne (BRN24) and Yalliwirra (BRN25) in 2017.

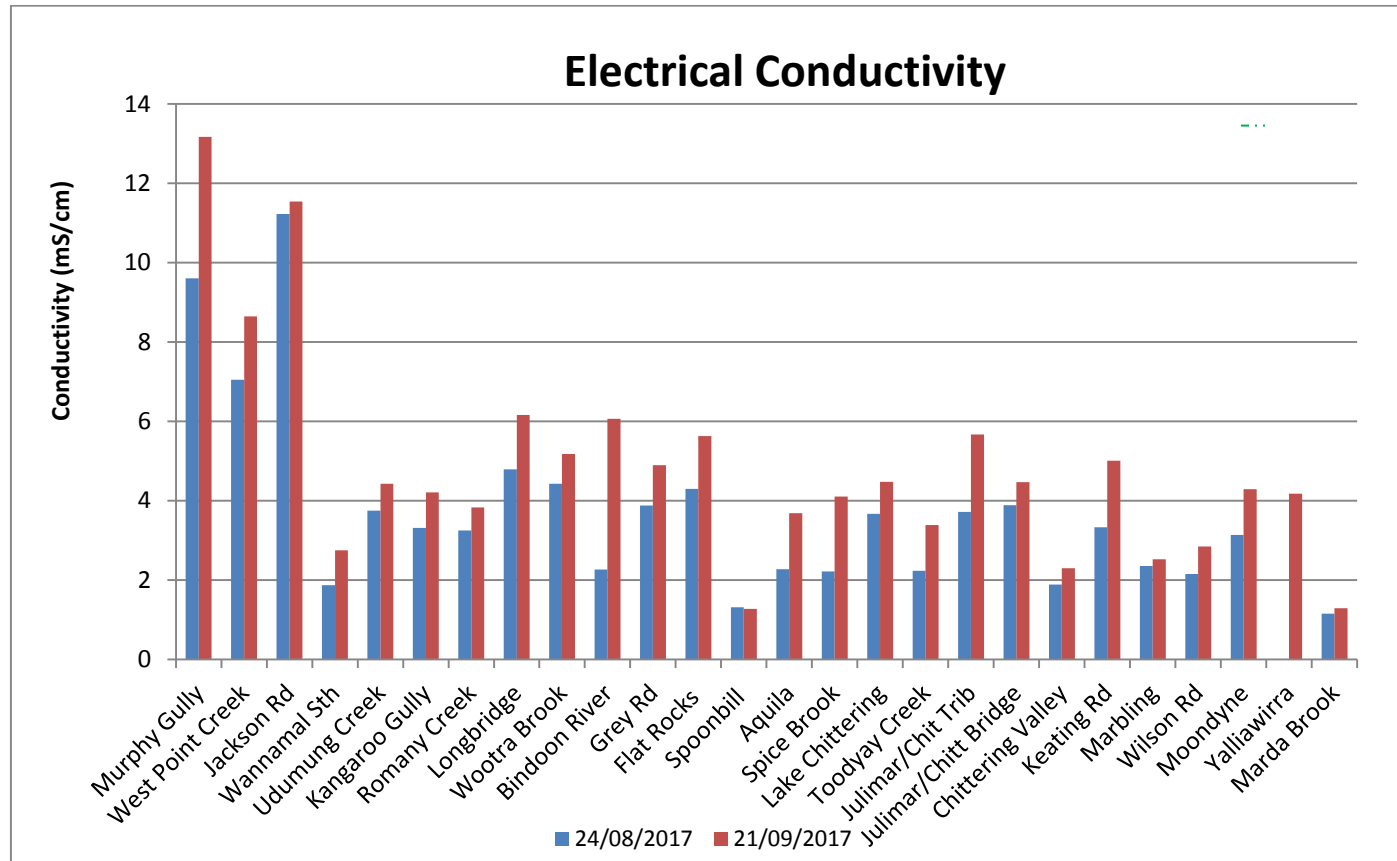
**Figure 9:** Conductivity in surface water within the Brockman River catchment 2017.

Electrical conductivity ranged from 0.582mS/cm at Marda Brook (BRN26) to 13.946mS/cm at Murphy Gully (BRN1). All sites consistently exceeded the ANZECC guidelines for freshwater lowland rivers of 0.12mS/cm to 0.3mS/cm (Figure 9). It should be noted that of the sites that exceeded the guidelines for ecosystem value, the majority of them were also within the brackish levels, with 22 sites within brackish levels on at least one sampling occasion. Brackish water is between 3mS/cm and 9.1mS/cm, saline water is between 9.5mS/cm and 23mS/cm), anything above 2.7 is becoming brackish and would be detrimental for irrigation of stone fruit and citrus orchards (Figure 9).

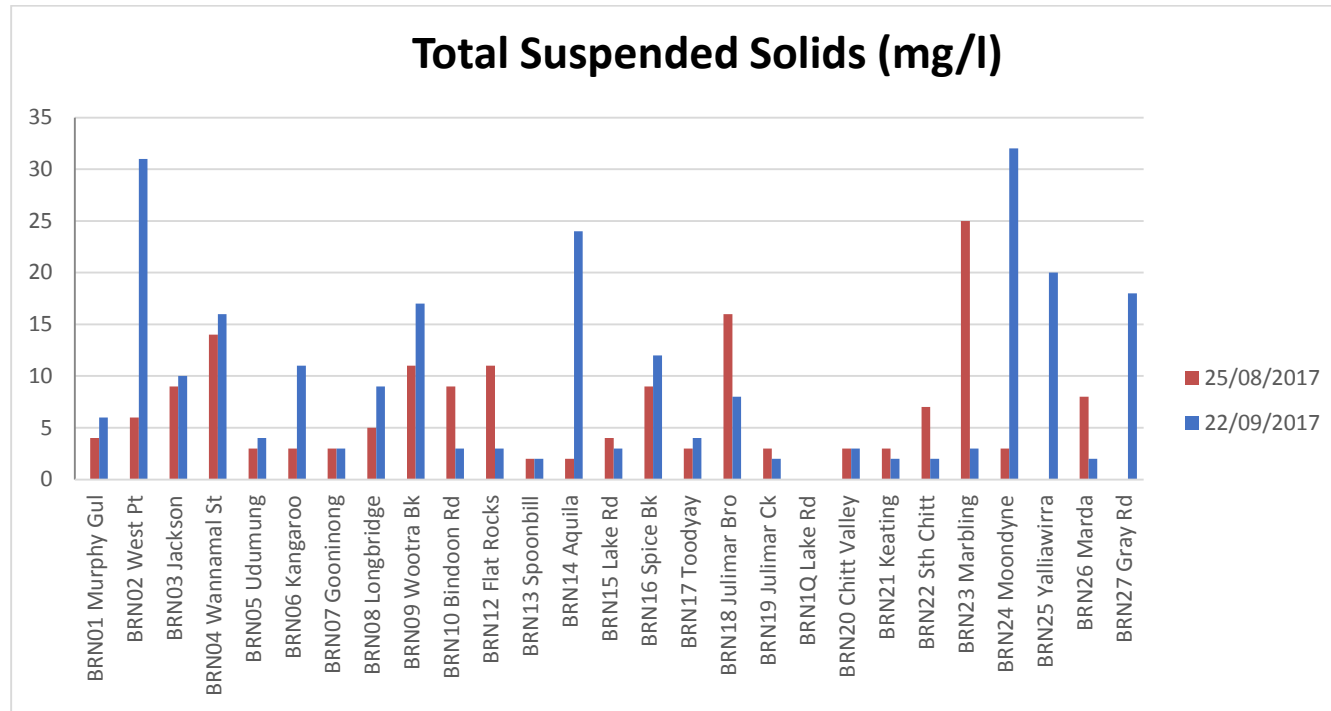
**Figure 10:** Total Suspended Solids in surface water within the Brockman River catchment 2017.

7 of the sites recorded a result over the guideline of 6mg/L for TSS during the September sampling run, while there were 10 sites with a reading over the guideline during the October sampling occasion.

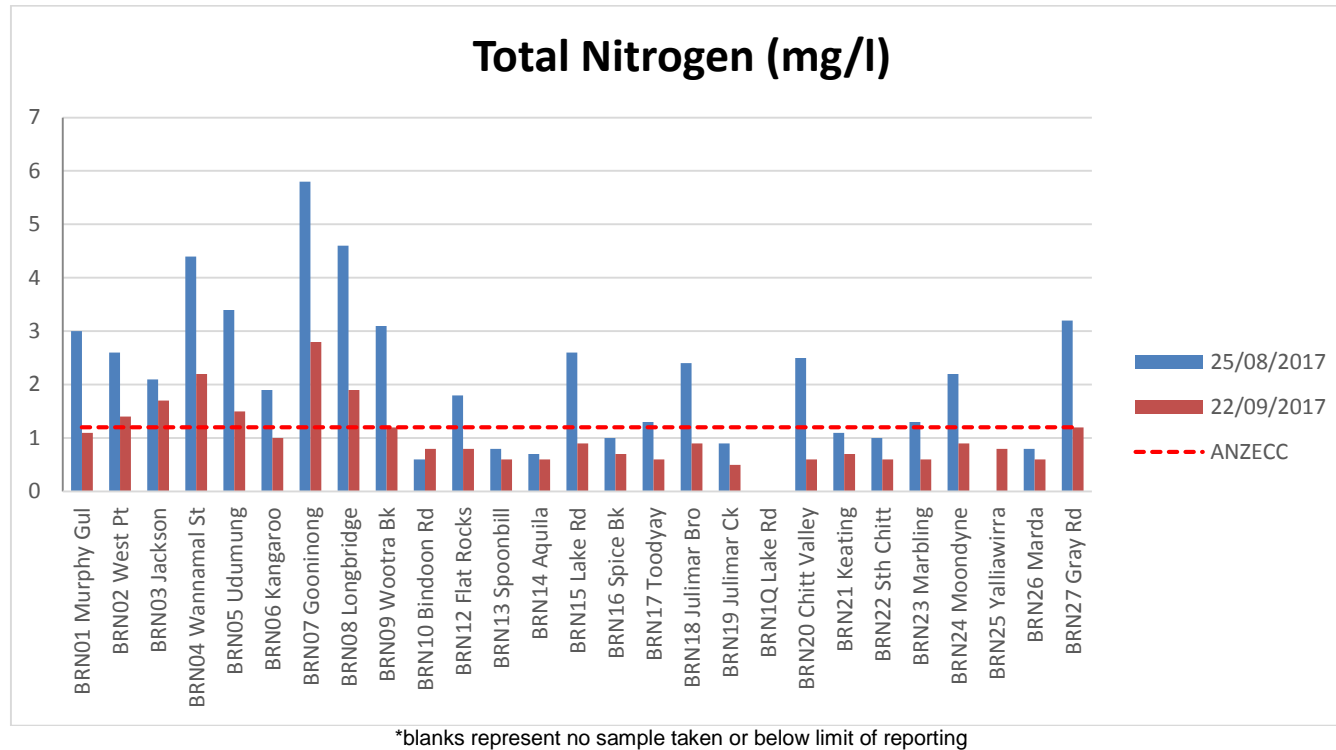
**Figure 11:** Total Nitrogen in surface water within the Brockman River catchment 2017.

The majority of the readings that were above the ANZECC guideline of 1.2mg/L were on the September sampling occasion when 10 of the twenty-six sites had a result greater or equal to the guideline. The majority were in the northern end of the catchment. Only 3 sites recorded Total Nitrogen readings above the guideline in October. Romany Creek (BRN7) recorded the highest concentration of 32.2mg/L on the September sampling occasion while Wannamal South (BRN 4) recorded the highest concentration for the October sampling run, with 2.8mg/L. Further monitoring is recommended.

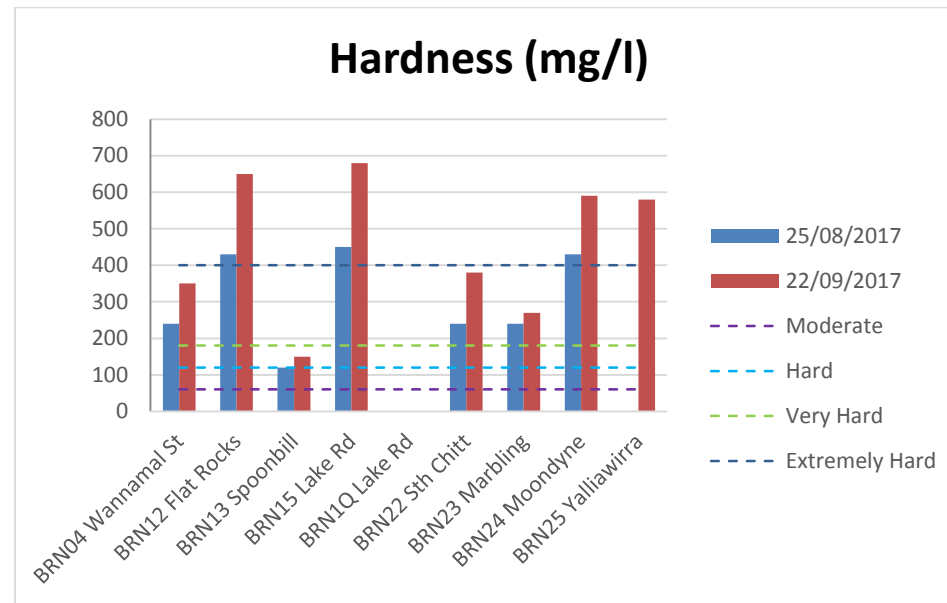
**Figure 14:** Water Hardness sampled from surface waters within the Brockman River catchment 2017.

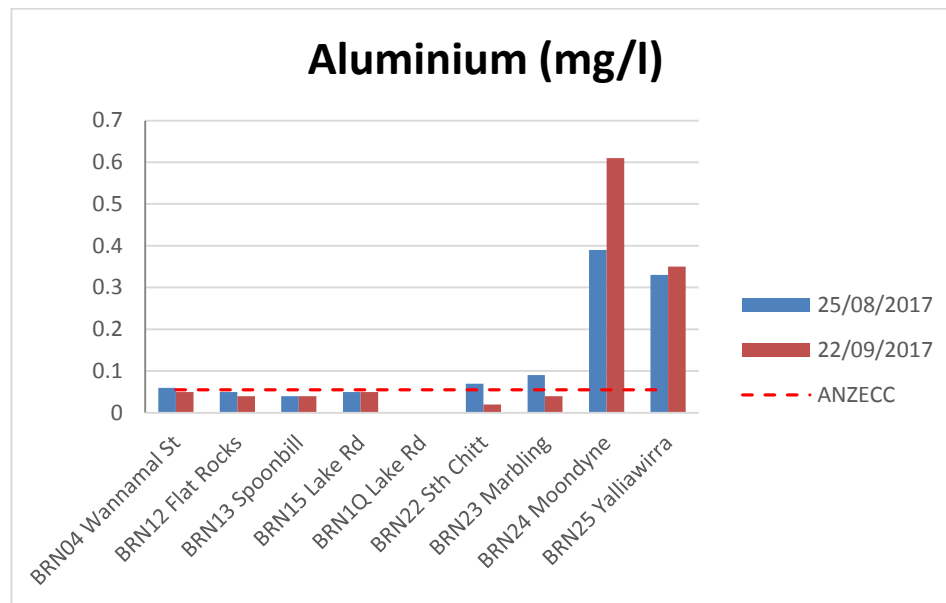
**Figure 15:** Aluminium concentrations in surface water within the Brockman River catchment 2017.

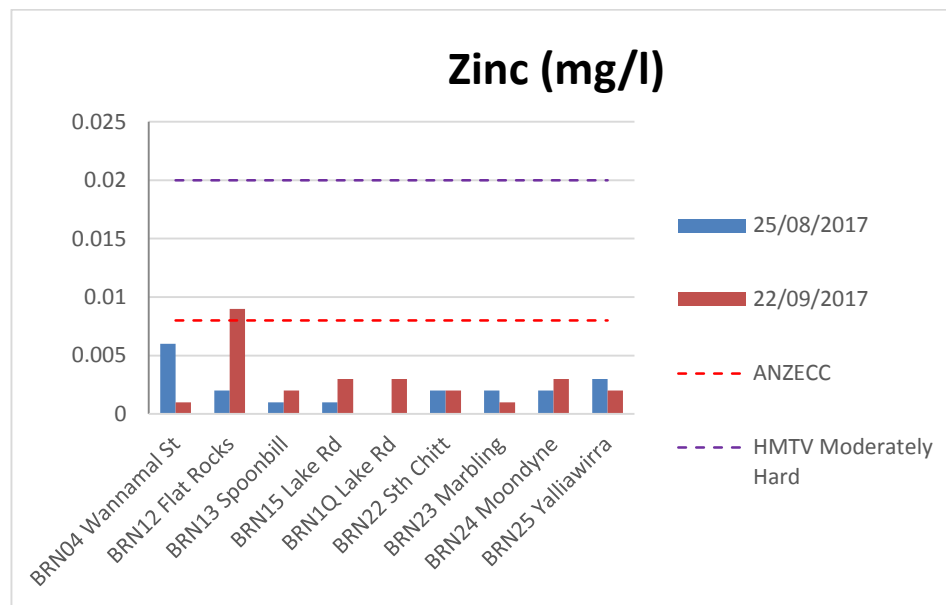
**Figure 17:** Zinc concentrations in surface water within the Brockman River catchment 2017.

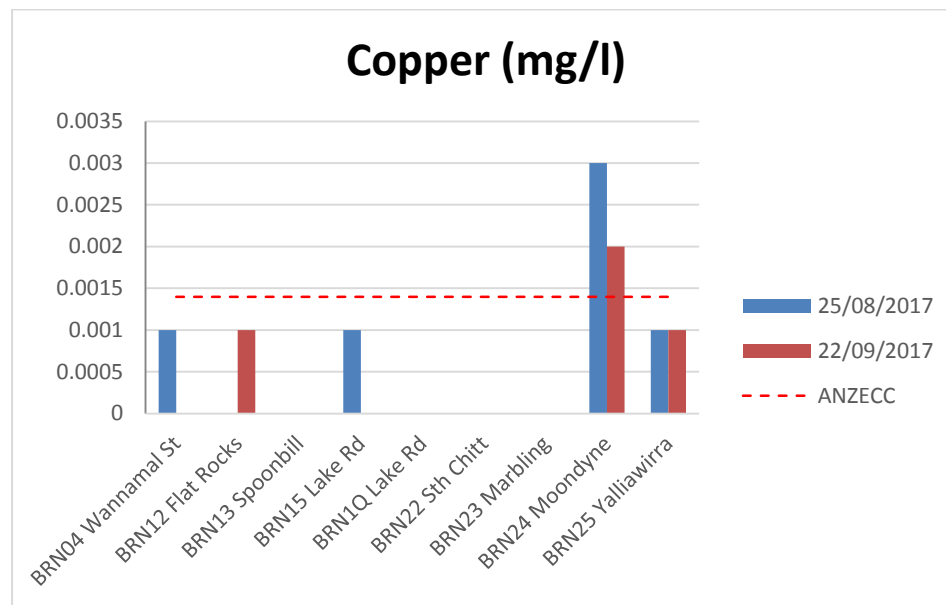
**Figure 18:** Copper concentrations in surface water within the Brockman River catchment 2017.

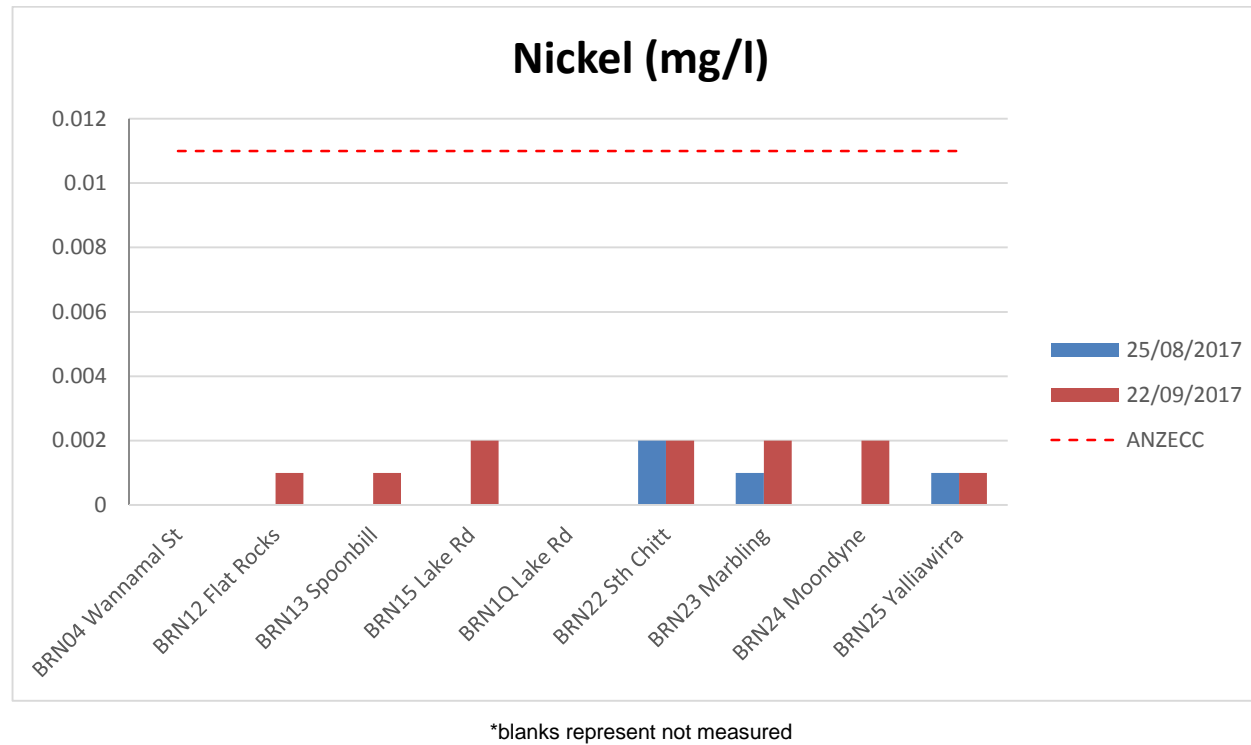
**Figure 19:** Nickel concentrations in surface water within the Brockman River catchment 2017.
