Ellen Brook Catchment

Water Quality Monitoring

July – October 2011

Prepared by the Ellen Brockman Integrated Catchment Group: March 2012.

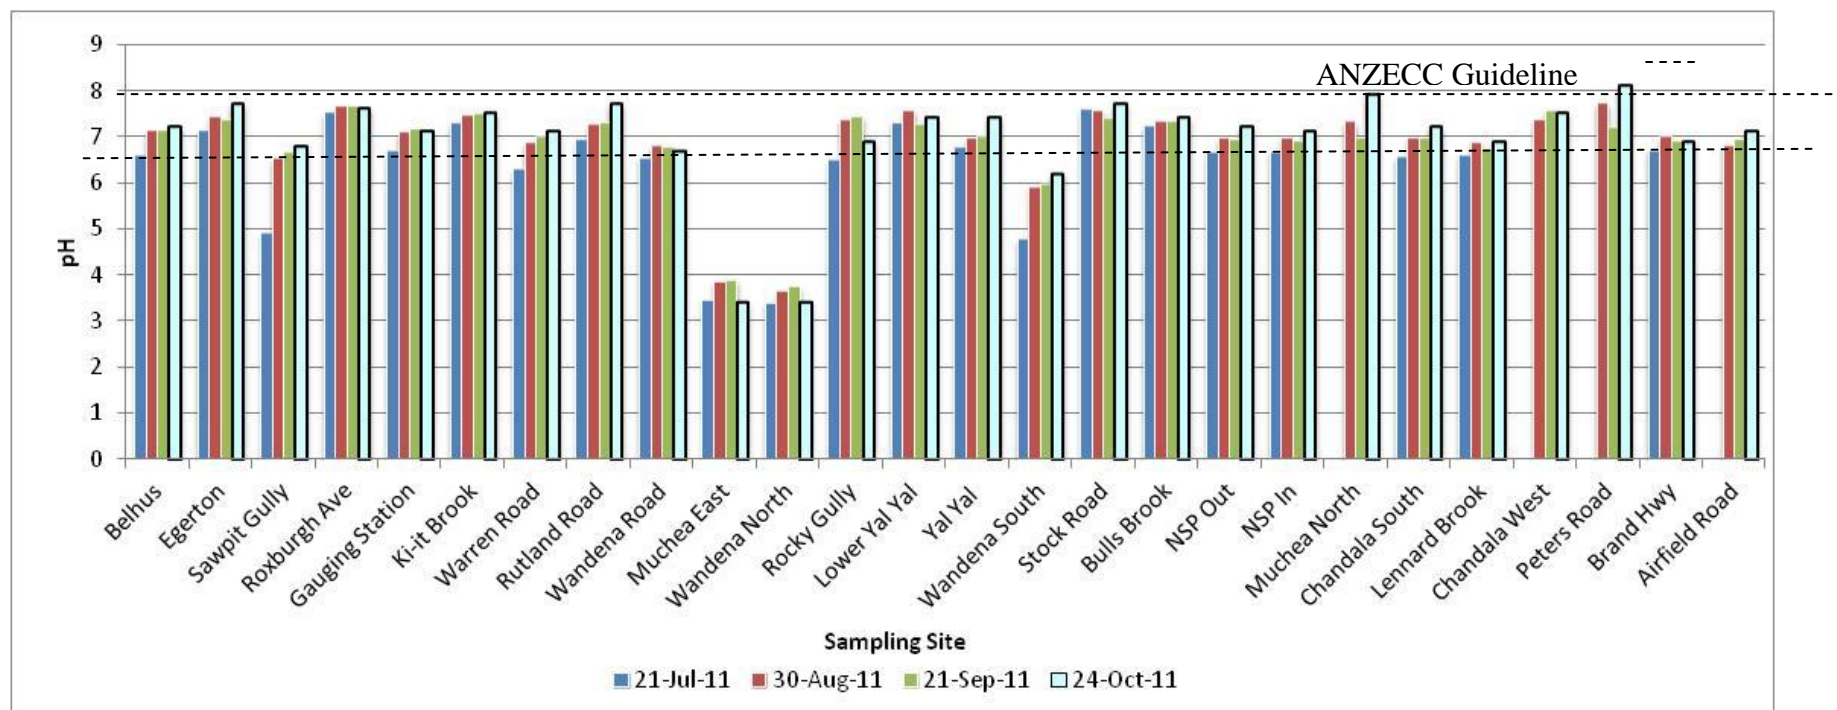
Figure 8: pH of surface water sampled within the Ellen Brook catchment between July and October 2011. *Note: blanks represent no sample

Peters Rd (EBN 23) recorded pH levels above the ANZECC guidelines on one out of three sampling occasions (Figure 8) This site has been sampled since 2007 and has never previously exceeded ANZECC guidelines. Increased pH can be caused by a combination of factors including reduced flow and an increase in temperature resulting in algal growth. Increased algal growth can result in an increase in pH. This is likely due to the reduced flow that was experienced at this site in the October sampling run. This site will be closely monitored in the 2012 sampling run to ensure these results are an anomaly rather than a decline in water quality.

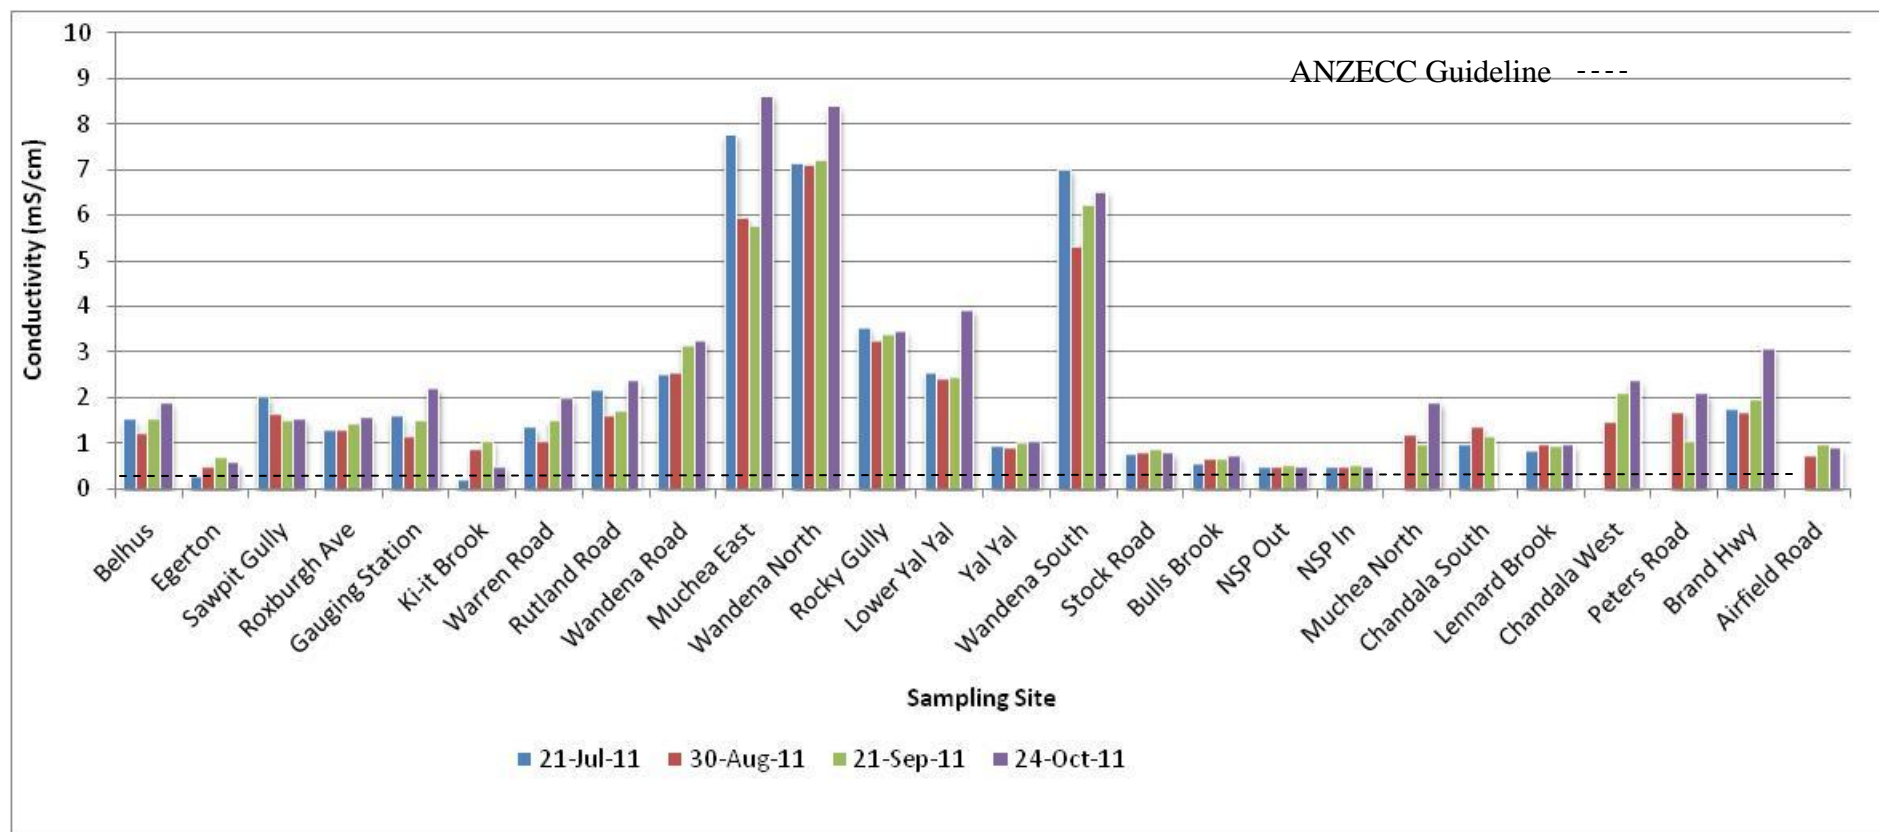
Figure 9: Electrical Conductivity of surface water within the Ellen Brook Catchment between July and October 2011. *Note blanks represent no sample

It is of great concern for environmental value that most sites consistently exceeded ANZECC water quality guidelines for lowland river systems and certainly warrants further monitoring. Over the four sampling occasions the conductivity reading for the southern most sampling site of the catchment, (Belhus Reserve, EBN19), averaged 1.52mS/cm. This shows that the higher concentrations of salts in the major tributaries are diluted as they flow into the Ellen Brook and through the catchment. However, this concentration is above the guideline, deemed to be marginal and unacceptable for stone fruit, citrus, peas, carrot, onion and hot water systems (Appendix D). The most brackish sites were in the mid-eastern part of the catchment (Horwood, 1997). This trend has been noted in previous water quality programs.

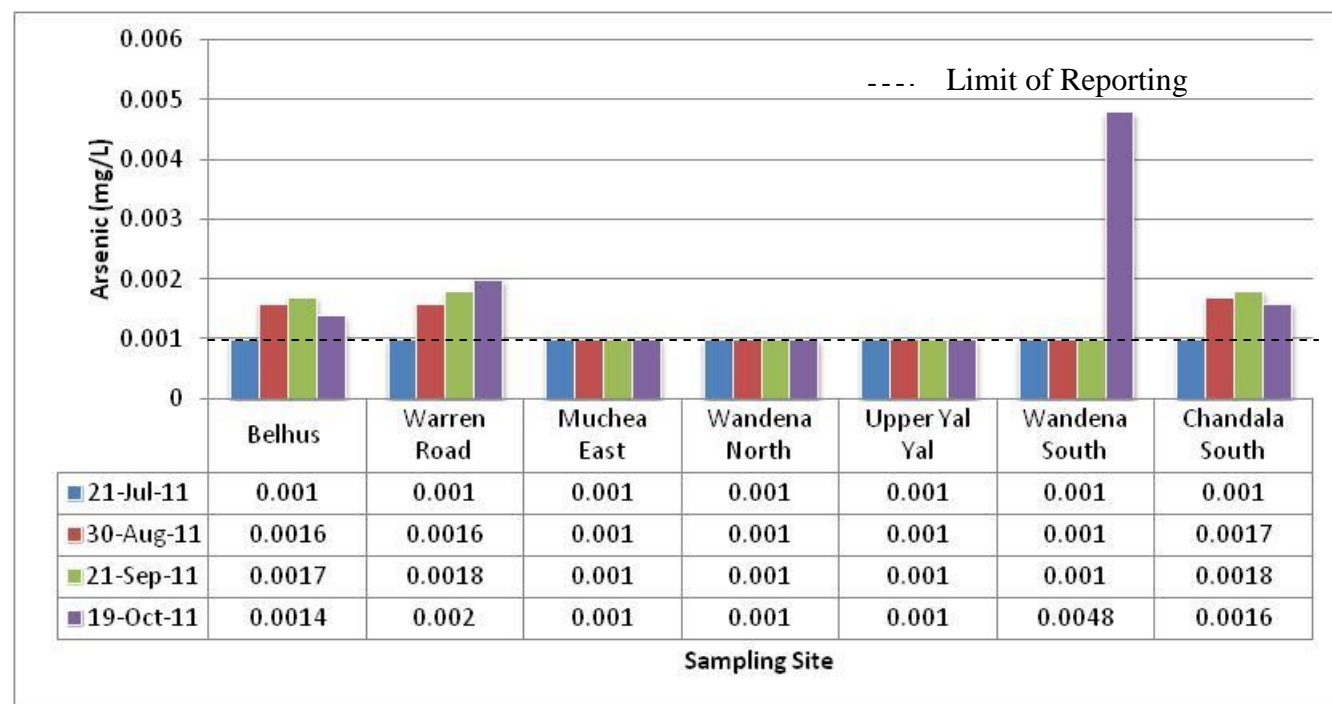
Figure 24: Arsenic concentrations in surface water within the Ellen Brook catchment between July and October 2011. *please note blanks represent no sample

Arsenic is found in pesticides, insecticides, herbicides, fertilisers and various alloys, and occurs naturally in the environment. The recorded concentrations could be a result of excess fertilisers and chemicals transported to the waterways via surface water run-off and subsurface flow.

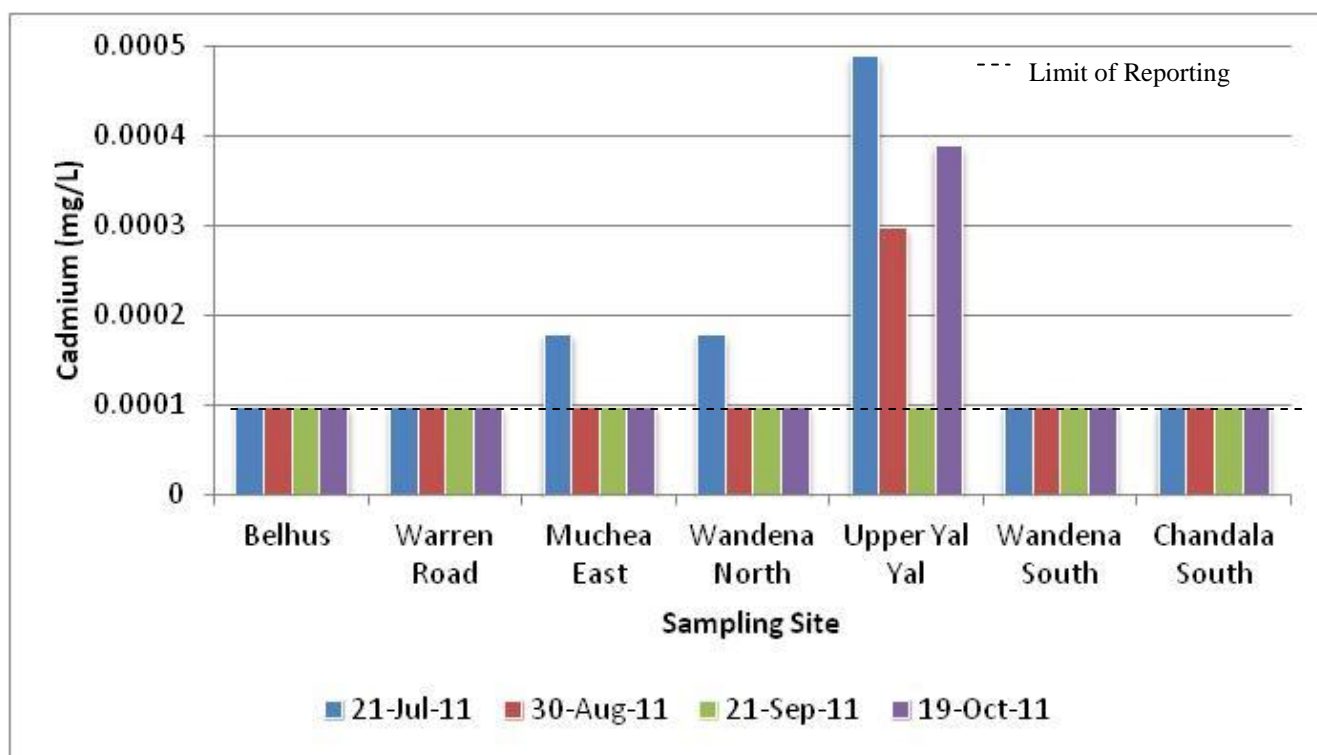
Figure 25: Cadmium concentrations in surface water within the Ellen Brook catchment between July and October 2011. *please note that blanks represent no sample

All sites recorded cadmium levels below the Hardness Modified Trigger Values (HMTV) of 0.002mg/L in very hard water, 0.0011 in extremely hard water.(Figure 21) Belhus (EBN19) and Warren Rd (EBN17) were well below there HMTV for very hard water (180-240mg/L) and the remaining sites were well below their HMTV for extremely hard water (>400mg/L). Upper Yal Yal (EBN28) Muchea East (EBN10) and Wandena North (EBN7) were the only sites with cadmium levels above the limit of reporting. All other sites are below the limit of reporting on all occasions.

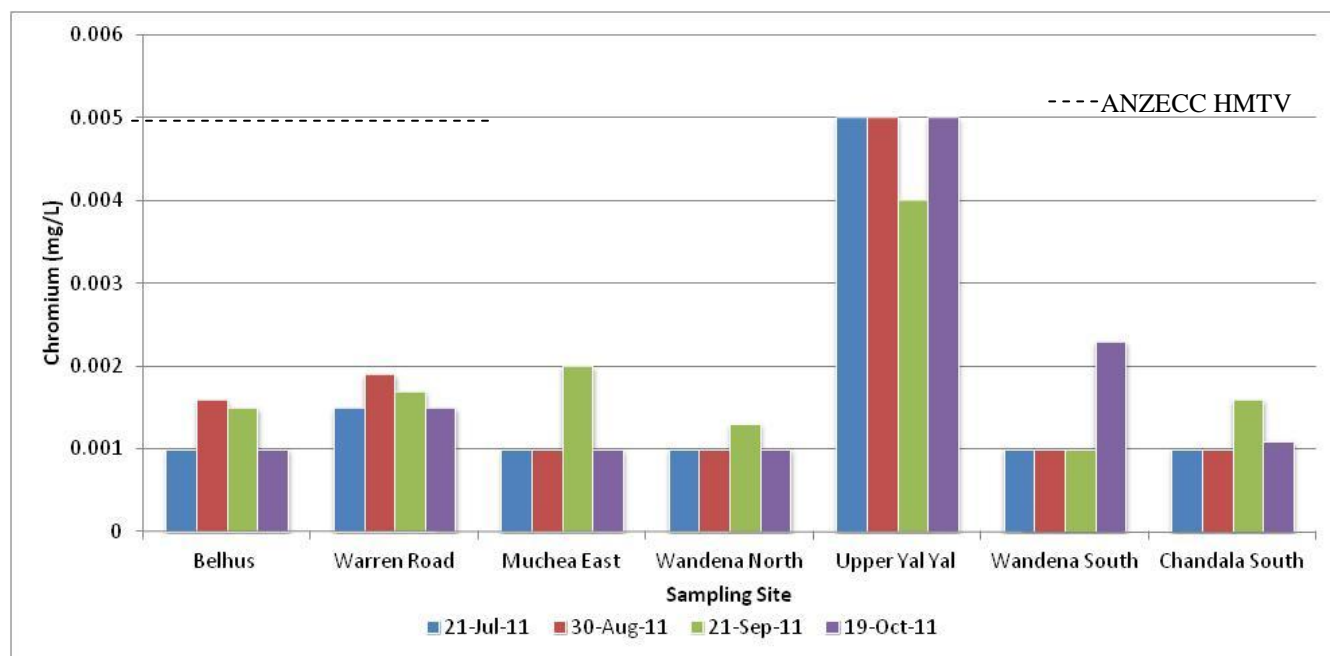
Figure 26: Chromium concentrations in surface water within the Ellen Brook catchment between July and October 2010. *Note blanks represent no sample.

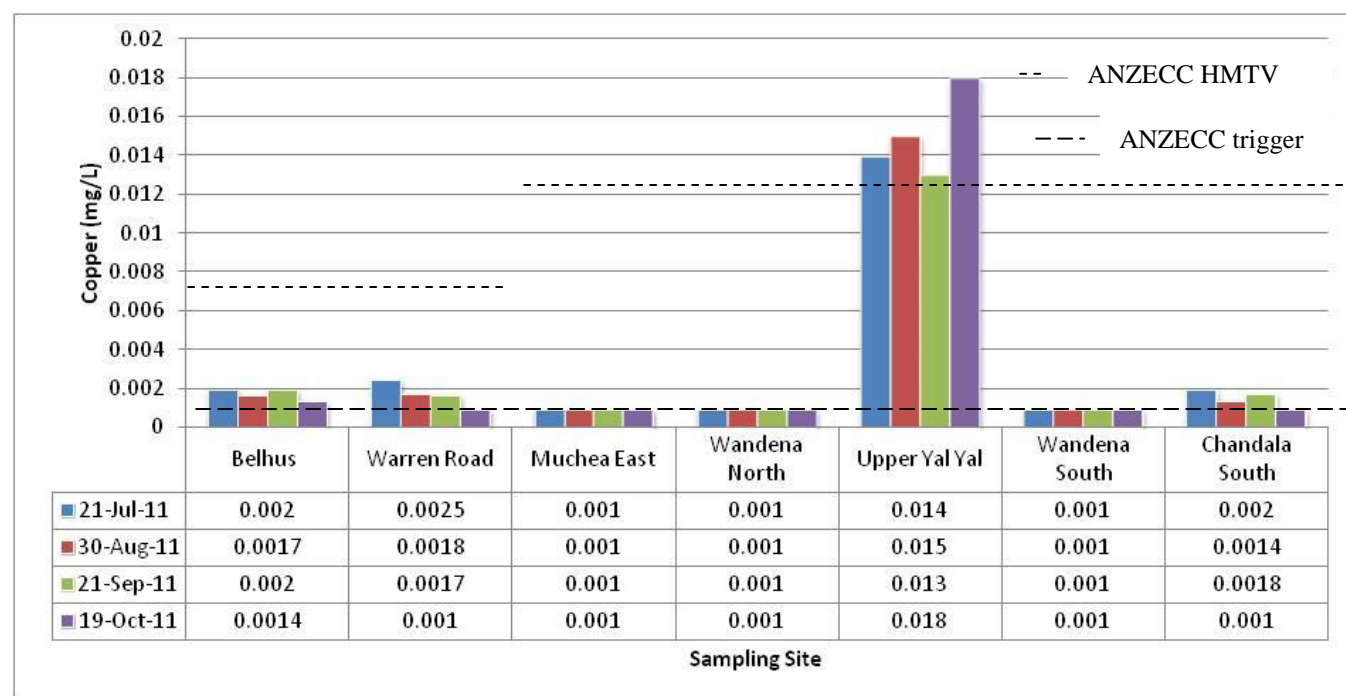
Figure 27: Copper concentrations in surface water within the Ellen Brook catchment between July and October 2011. *note that blanks represent no sample.

Copper is used in building material, electrical and heat conductors, and in household products. It is also an essential trace element; however in sufficient amounts it can be toxic. The proximity of these sites to the tip site, old clay extraction pits, Pearce RAAF Base, and urban development, accompanied by low pH levels and extremely/very hard water could have increased the mobilisation of the metal through the soil and resulted in increased concentrations in the waterways.

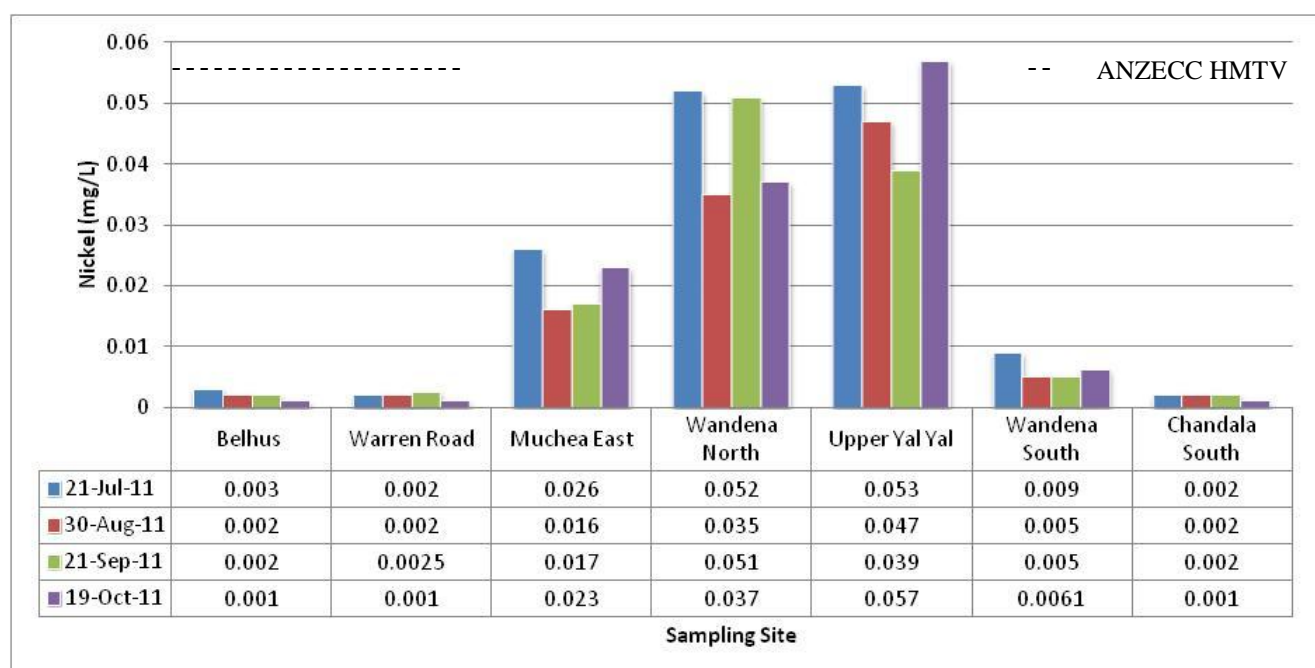
Figure 30: Nickel concentrations in surface water within the Ellen Brook catchment between July and October 2011. *Note blanks represent no sample
