Ellen Brook Catchment

Water Quality Monitoring

July – October 2013

Prepared by the Ellen Brockman Integrated Catchment Group: March 2014.

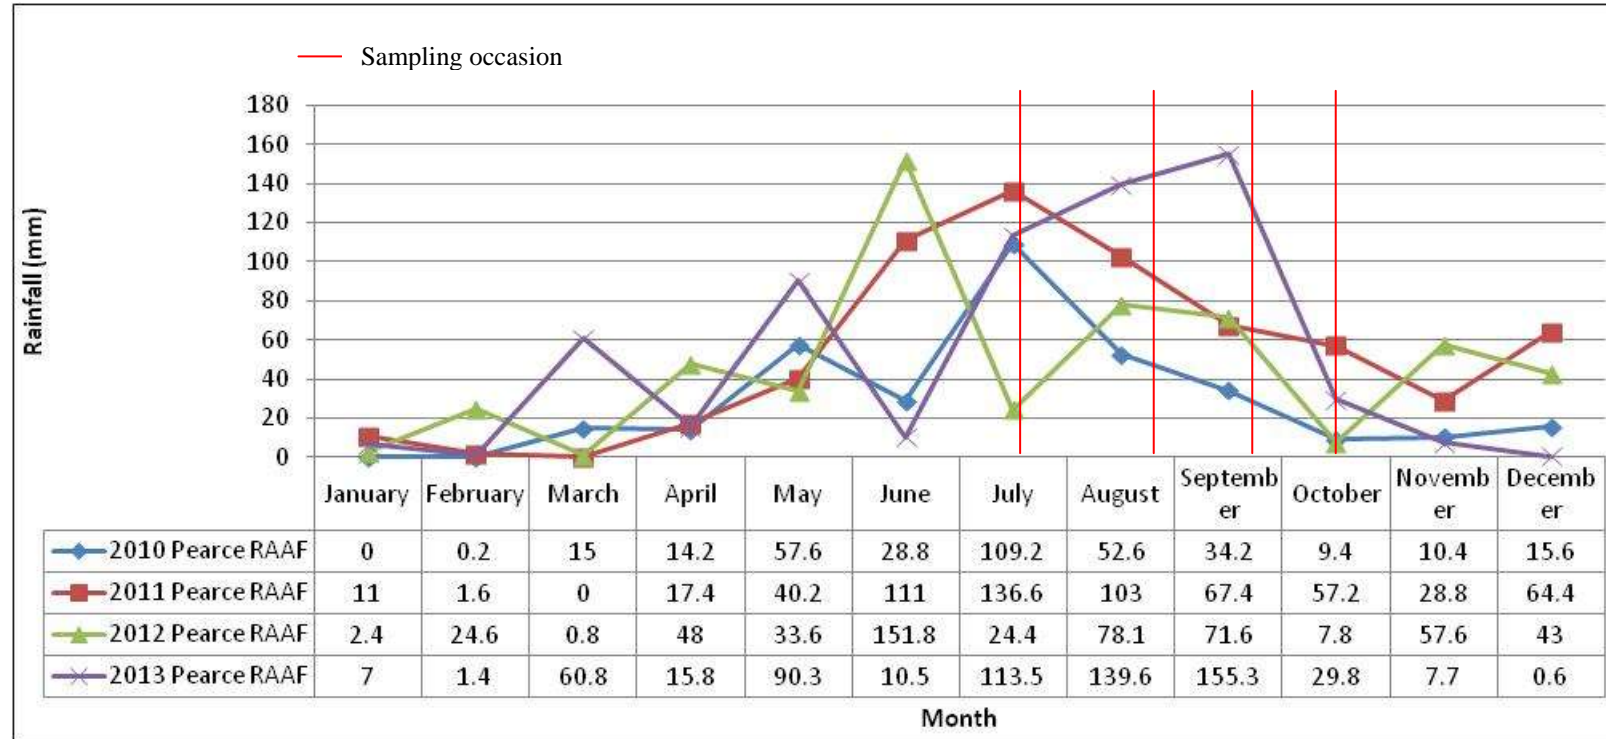
Figure 6: Total monthly rainfall for 2013, 2012 and 2011 within the Ellen Brook Catchment at 009053 – Pearce RAAF Base.

Figure 6 shows the total rainfall for Station 009053 – Pearce RAAF Base. In 2010, July had the highest monthly rainfall of 109.2mm. Overall the season was very dry which severely impacted on revegetation efforts in the catchment, particularly in the more sandy sites where water retention is at its lowest. In 2011 July had the highest monthly rainfall, however the season broke earlier with the 2nd highest monthly rainfall in June. There was however a continuous rainfall season which was beneficial for revegetation projects, but also caused significant growth of summer weeds. In 2012 the season broke in June with the highest monthly rainfall received in June but unfortunately July was very dry and no substantial rain was received until August. In 2013 the season broke in late July but the highest

monthly rainfall received in September. Unfortunately we had very little rain since then and any summer flows were greatly reduced.

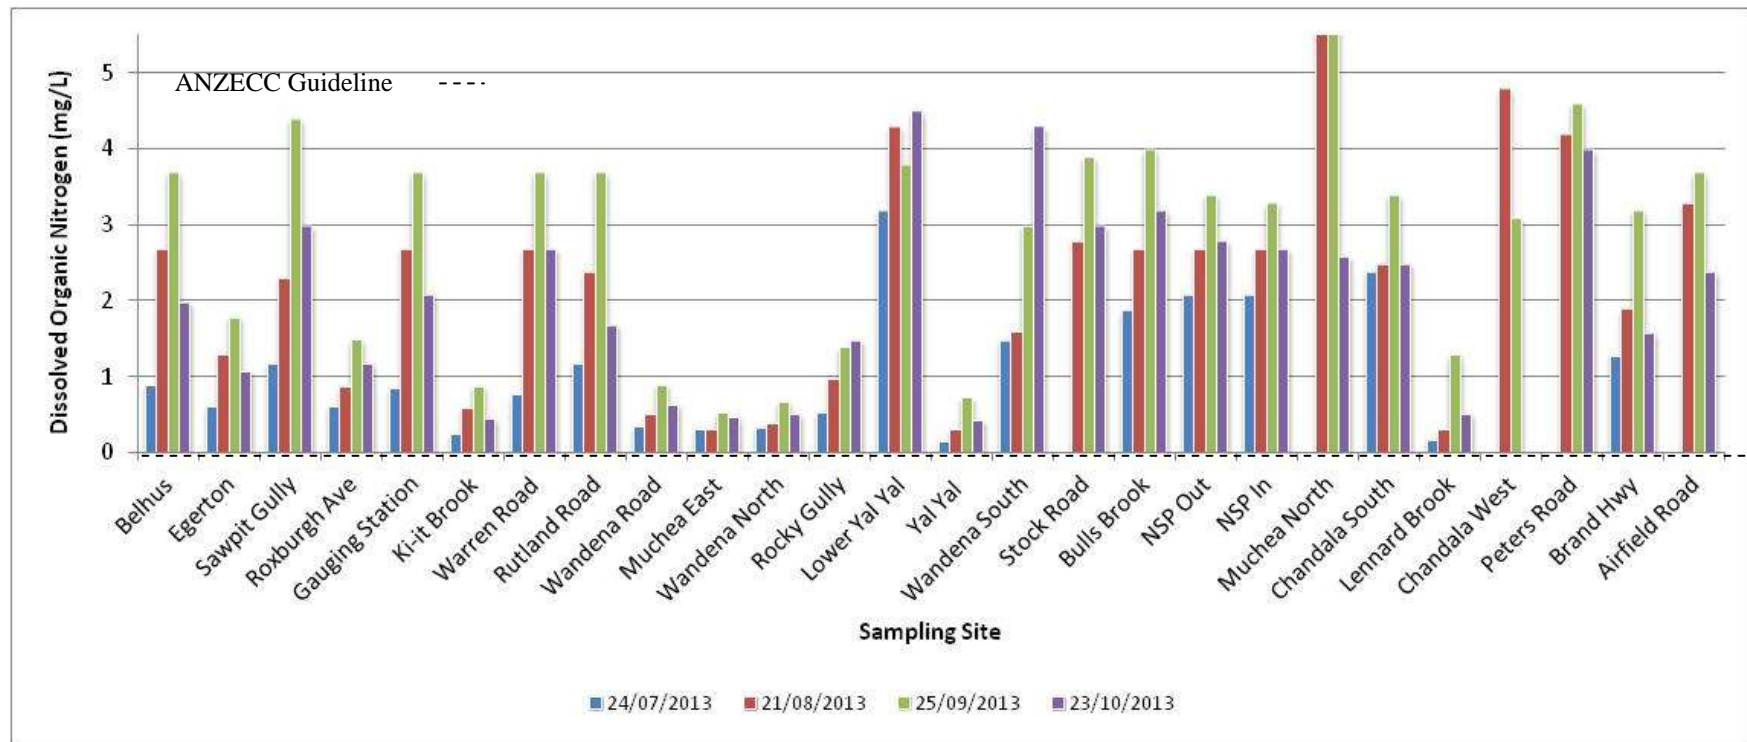
Figure 14: Dissolved Organic Nitrogen (DON) sampled within the Ellen Brook catchment between July and October 2013. *Note blanks represent no sample

Dissolved Organic Nitrogen (Dissolved Organic Nitrogen) is comprised of the organic forms of nitrogen including amino acids, proteins, urea and humic acid. All sampling sites exceeded the ANZECC guideline of 0.04mg/L on all sampling occasions. The DON results show a direct correlation with the Total Nitrogen (TN). Additionally, DON concentrations when compared with total nitrogen, ammonia and total oxidised nitrogen concentrations showed that nitrogen exists primarily in its soluble form in the Ellen Brook catchment.

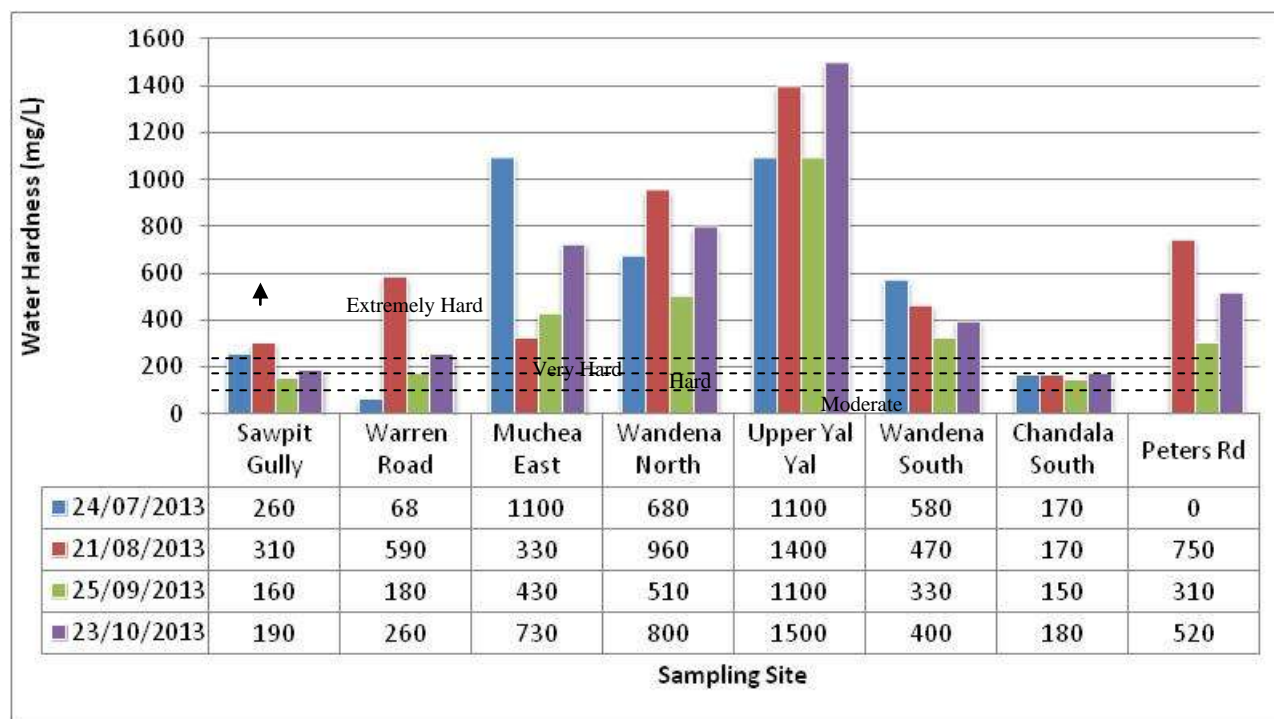
Figure 22: Water hardness of surface water within the Ellen Brook Catchment at sites sampled for metal contamination, between July and October 2013. *Blanks represent no sample

Water hardness at six sites remained relatively the same as those recorded in 2012 in regard to the hardness category, except for Wandena North which recorded hardness values less than 2012. Hardness Values were highly variable in 2013 sampling occasions. Refer to Table 6 for the calculated hardness-modified trigger values (HMTV) for cadmium, copper, chromium, lead, nickel and zinc.

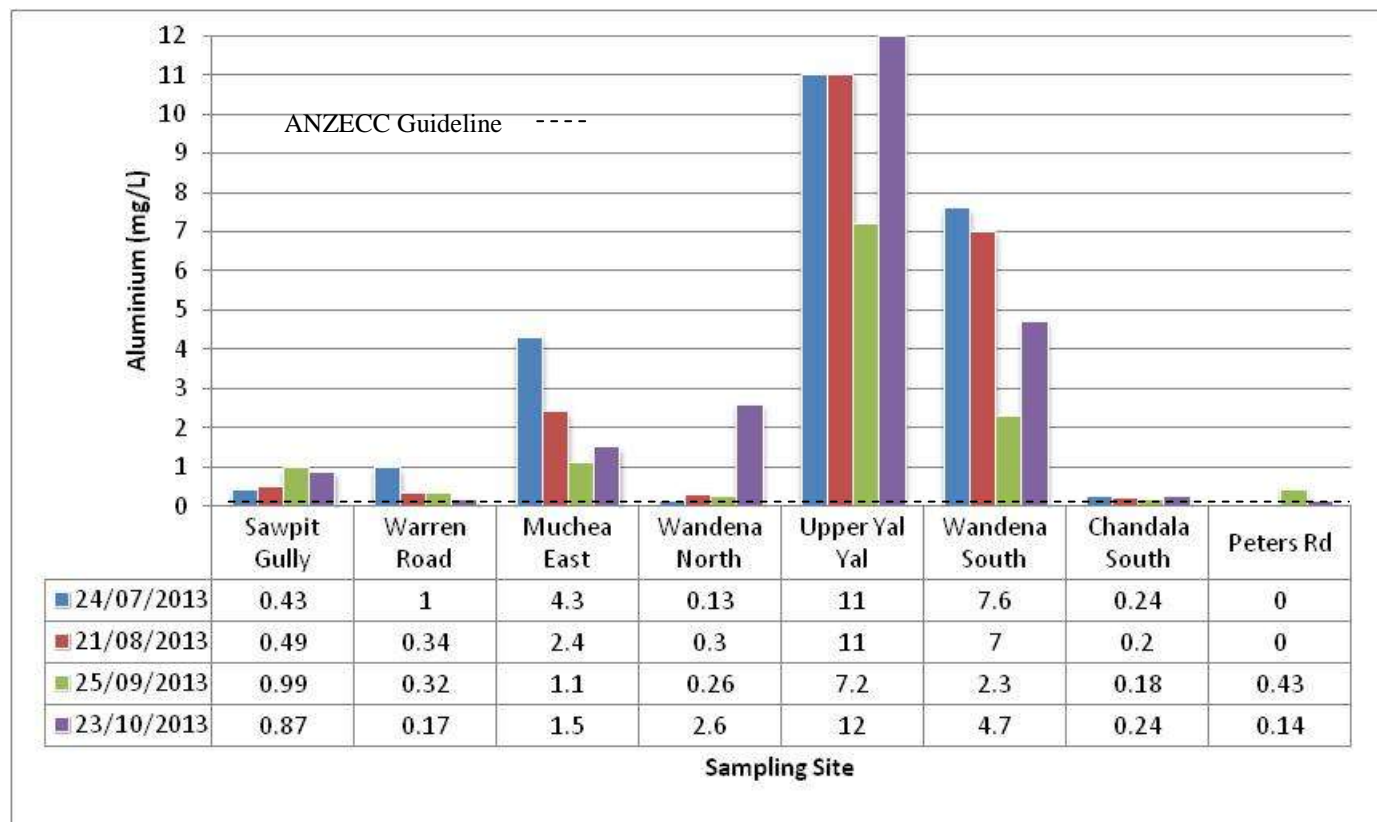
Figure 23: Aluminium concentrations in surface water within the Ellen Brook catchment between July and October 2013. *please note blanks represent no sample

Concentrations reached as high as 12mg/L on the October sampling occasion at Upper Yalyal (EBN28). This is Lower than the 2012 sampling for that site however the decrease in Aluminium could be attributed to the increased winter rainfall received in 2013. It is of concern that all the sites recorded levels above the guideline however levels are not so high that they would be detrimental to the livestock or fauna using the water for drinking. What this also means is that the Ellen Brook is a contributor of aluminium to the Swan River (Figure 5).

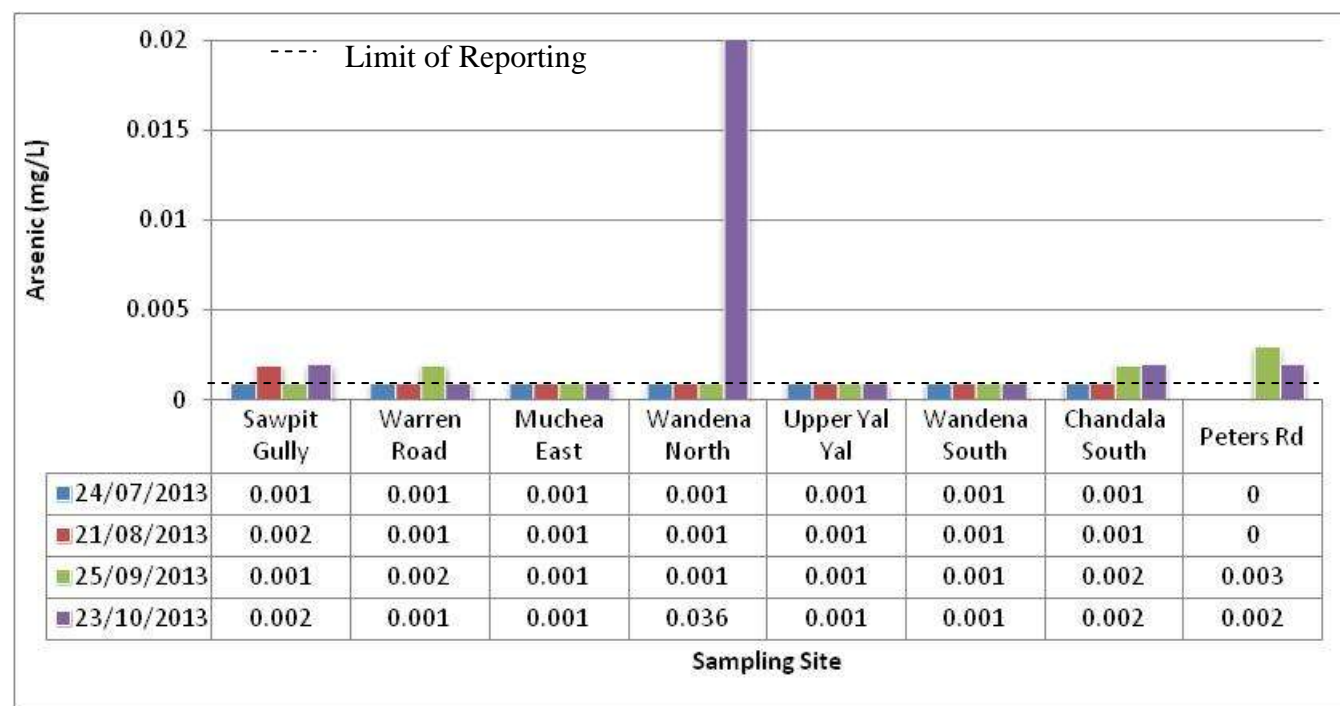
Figure 24: Arsenic concentrations in surface water within the Ellen Brook catchment between July and October 2013. *please note blanks represent no sample

Arsenic is found in pesticides, insecticides, herbicides, fertilisers and various alloys, and occurs naturally in the environment. The recorded concentrations could be a result of excess fertilisers and chemicals transported to the waterways via surface water run-off and subsurface flow.

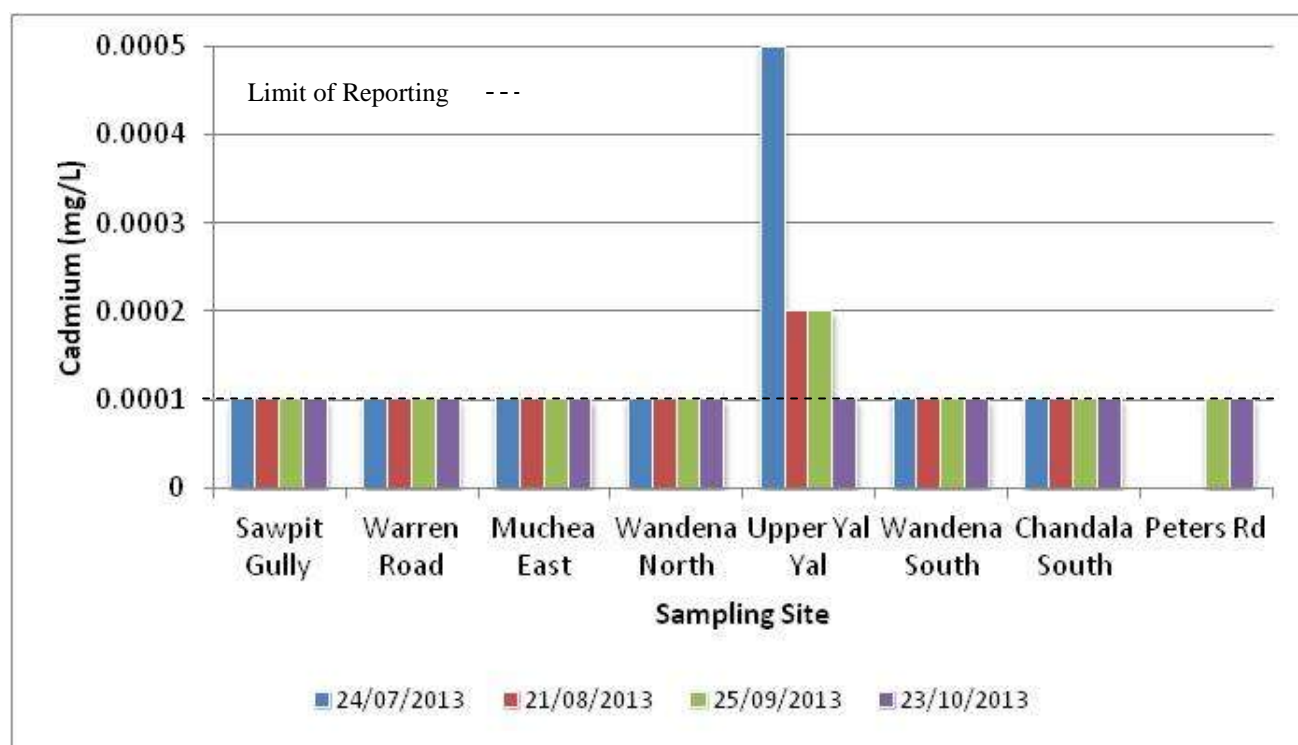
Figure 25: Cadmium concentrations in surface water within the Ellen Brook catchment between July and October 2013. *please note that blanks represent no sample

All sites recorded cadmium levels below the Hardness Modified Trigger Values (HMTV) of 0.002mg/L in very hard water, 0.0011 in extremely hard water.(Figure 21) Sawpit Gully (EBN25), Chandala South (EBN4) and Warren Rd (EBN17) were well below the HMTV for very hard water (180-240mg/L) and the remaining sites were well below their HMTV for extremely hard water (>400mg/L). Upper Yal Yal (EBN28) was the only site with cadmium levels above the limit of reporting. All other sites are below the limit of reporting on all occasions.

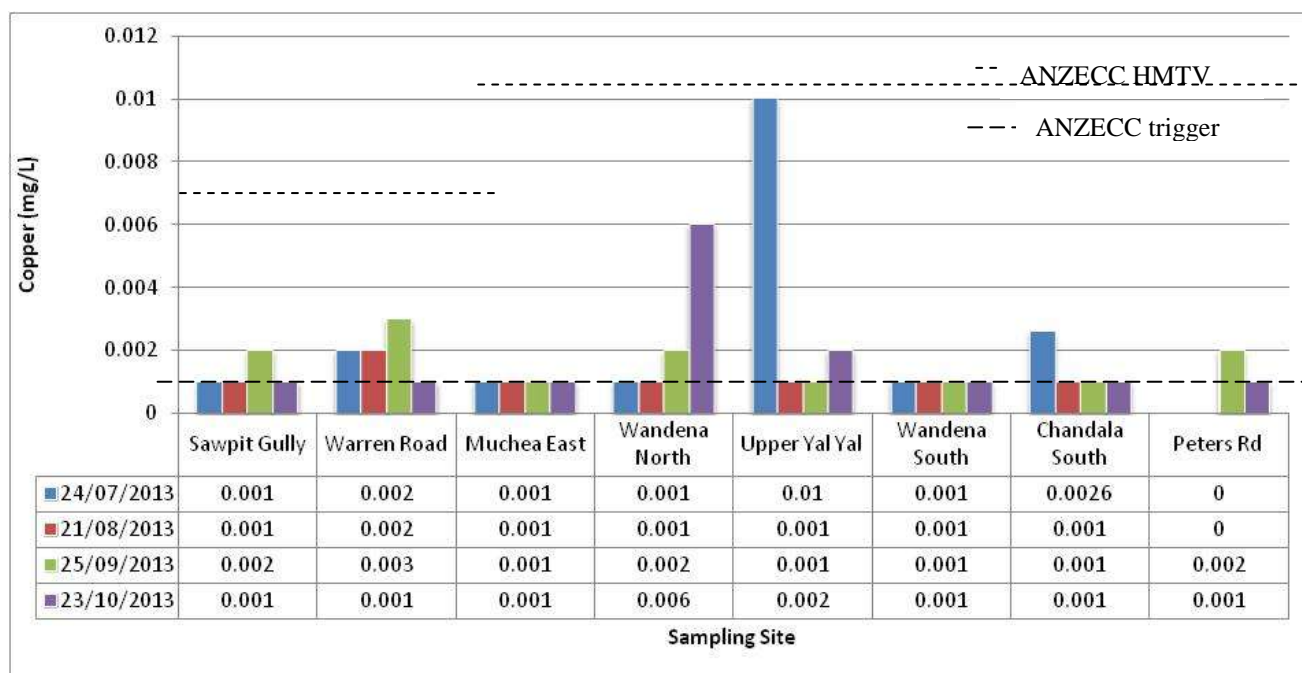
Figure 27: Copper concentrations in surface water within the Ellen Brook catchment between July and October 2013.*note that blanks represent no sample.

Copper is used in building material, electrical and heat conductors, and in household products. It is also an essential trace element; however in sufficient amounts it can be toxic. The proximity of these sites to the tip site, old clay extraction pits, Pearce RAAF Base, and urban development, accompanied by low pH levels and extremely/very hard water could have increased the mobilisation of the metal through the soil and resulted in increased concentrations in the waterways.

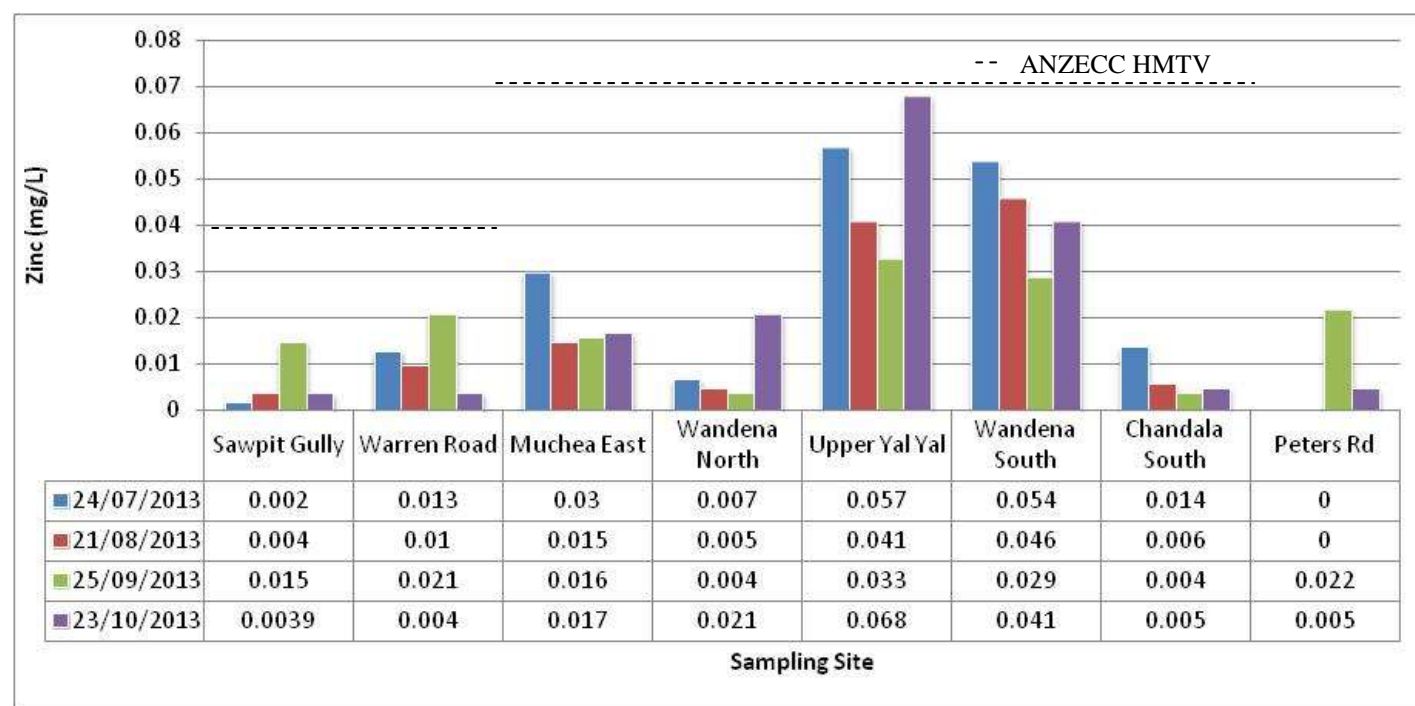
Figure 31: Zinc concentrations in surface water within the Ellen Brook catchment between July and October 2013. *Note that blanks represent no sample

Concentrations of Zinc rarely exceed 0.01mg/L in natural water. Higher concentrations can be associated with pollution from industrial wastes or corrosion of zinc coated plumbing or galvanized water tanks, particularly in areas of low pH (ANZECC and ARMCANZ, 2000).
