# **Ellen Brook Catchment**

## ***Water Quality Monitoring***

### ***June – September 2014***

**Prepared by the Ellen Brockman Integrated Catchment Group: March 2015.**

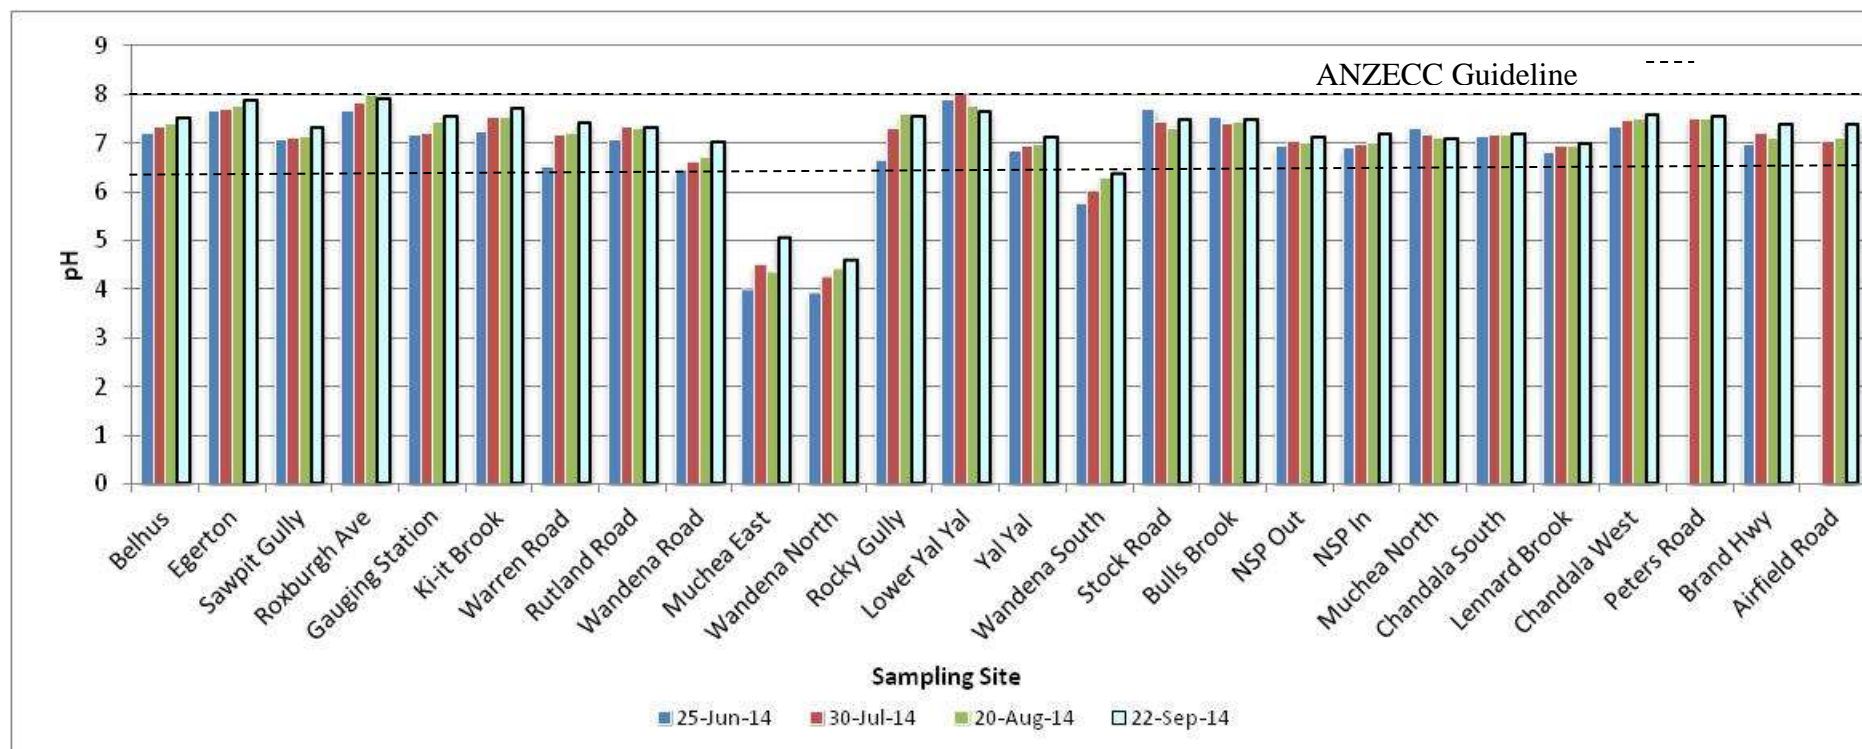
Peters Rd (EBN 23) recorded pH levels above the ANZECC guidelines on one out of three sampling occasions (Figure 8) This sites have been sampled since 2007 and prior to 2011 had never previously exceeded ANZECC guidelines on more than one occasion. Increased pH can be caused by a combination of factors including reduced flow and an increase in temperature resulting in algal growth. Increased algal growth can result in an increase in pH. This site was closely monitored in the 2014 sampling run and it appears that previous pH results above the guideline were an anomaly.

**Figure 8:** pH of surface water sampled within the Ellen Brook catchment between July and October 2014. \*Note: blanks represent no sample

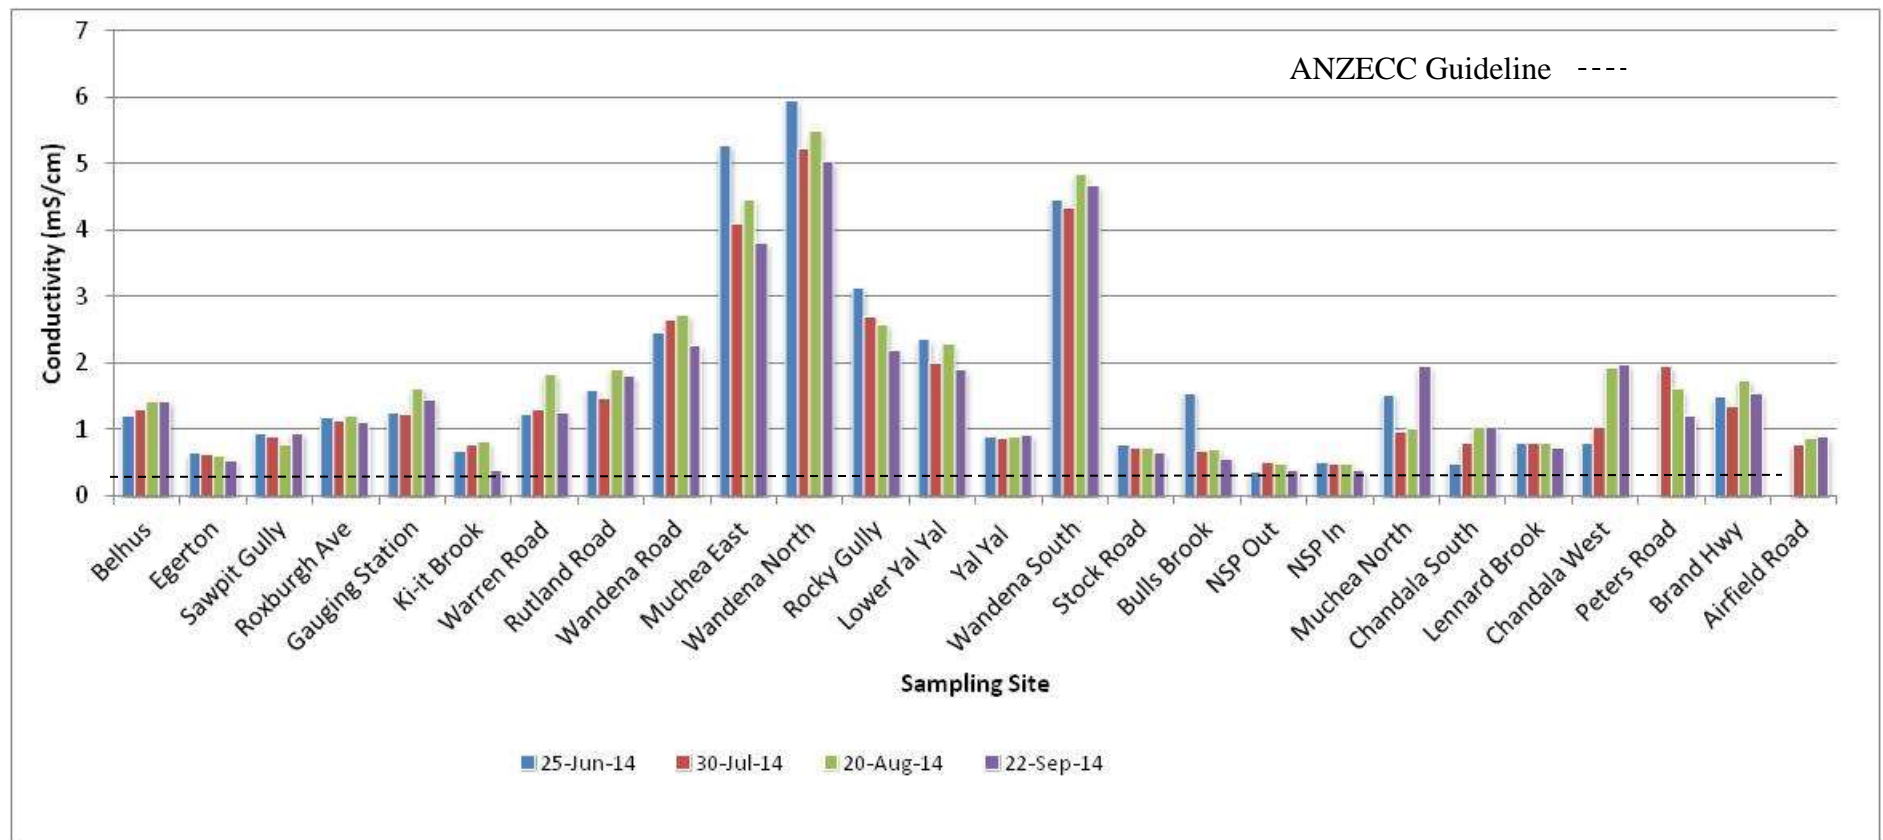
**Figure 9:** Electrical Conductivity of surface water within the Ellen Brook Catchment between June and September 2014.\*Note blanks represent no sample

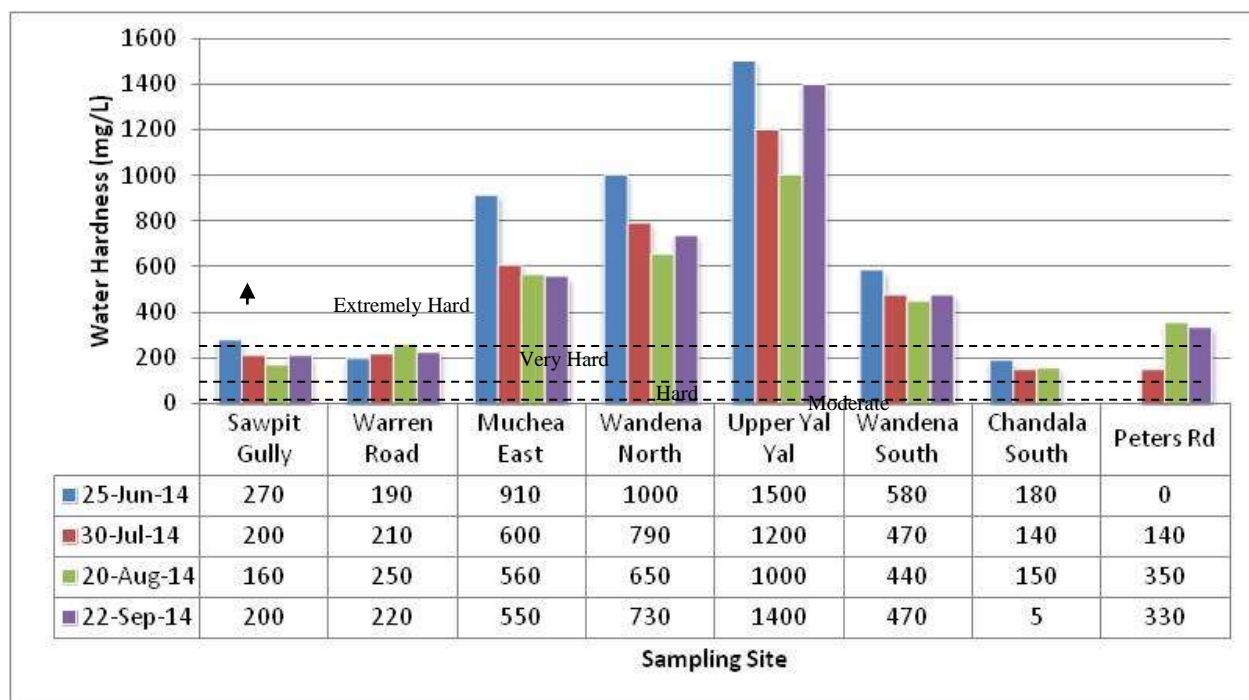
Water hardness at six sites remained relatively the same as those recorded in 2013 in regard to the hardness category. Hardness Values were highly variable in 2014 sampling occasions. Refer to Table 6 for the calculated hardness-modified trigger values (HMTV) for cadmium, copper, chromium, lead, nickel and zinc.

**Figure 22:** Water hardness of surface water within the Ellen Brook Catchment at sites sampled for metal contamination, between June and September 2014. \*Blanks represent no sample

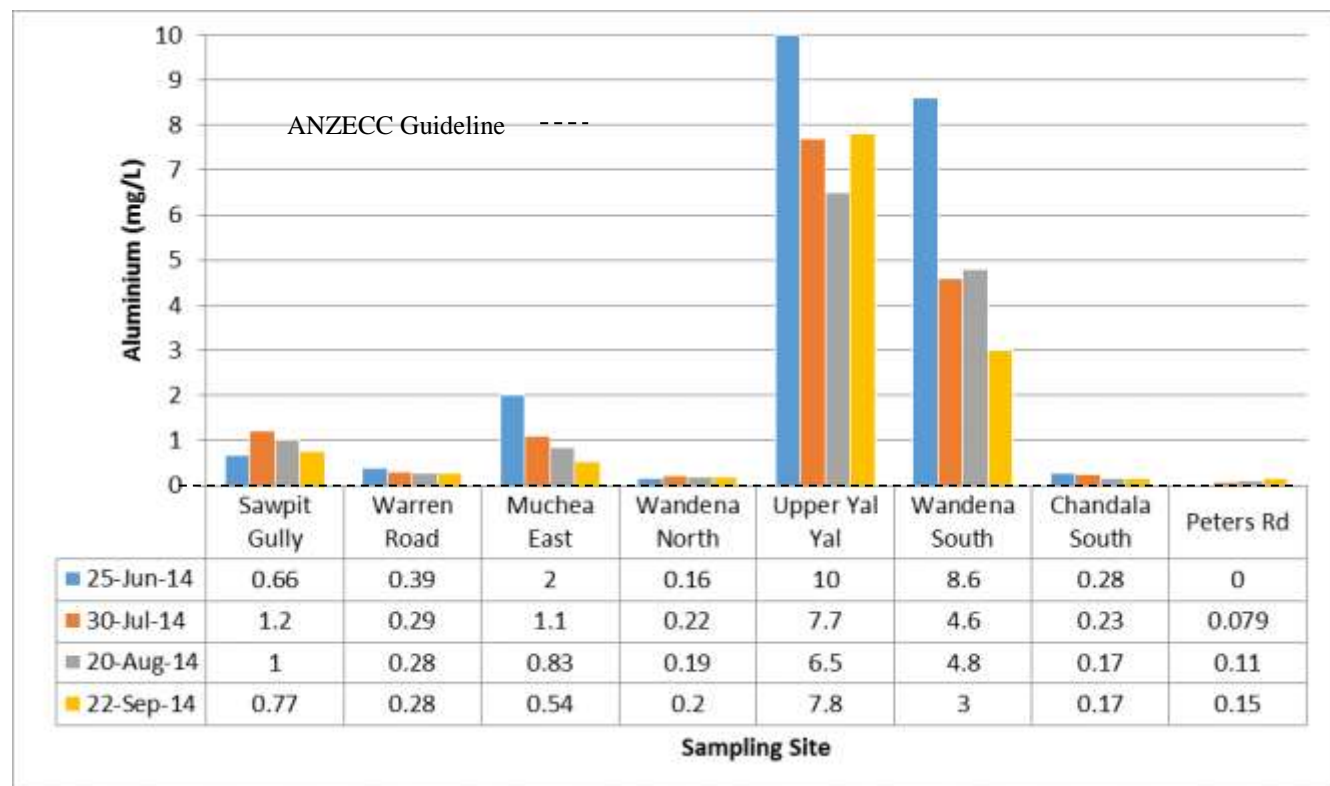
Concentrations reached as high as 10mg/L on the June sampling occasion at Upper Yalyal (EBN28). This is Lower than the 2013 sampling for that site however the decrease in Aluminium could be attributed to the increased winter rainfall received in 2014. It is of concern that all the sites recorded levels above the guideline however levels are not so high that they would be detrimental to the livestock or fauna using the water for drinking. What this also means is that the Ellen Brook is a contributor of aluminium to the Swan River (Figure 5).

**Figure 23:** Aluminium concentrations in surface water within the Ellen Brook catchment between June and September 2014. \*please note blanks represent no sample

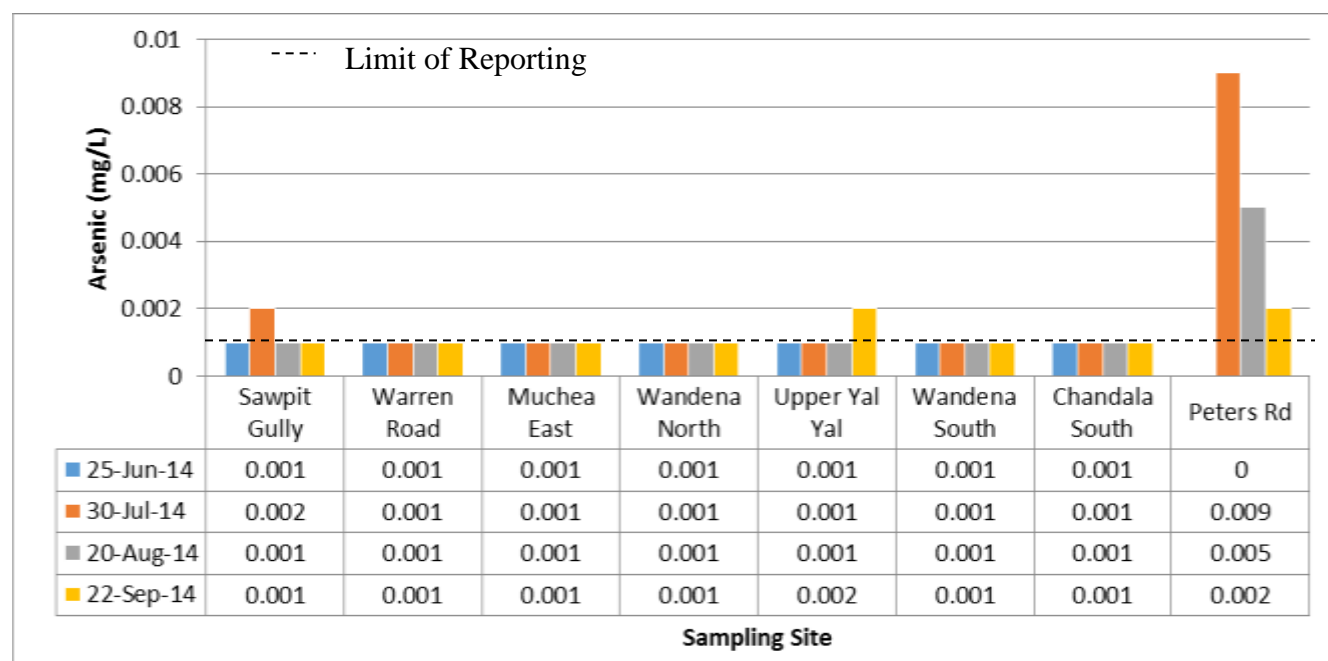
Arsenic is found in pesticides, insecticides, herbicides, fertilisers and various alloys, and occurs naturally in the environment. The recorded concentrations could be a result of excess fertilisers and chemicals transported to the waterways via surface water run-off and subsurface flow.

**Figure 24:** Arsenic concentrations in surface water within the Ellen Brook catchment between June and September 2014. \*please note blanks represent no sample

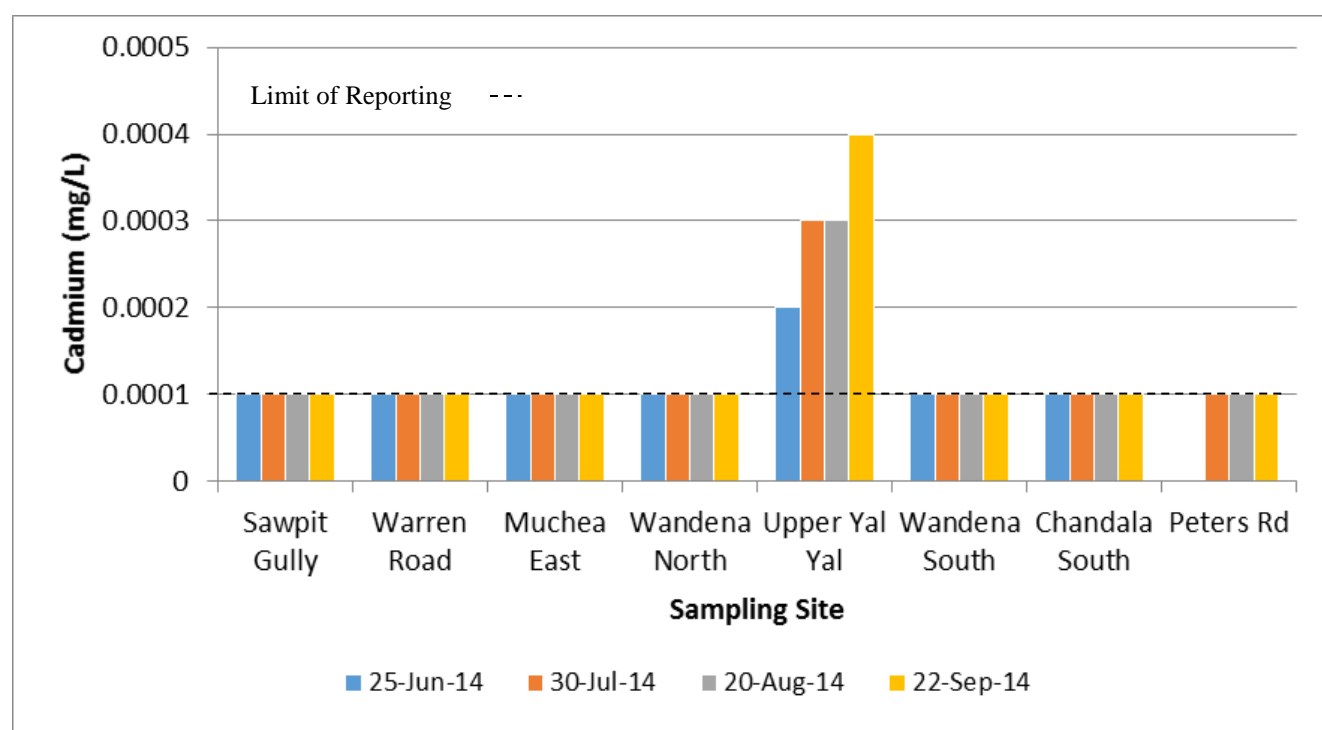
All sites recorded cadmium levels below the Hardness Modified Trigger Values (HMTV) of 0.002mg/L in very hard water, 0.0011 in extremely hard water.(Figure 21) Sawpit Gully (EBN25), Chandala South (EBN4) and Warren Rd (EBN17) were well below the HMTV for very hard water (180-240mg/L) and the remaining sites were well below their HMTV for extremely hard water (>400mg/L). Upper Yal Yal (EBN28) was the only site with cadmium levels above the limit of reporting. All other sites are below the limit of reporting on all occasions.

**Figure 25:** Cadmium concentrations in surface water within the Ellen Brook catchment between June and September 2014. \*please note that blanks represent no sample

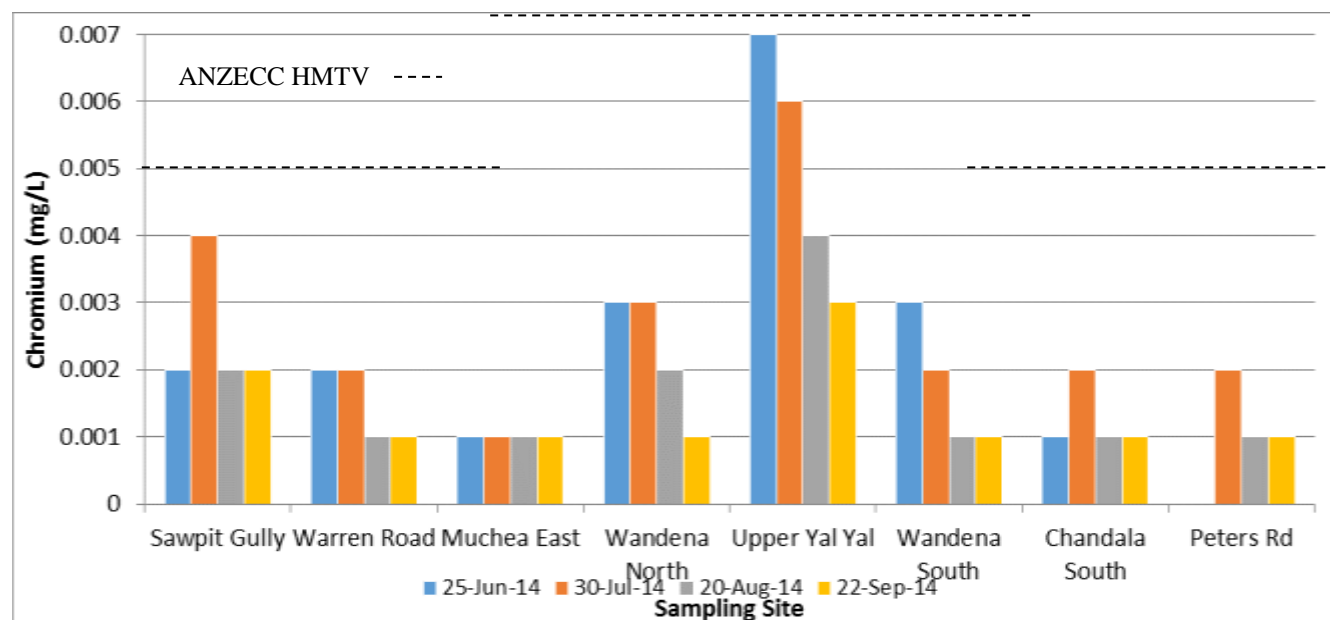
**Figure 26:** Chromium concentrations in surface water within the Ellen Brook catchment between June and September 2014. \*Note blanks represent no sample.

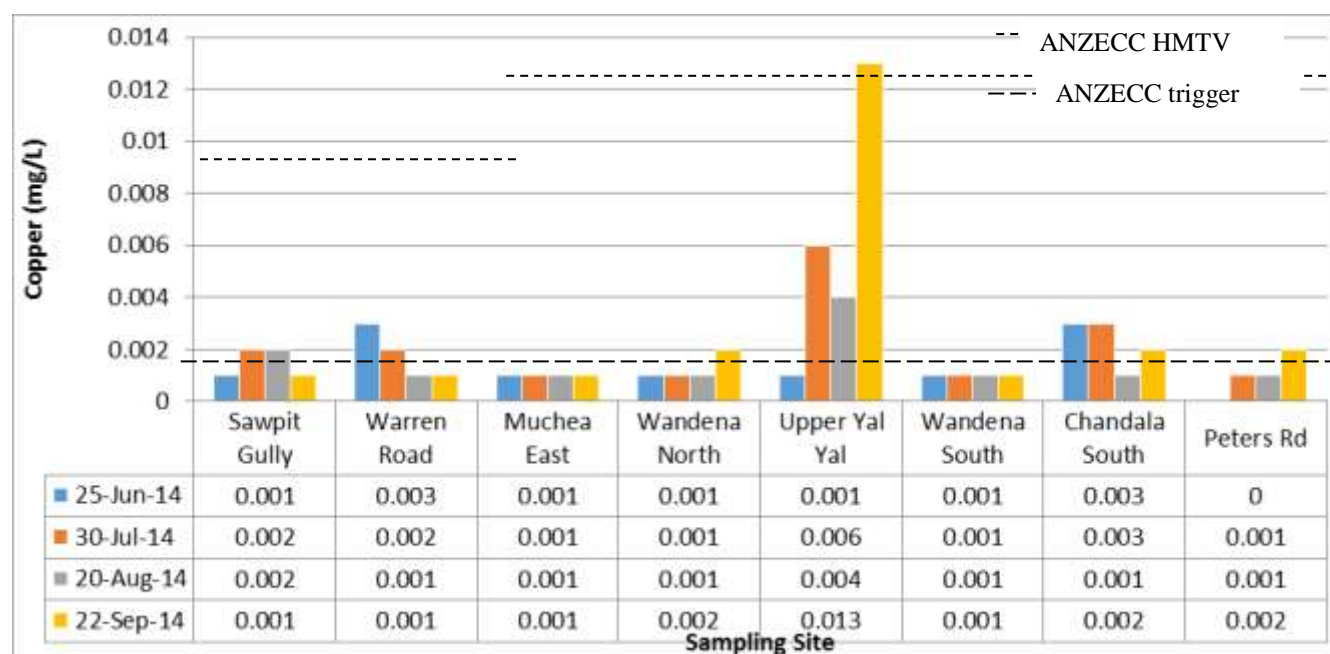
Six of the sites were above the recommended ANZECC trigger value of 0.0014mg/L. Sawpit Gully (EBN25) Warren Rd (EBN17), Upper Yal Yal (EBN28) Wandena North (EBN7) Peters Rd (EBN23) and Chandala South (EBN4) exceeded the ANZECC trigger value on one or more sampling occasions. The sites are well below the ANZECC values for livestock watering, being 0.5 mg/L for sheep, 5 mg/L for pigs and poultry and 1mg/L for cattle. (ANZECC and ARMCANZ, 2000)

**Figure 27:** Copper concentrations in surface water within the Ellen Brook catchment between June and September 2014.\*note that blanks represent no sample.

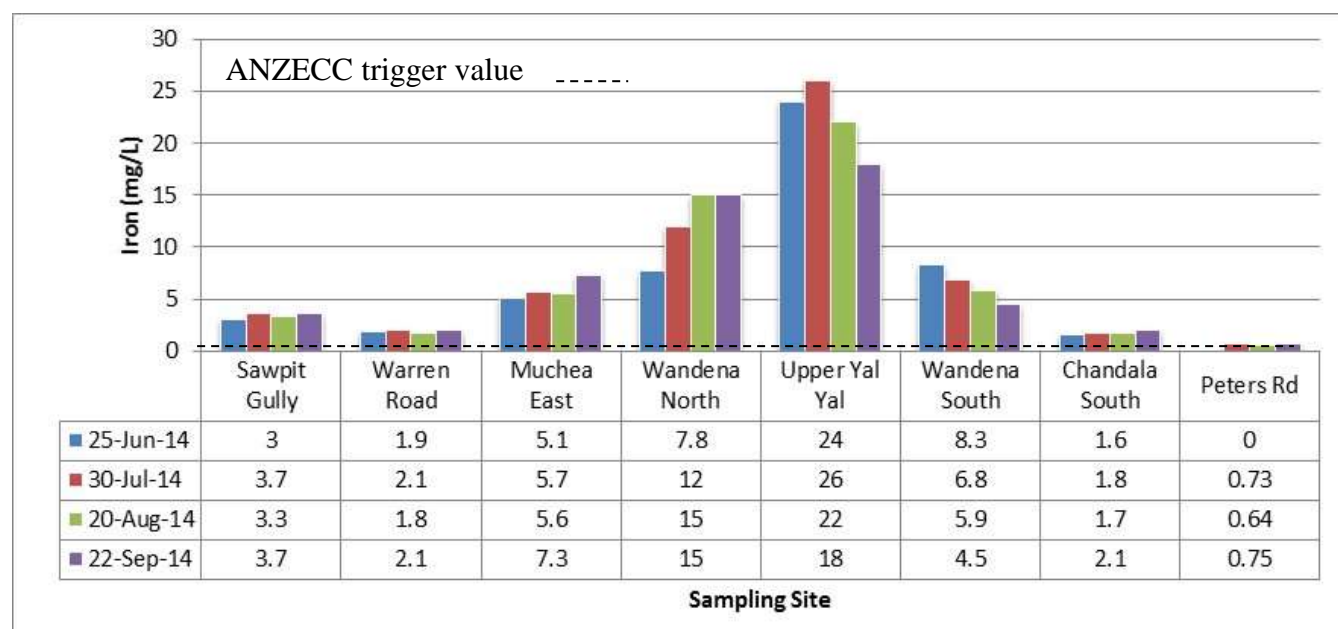
Iron concentrations have been well above the guideline of 0.3mg/L on all sampling occasions since 2005. Since 2005, iron concentrations appear to have increased at each of the sites. Potential causes of high iron concentrations in surface waters include the geology and soil type, the time of sampling and rainfall experienced on the day of sampling, and high acidity enabling the mobilisation of metal ions into solution. These metal ions are generally trapped in the sediments. The sites with higher concentrations than the guideline would more likely have a slight odour and cause an iron stain after irrigating.

**Figure 28:** Iron concentrations in surface water within the Ellen Brook Catchment between June and September 2014. \*please note blanks represent no sample

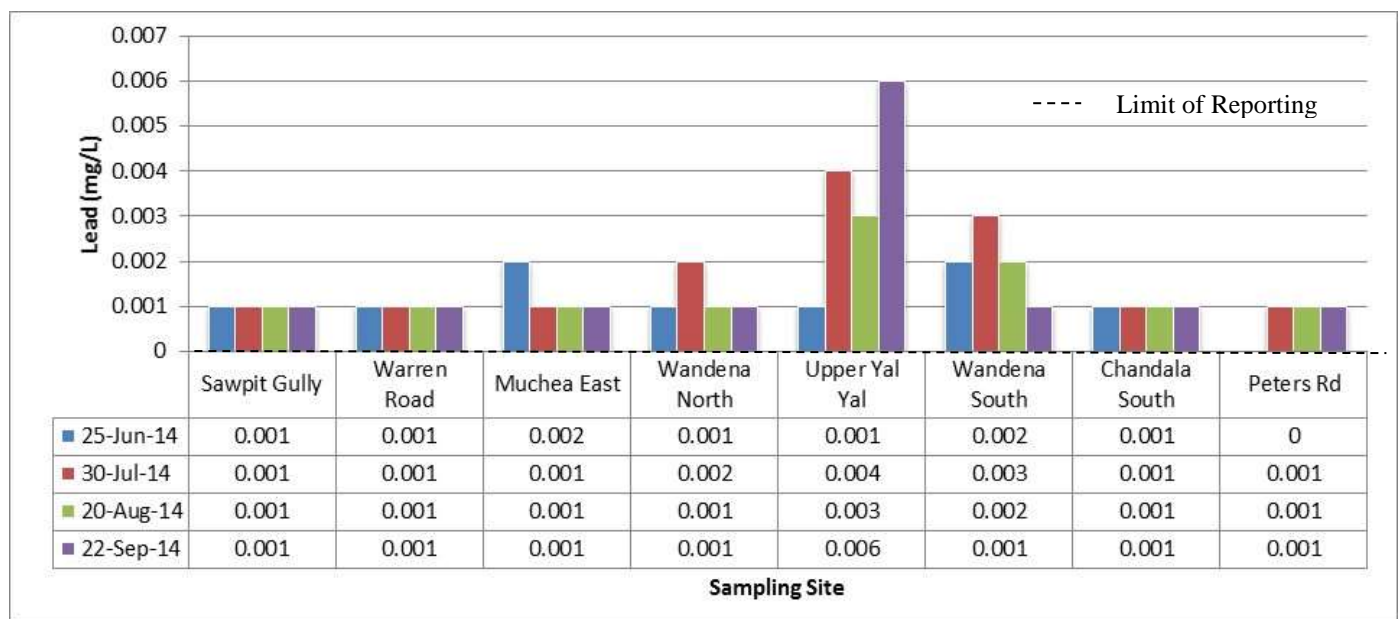
Figure 29: Lead concentrations in surface water within the Ellen Brook catchment between June and September 2014. \*Note blanks represent no sample

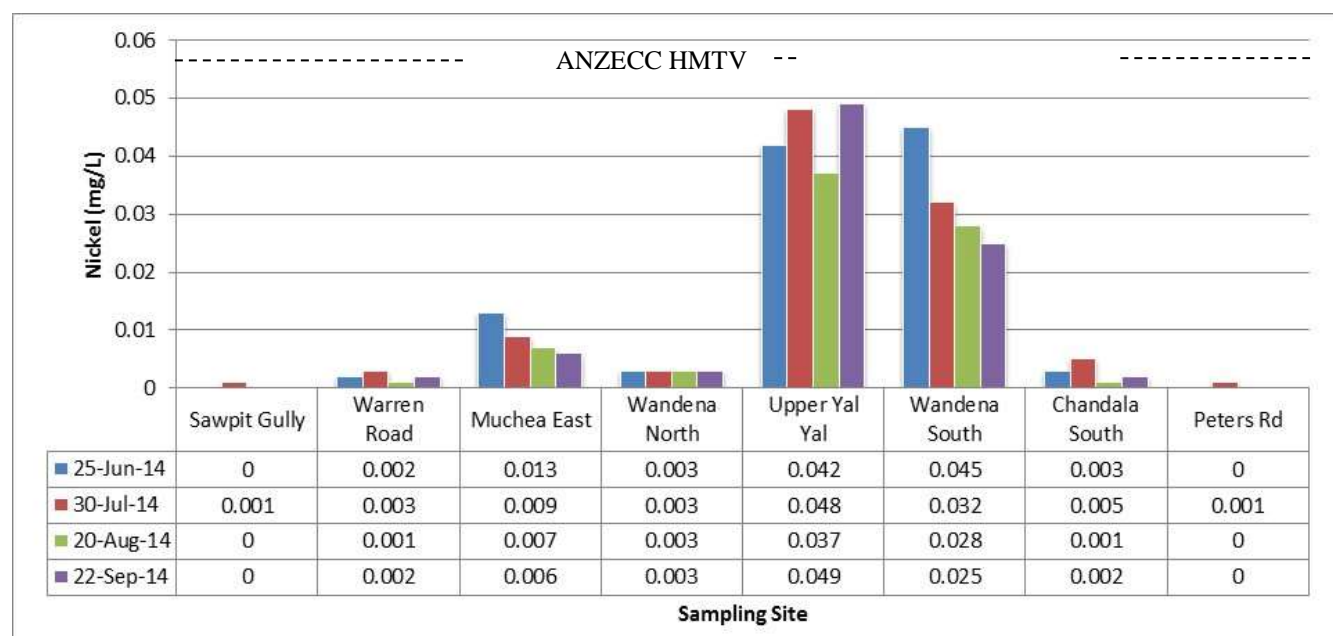
**Figure 30:** Nickel concentrations in surface water within the Ellen Brook catchment between June and September 2014. \*Note blanks represent no sample

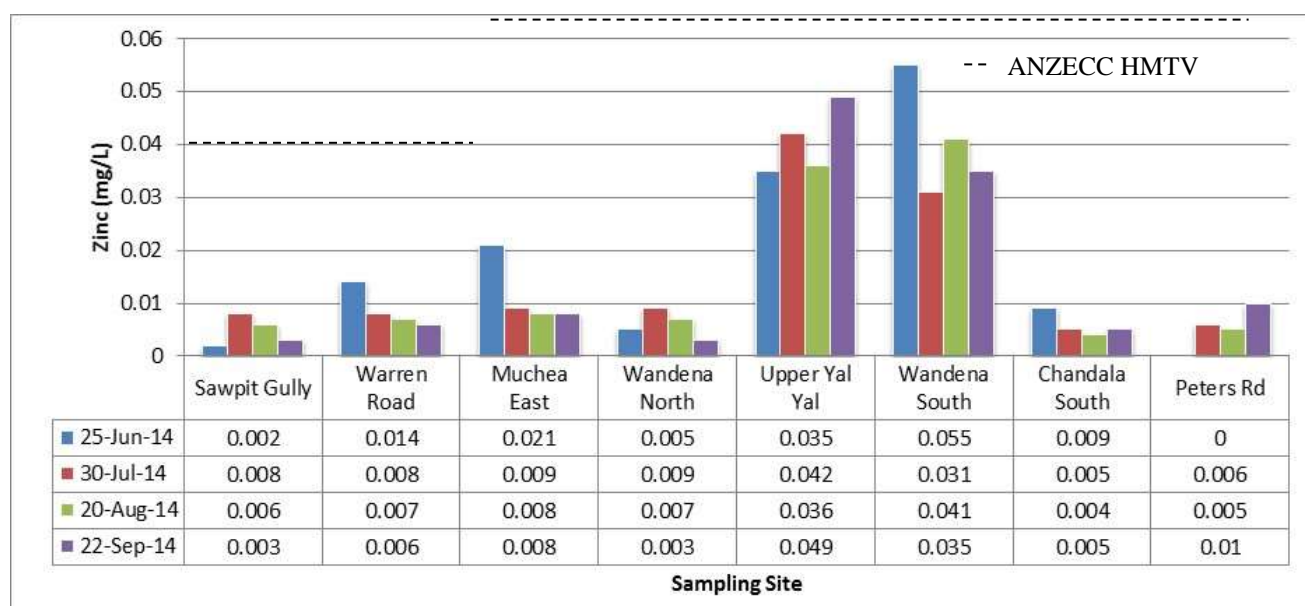
Concentrations of Zinc rarely exceed 0.01mg/L in natural water. Higher concentrations can be associated with pollution from industrial wastes or corrosion of zinc coated plumbing or galvanized water tanks, particularly in areas of low pH (ANZECC and ARMCANZ, 2000).

**Figure 31:** Zinc concentrations in surface water within the Ellen Brook catchment between June and September 2014. \*Note that blanks represent no sample

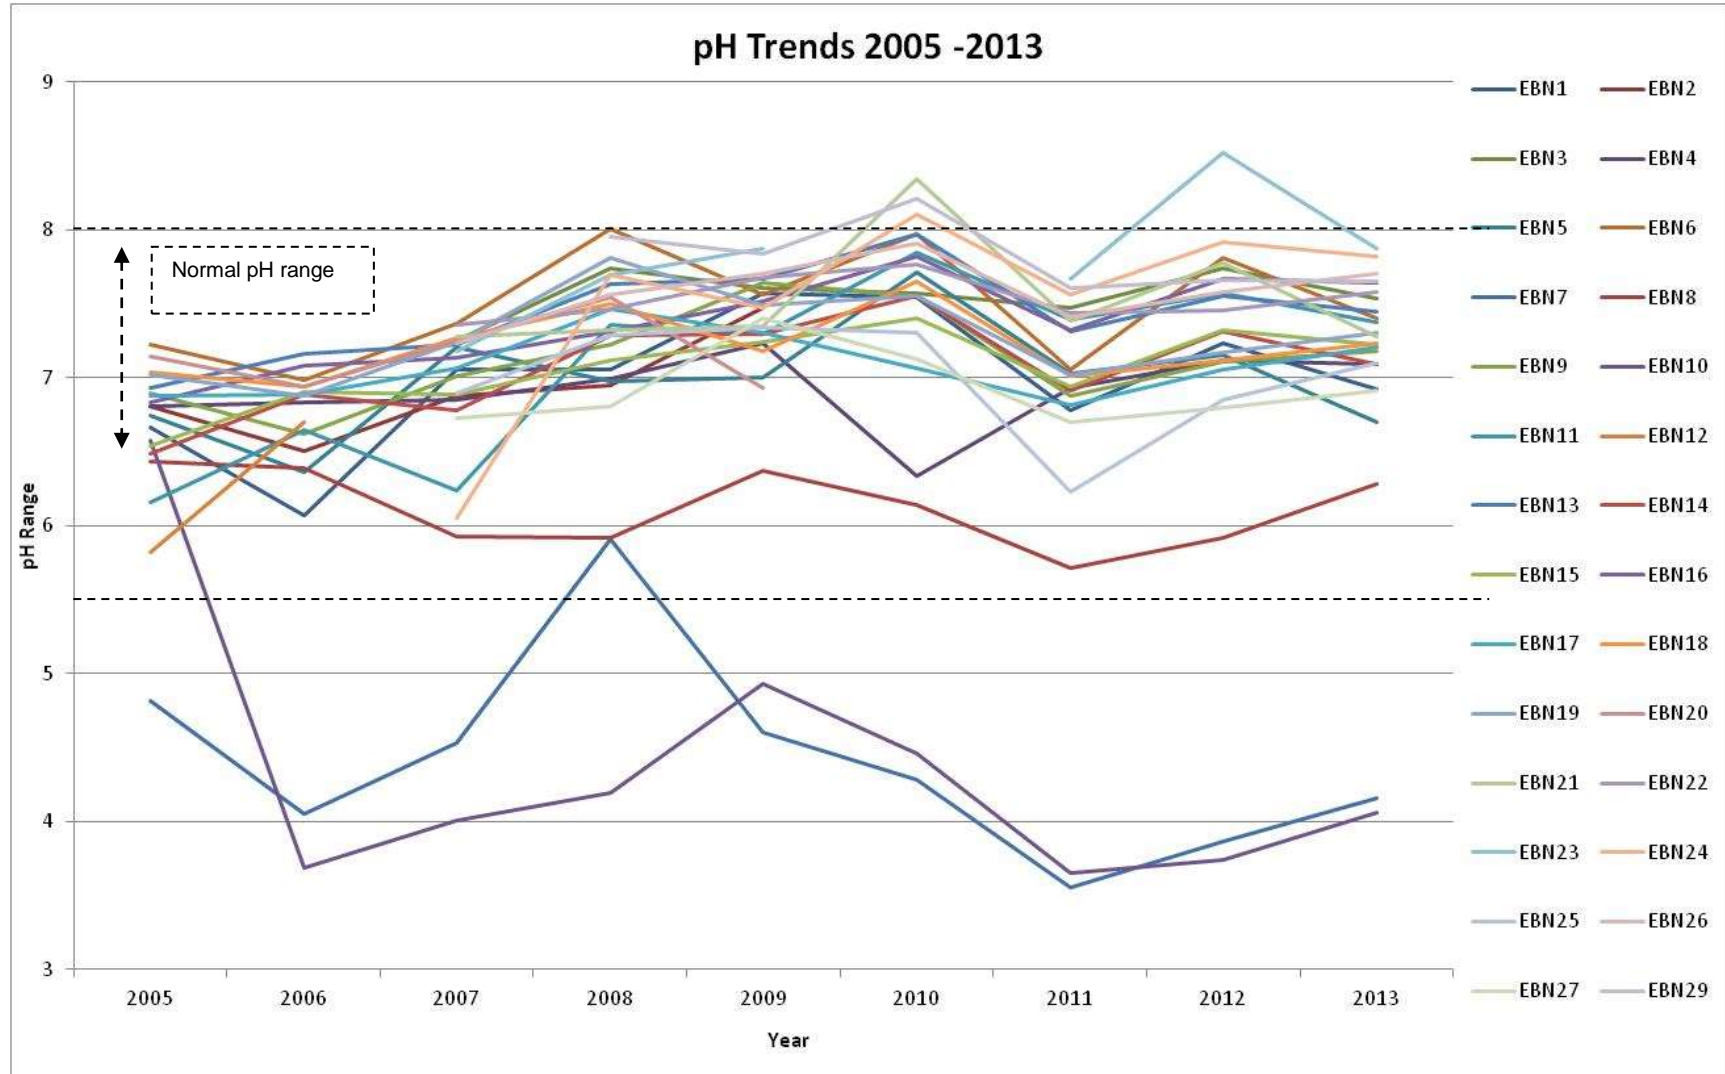
Wandena North has recorded pH values between 3.17 and 8.24. Wandena South recorded pH values between 3.85 and 7.16. Muchea East recorded pH values between 3.15 and 6.95. It is interesting to note that in 2005 at Muchea East pH values were all above 6.3; however 2006 to 2014 averages being considerable lower. In 2014 the average pH was 4.29 which is relatively consistent with the years since 2005. There has definitely been a been a drastic fall in pH at Muchea East. The following graph has been included to illustrate the average pH trends from 2005 through to 2014 for each site(Figure 32). It is evident that the majority of sites have remained within the guideline. The few sites that have acidity issues are quite different from the other sites.

**Figure 32: Average pH levels in surface water within the Ellen Brook catchment between 2005 and 2013.**
